**Joint ICTP/IAEA Advanced Workshop on Earthquake Engineering
for Nuclear Facilities**

**Kashiwazaki-Kariwa Nuclear Power Station's
Case of Evaluation on Plant Integrity and
Seismic Reinforcement**

Yamamiya T.
*Tokyo Electric Power Company
Japan*

Dec 4, 2009

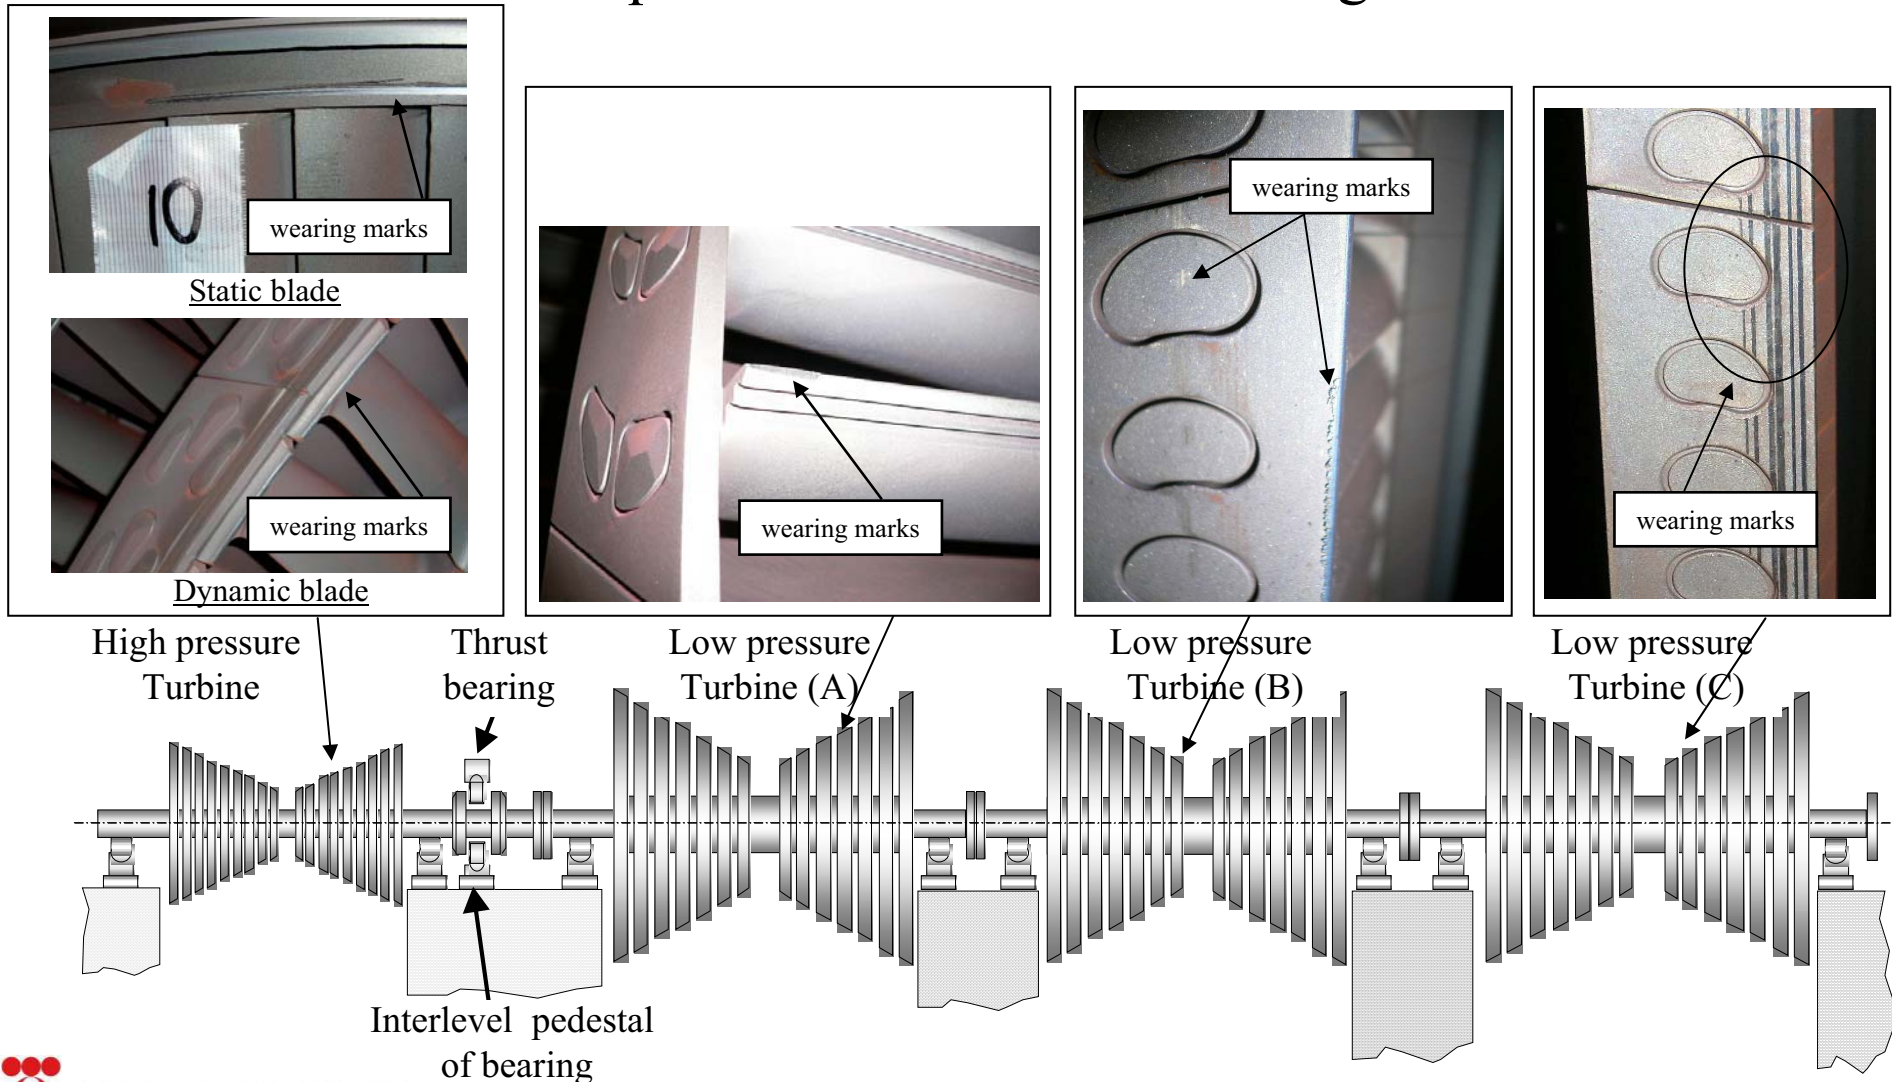
Minor damages such as turbine blade wearing marks not to decrease safety of NPS

- Due to NCO earthquake: turbine blade wearing marks

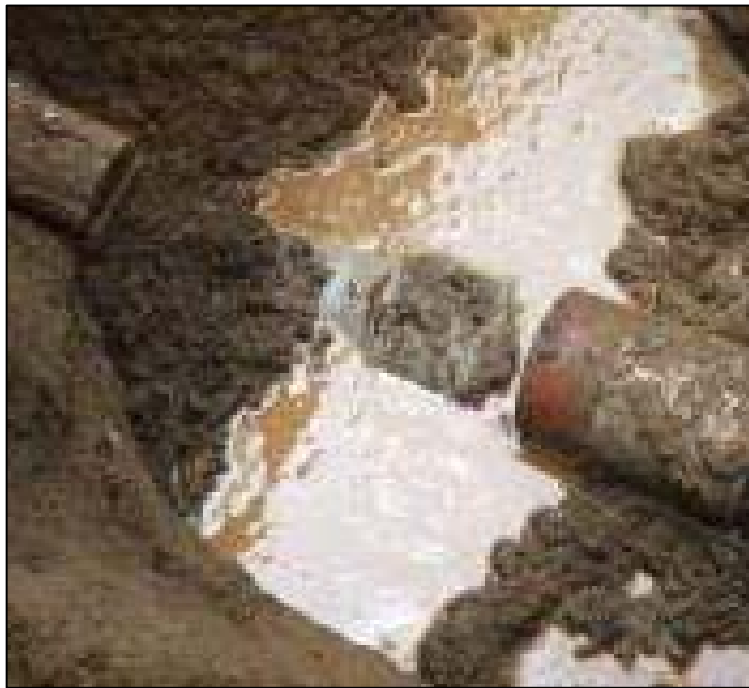
■ Fire Protection Piping joint Rupture

Coupling joint

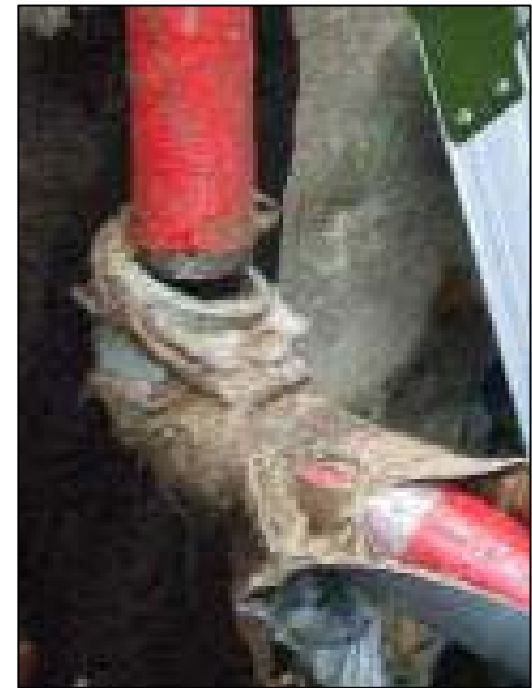
Threaded joint

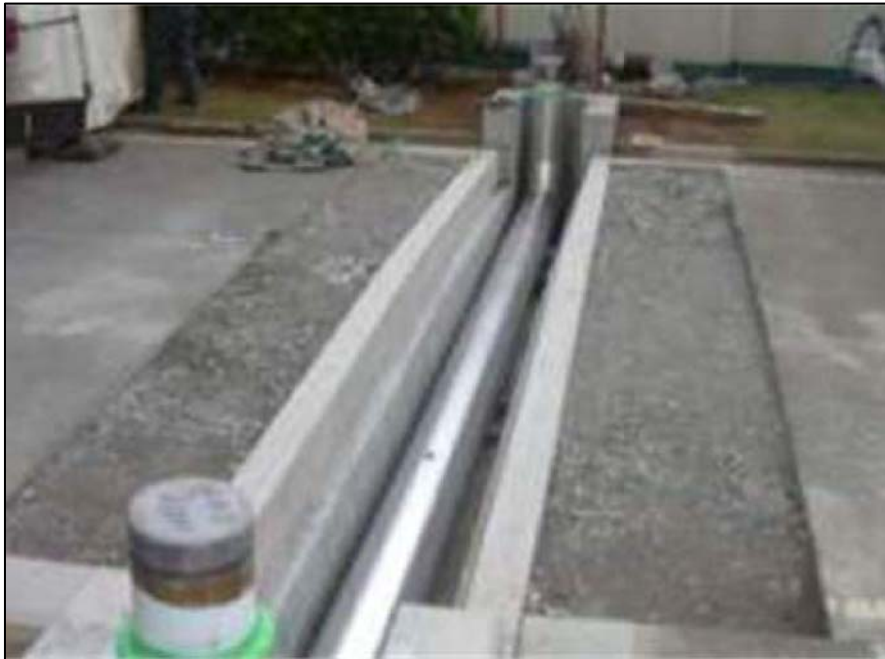
FP piping trench

- Fire Protection Piping joint Rupture
 - Restoration state

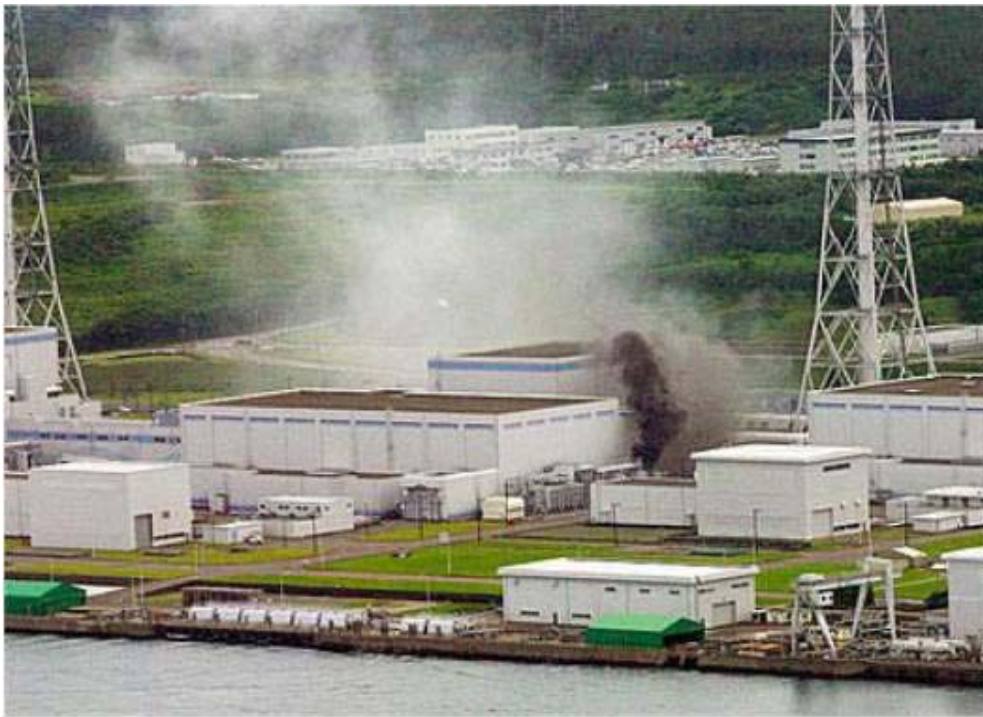
A fire of house transformer

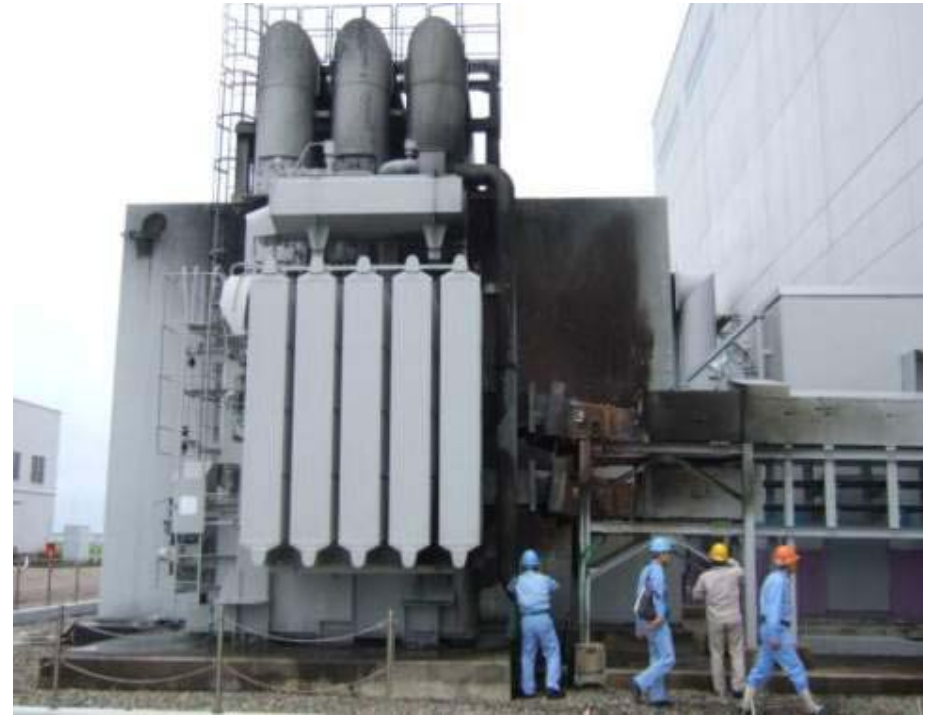
Burned house transformer

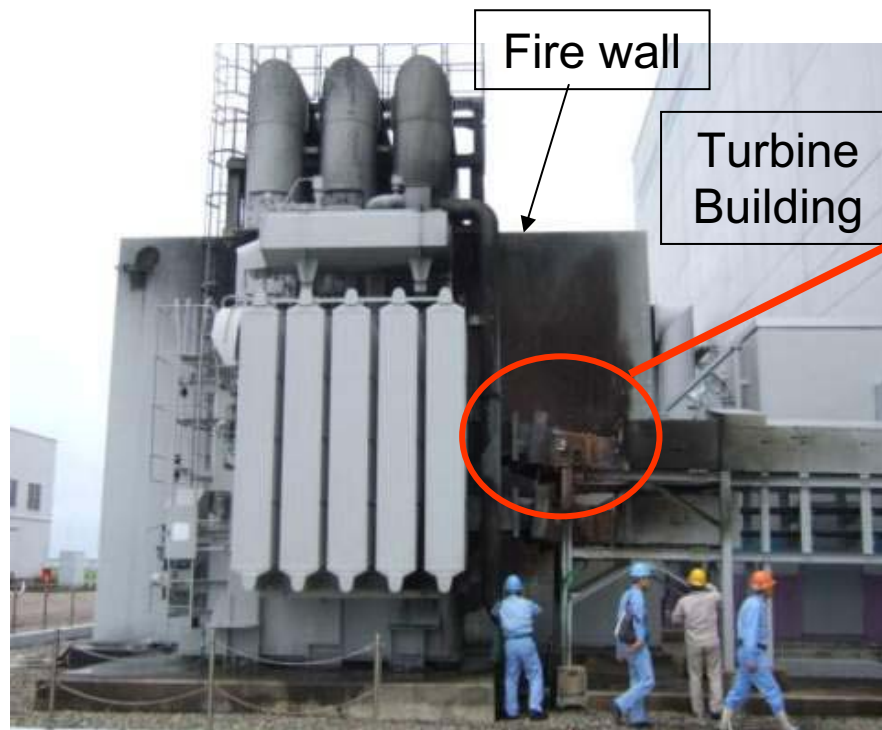
Fire of House Transformer of unit 3

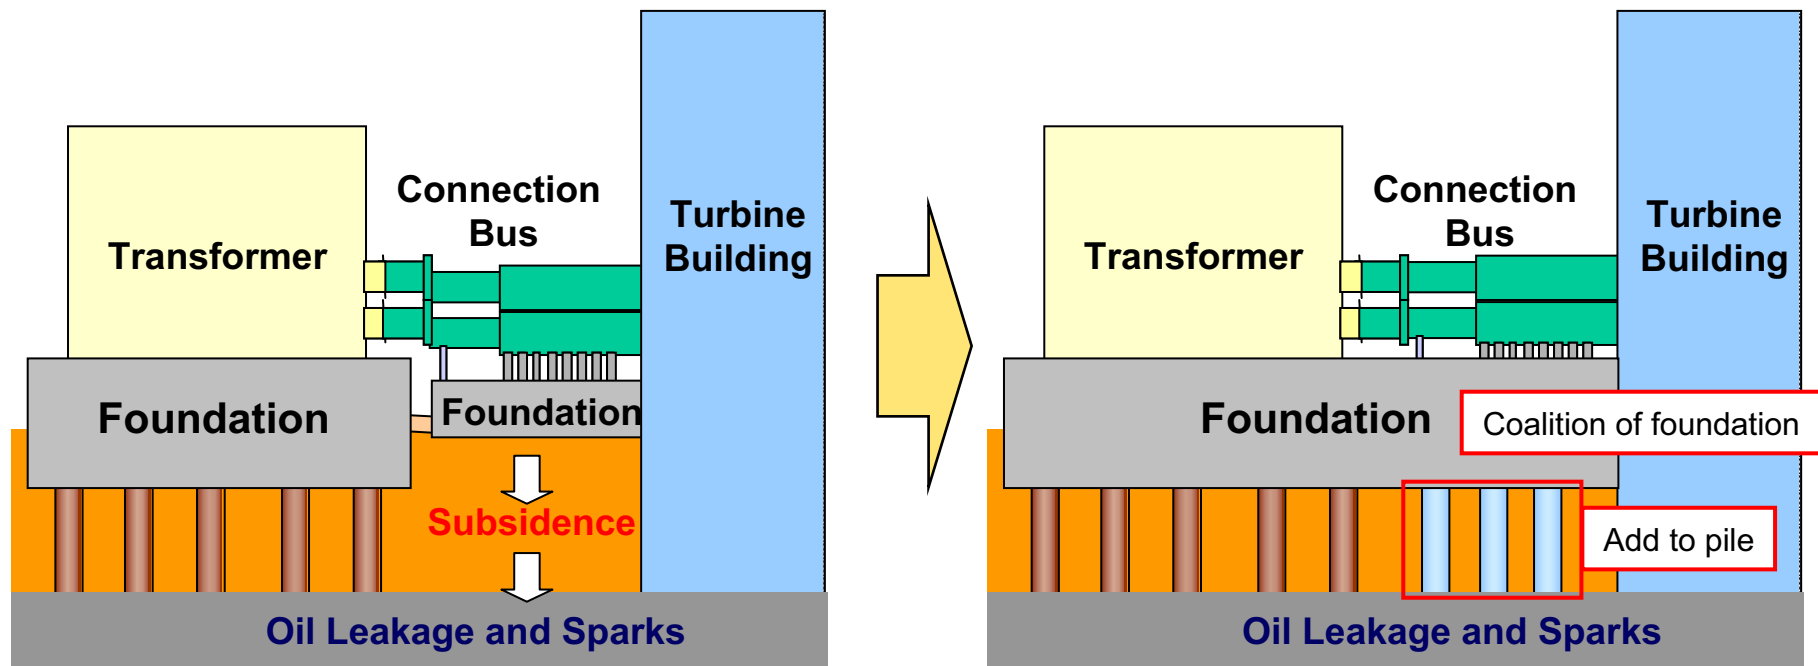
Damage situation

Restoration state

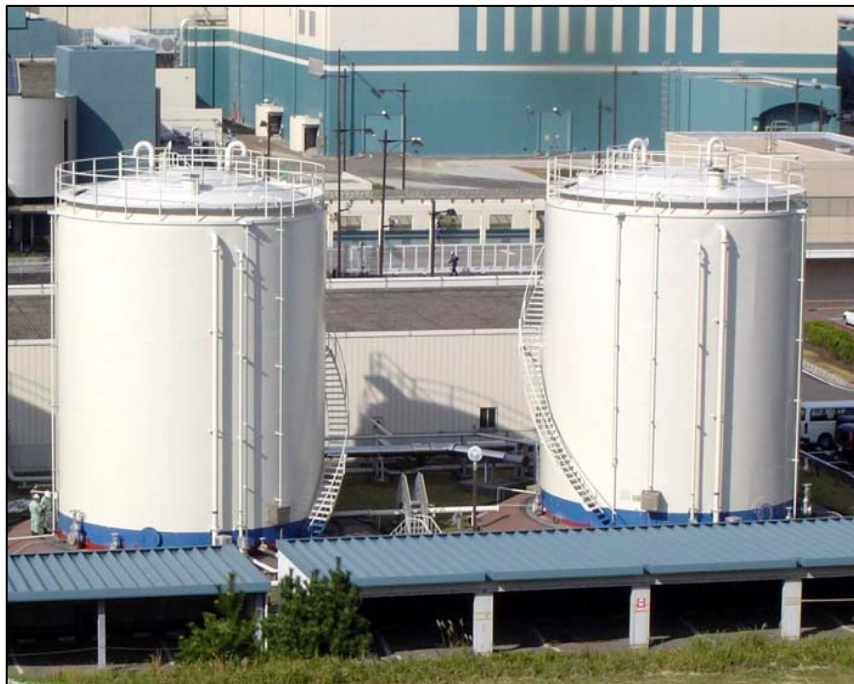
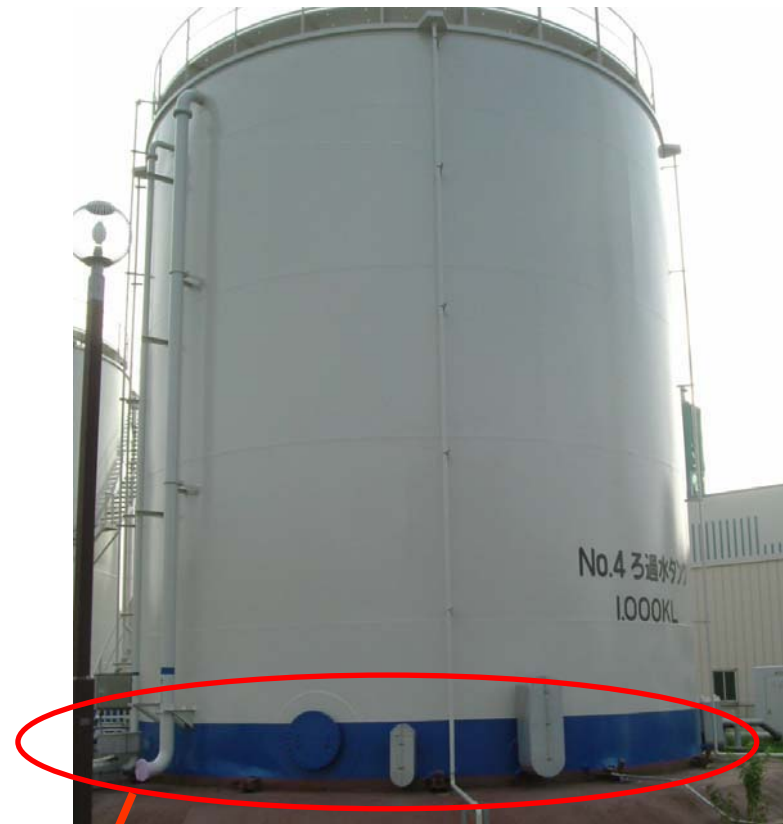
Anchor Bolts and Brackets were damaged

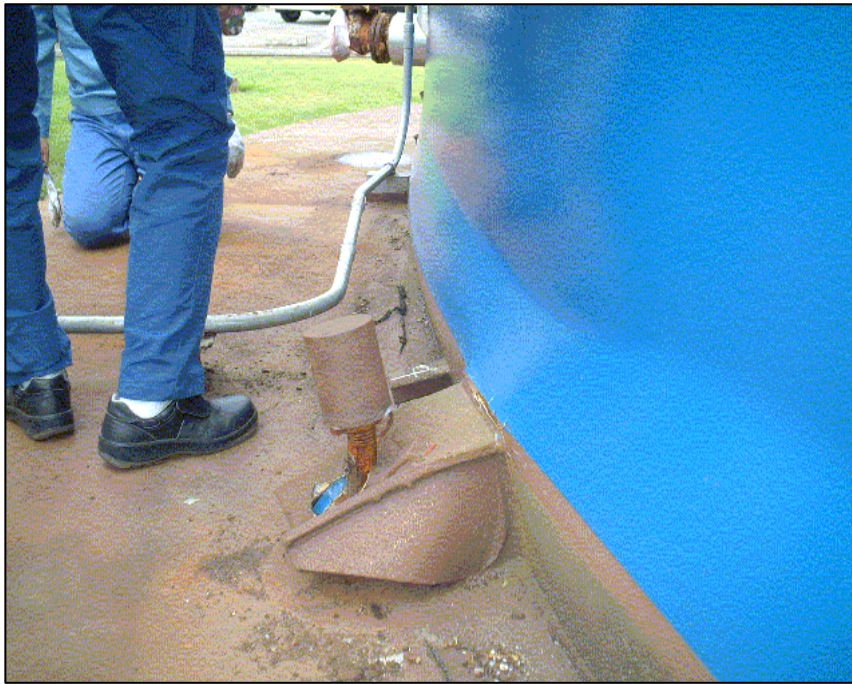
Damage of Anchor
Bolts and Brackets

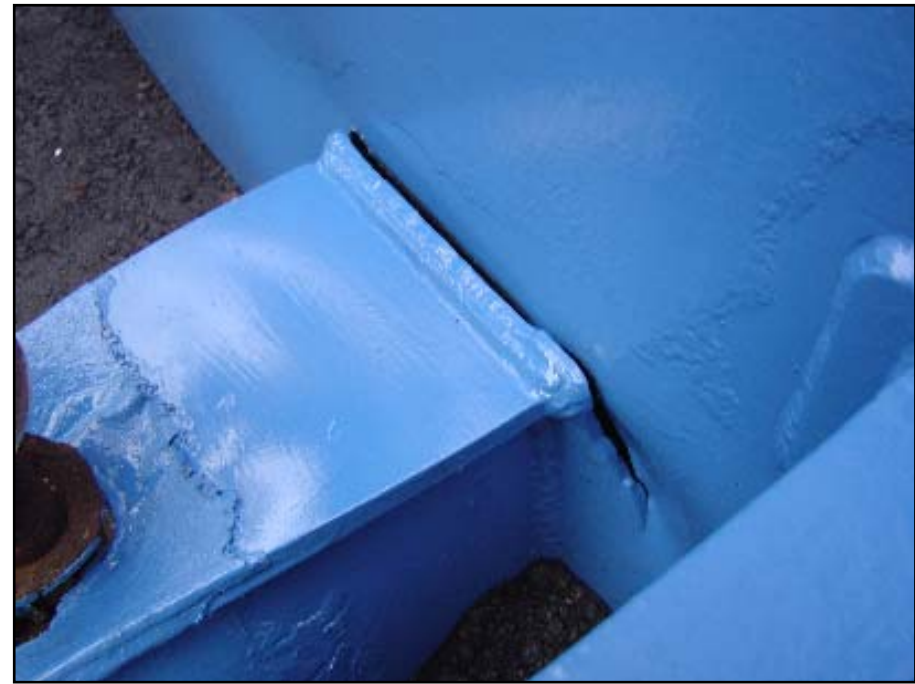
Leakage from the Tank

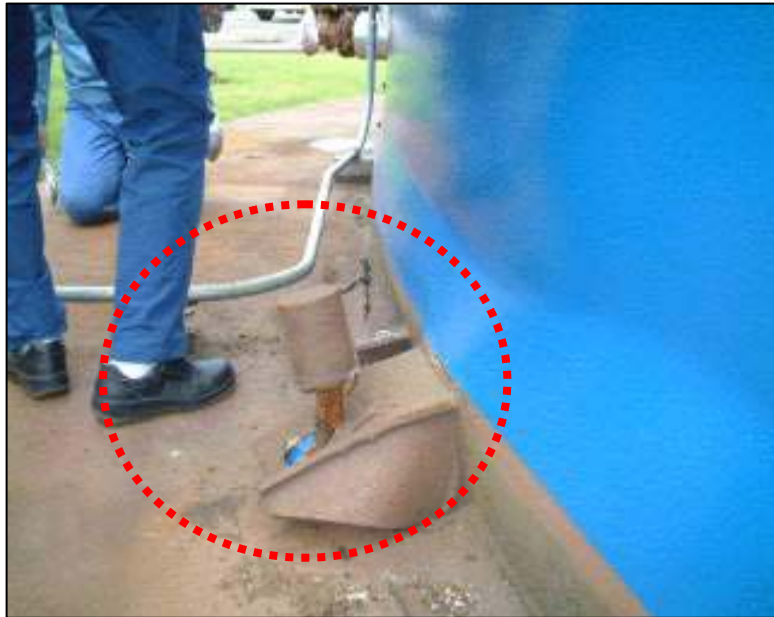
Damage situation

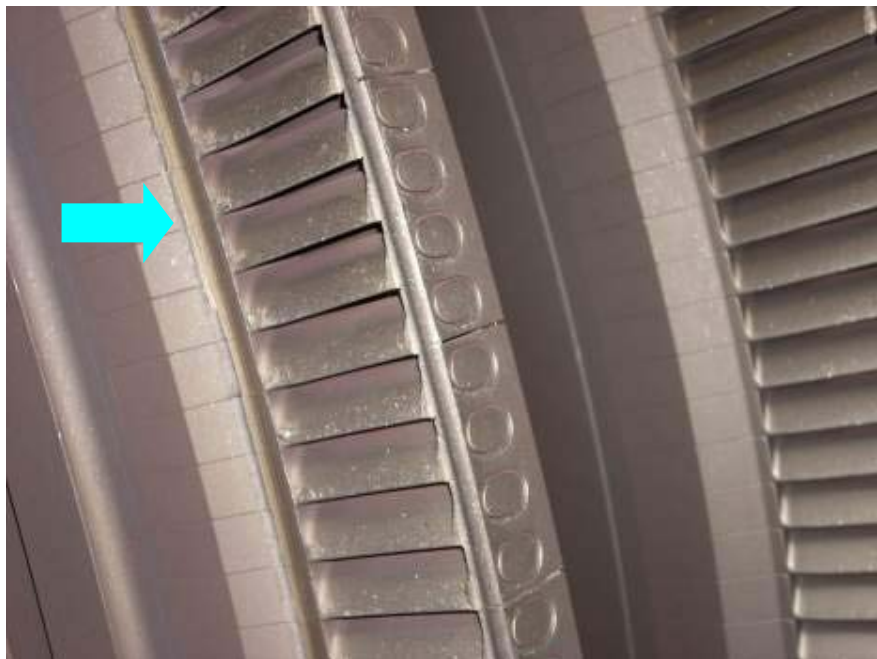
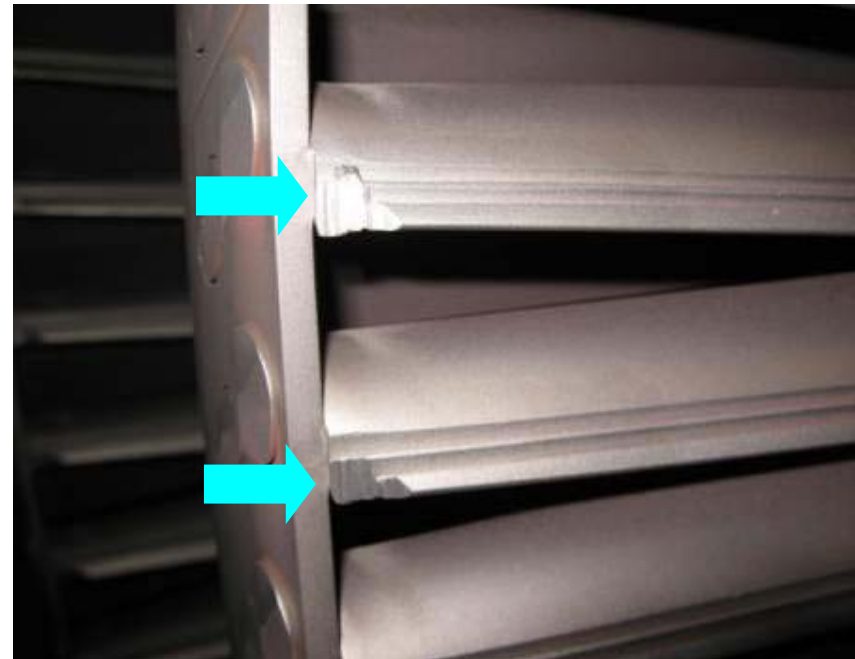
Turbine Blade Wear Marks of KK-3/4 LP(A)

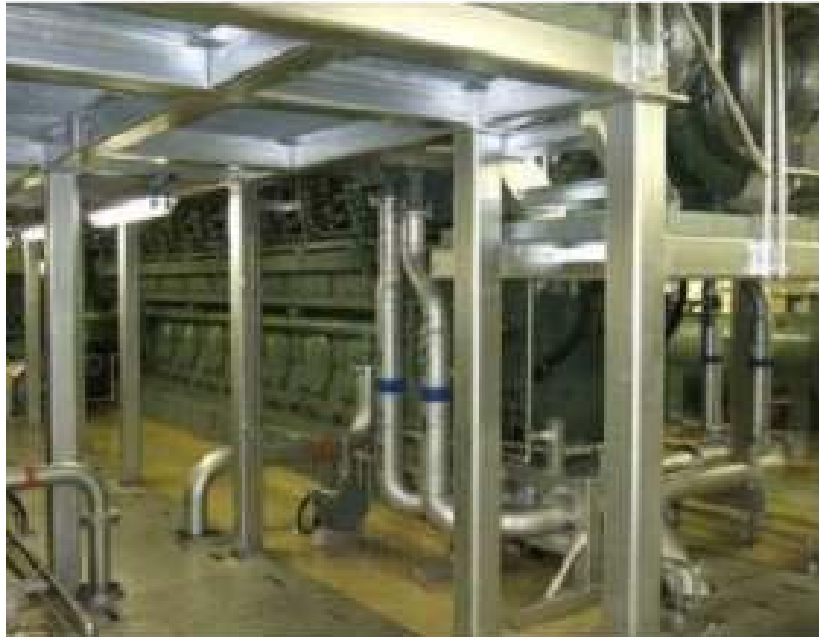
Diesel Generator

■ **No Damage in Safety Related Facilities**
