**Advanced Conference on Seismic Risk Mitigation and Sustainable  
Development**

**EARTHQUAKE ENGINEERING LESSONS FROM STRONG EARTHQUAKES  
RELATED TO ADVANCED WAYS FOR SEISMIC RISK MITIGATIONS**

G. Rodolfo Saragoni  
*Universidad de Chile  
Santiago  
Chile*

# *THE 2010 CHILE, $M_w=8.8$ EARTHQUAKE*

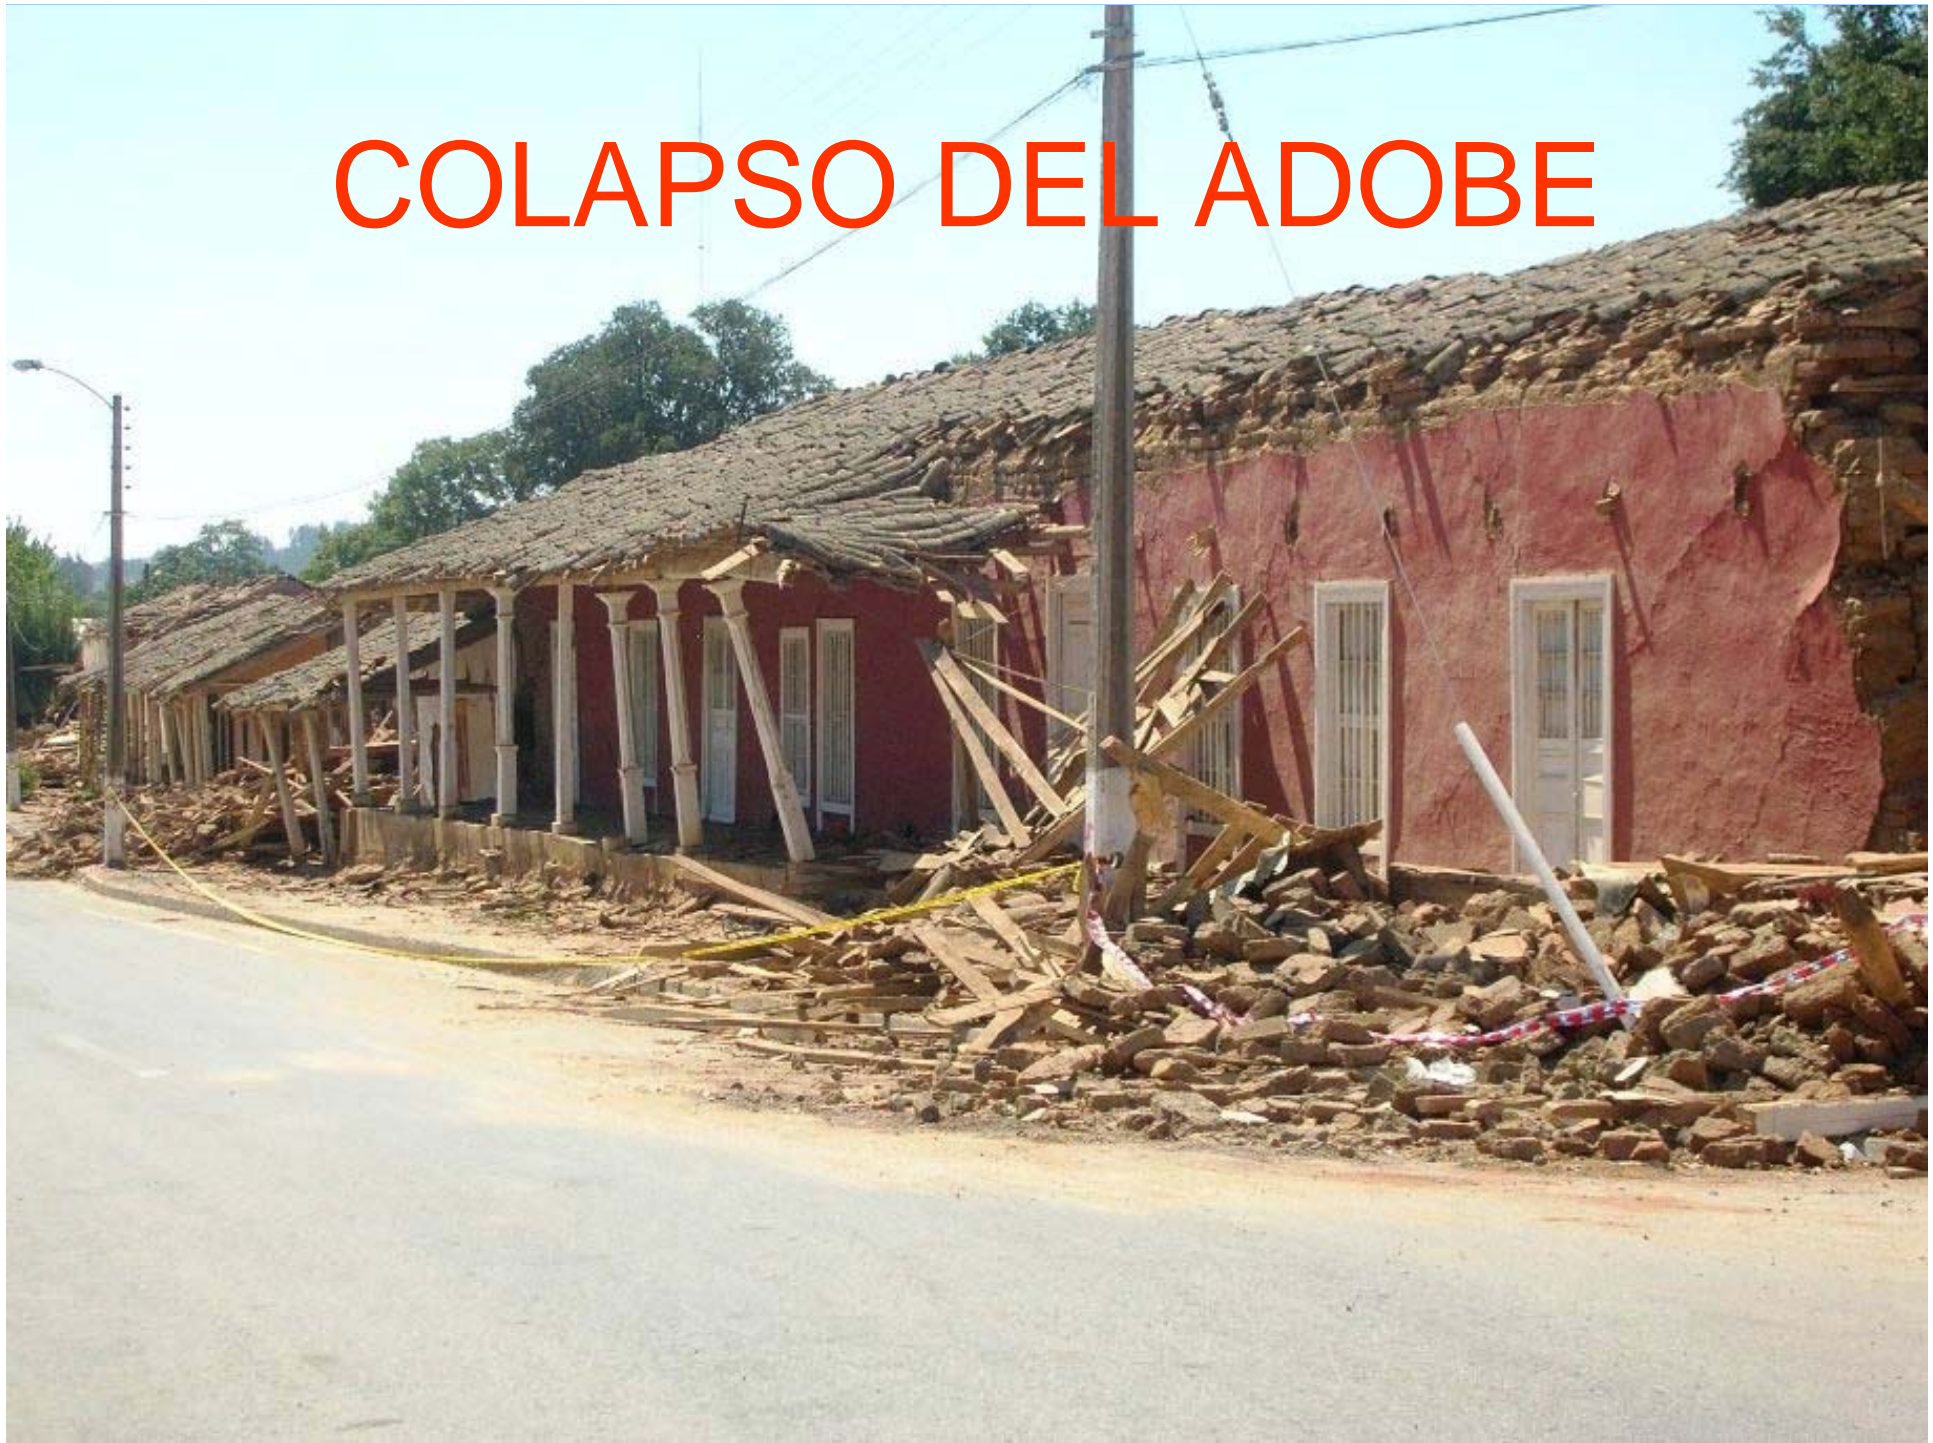
# COLAPSO DEL ADOBE

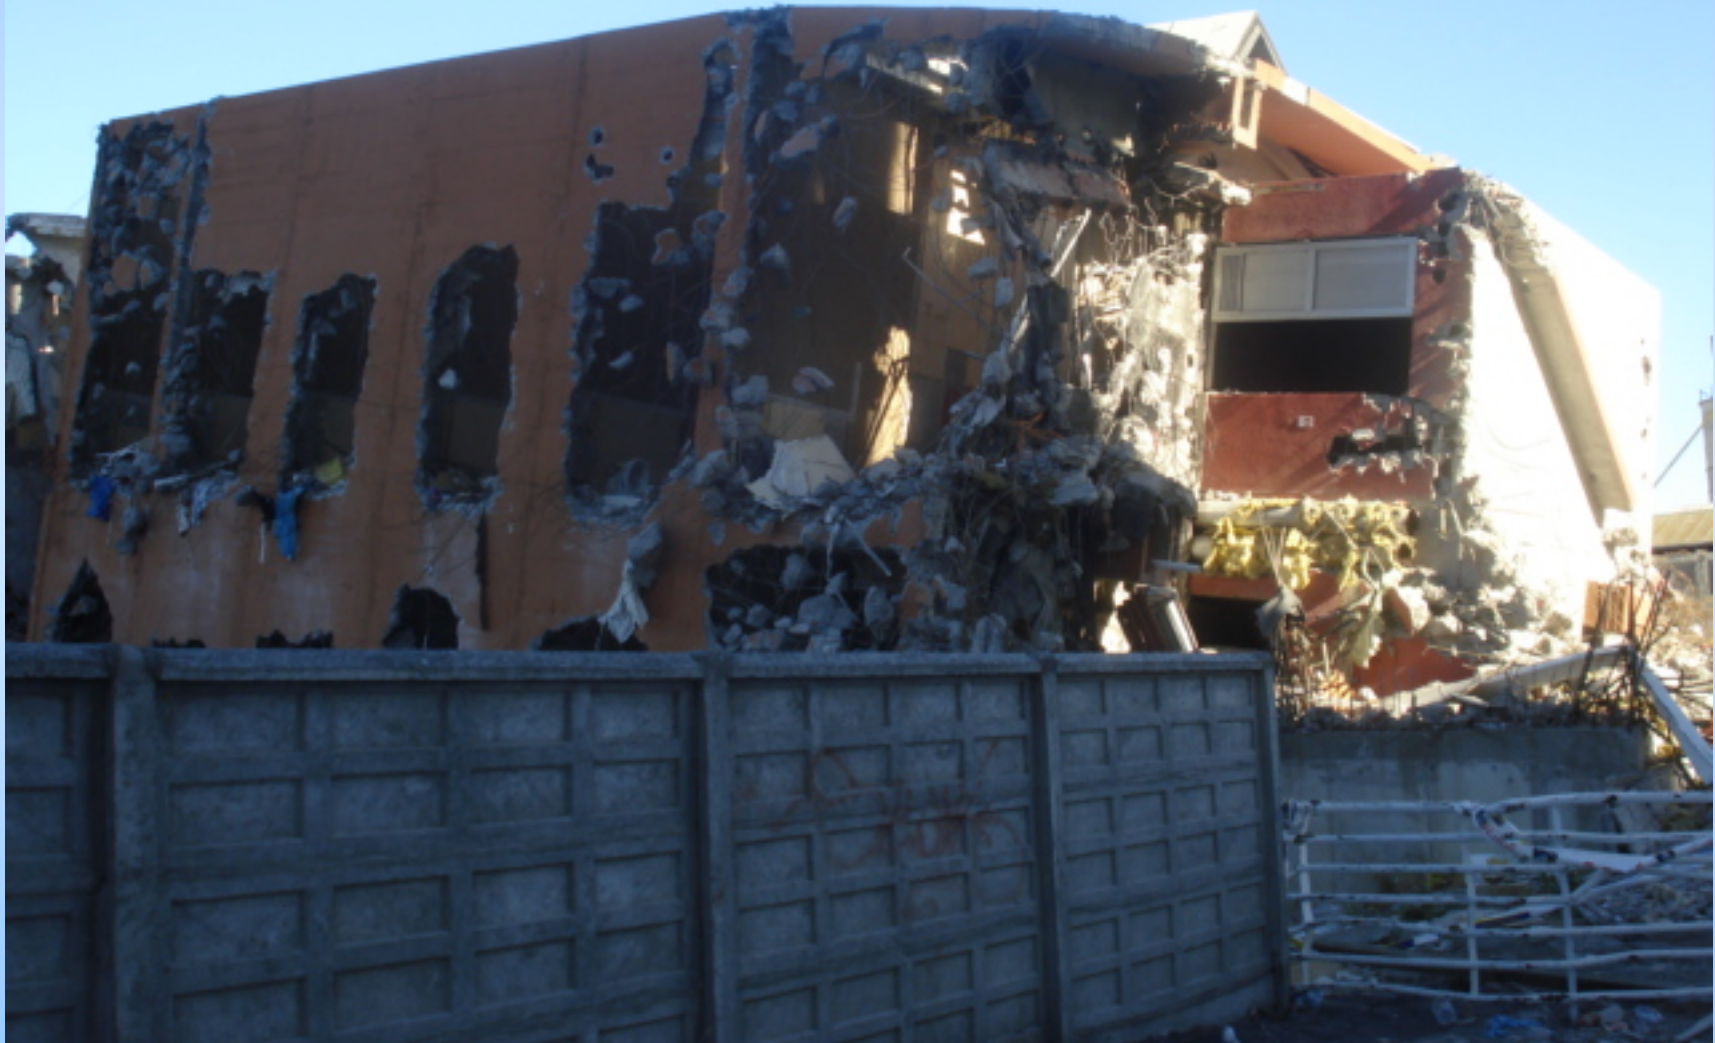
# Alto Río - Concepción

- THREE BUILDINGS COLLAPSED:  
ONE IN CONCEPCION  
TWO IN SANTIAGO

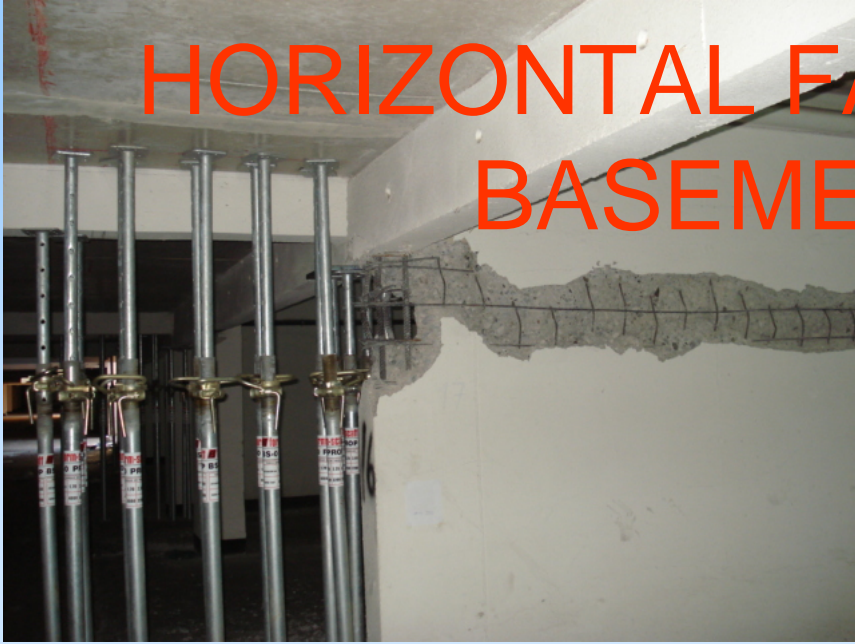
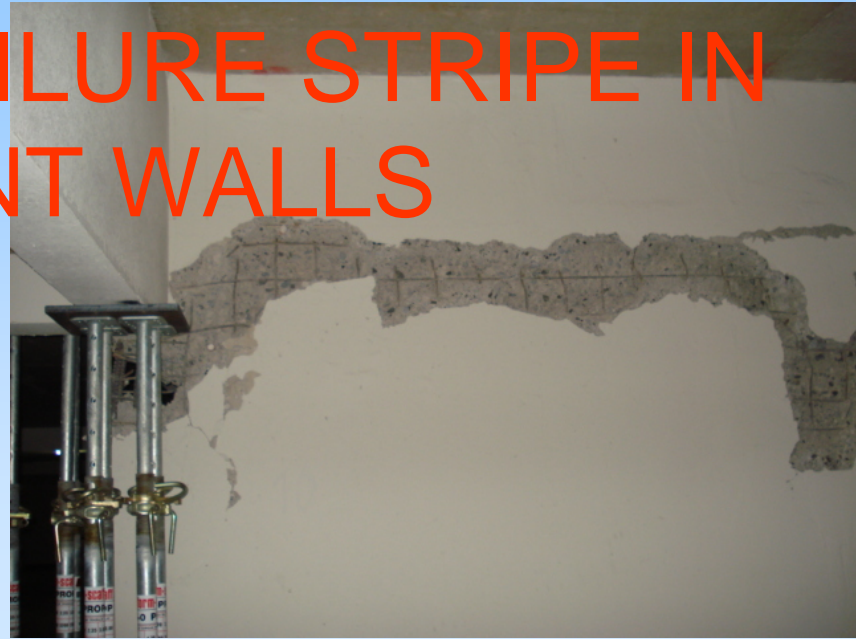
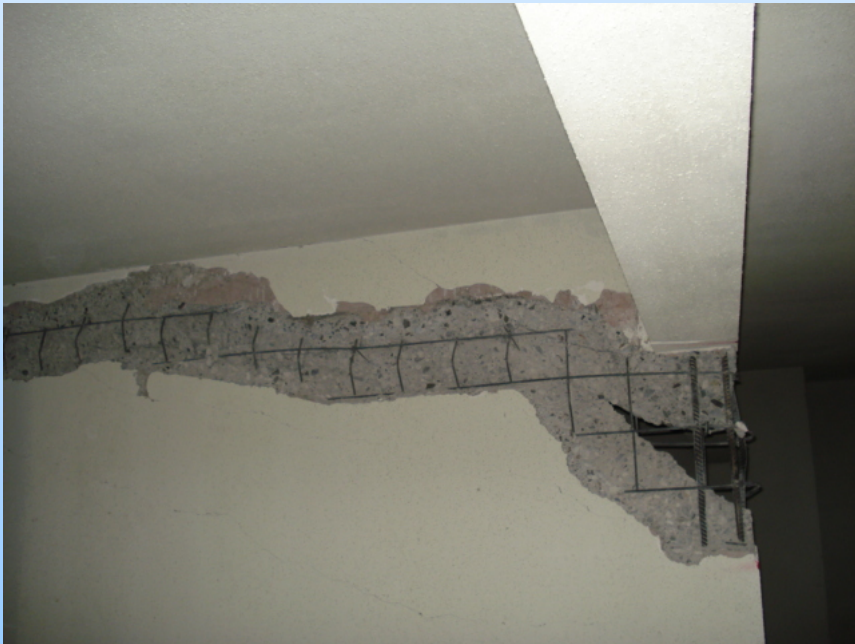
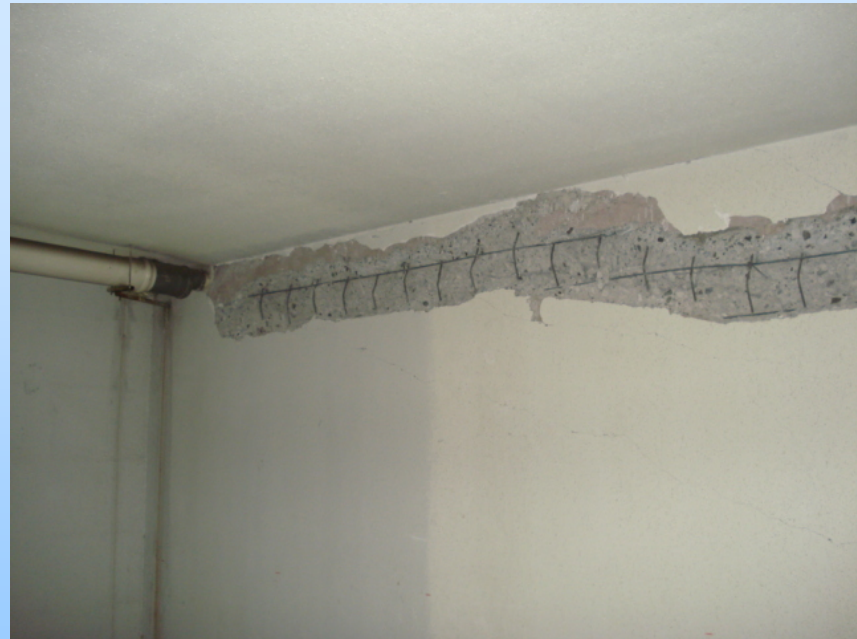
# HORIZONTAL FAILURE STRIPE IN BASEMENT WALLS

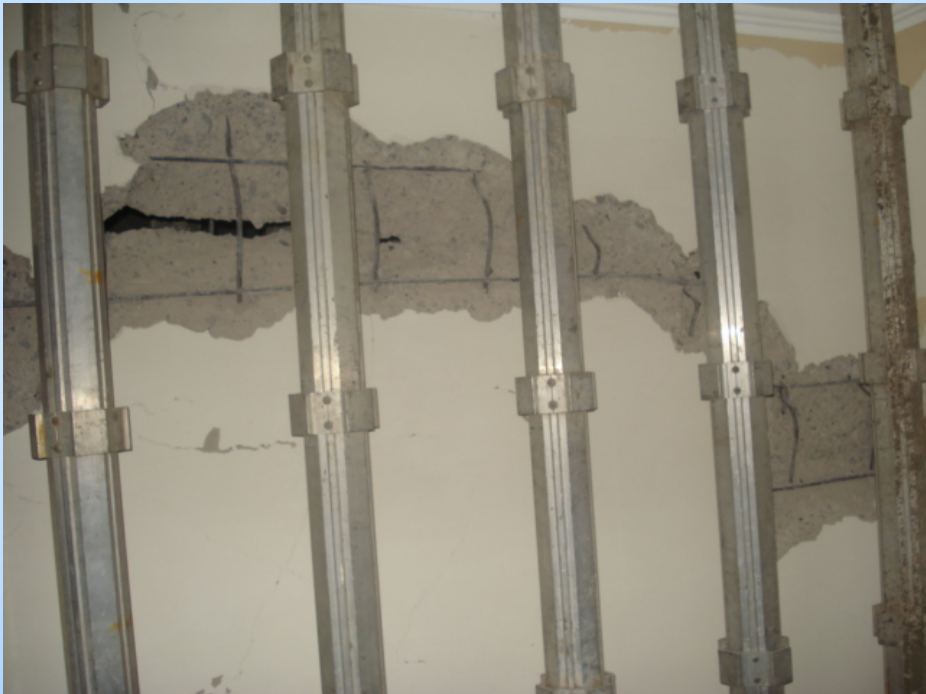
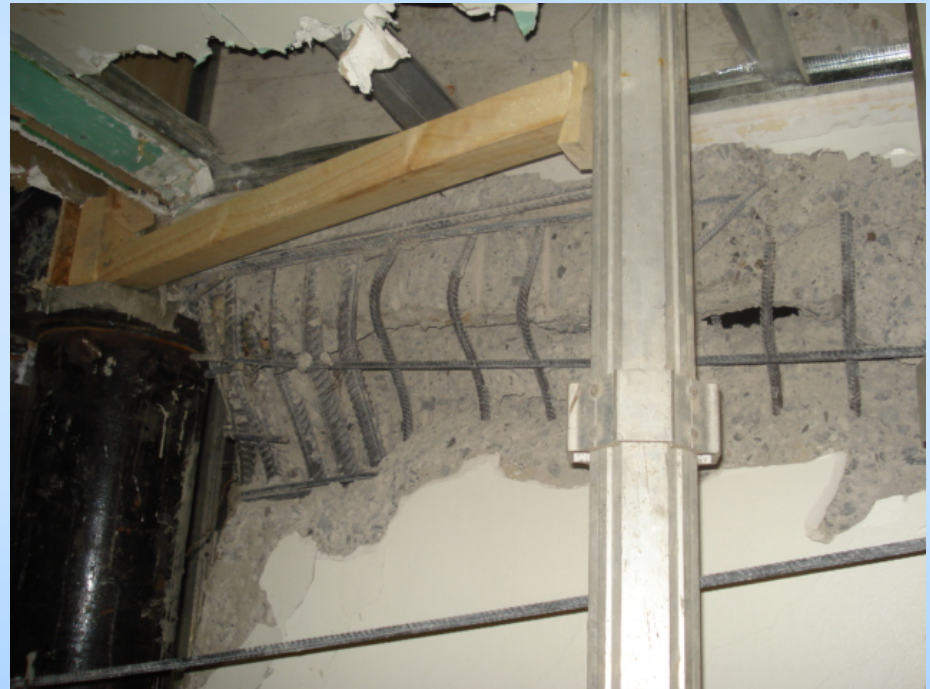
# HORIZONTAL FAILURE STRIPE IN BASEMENT WALLS

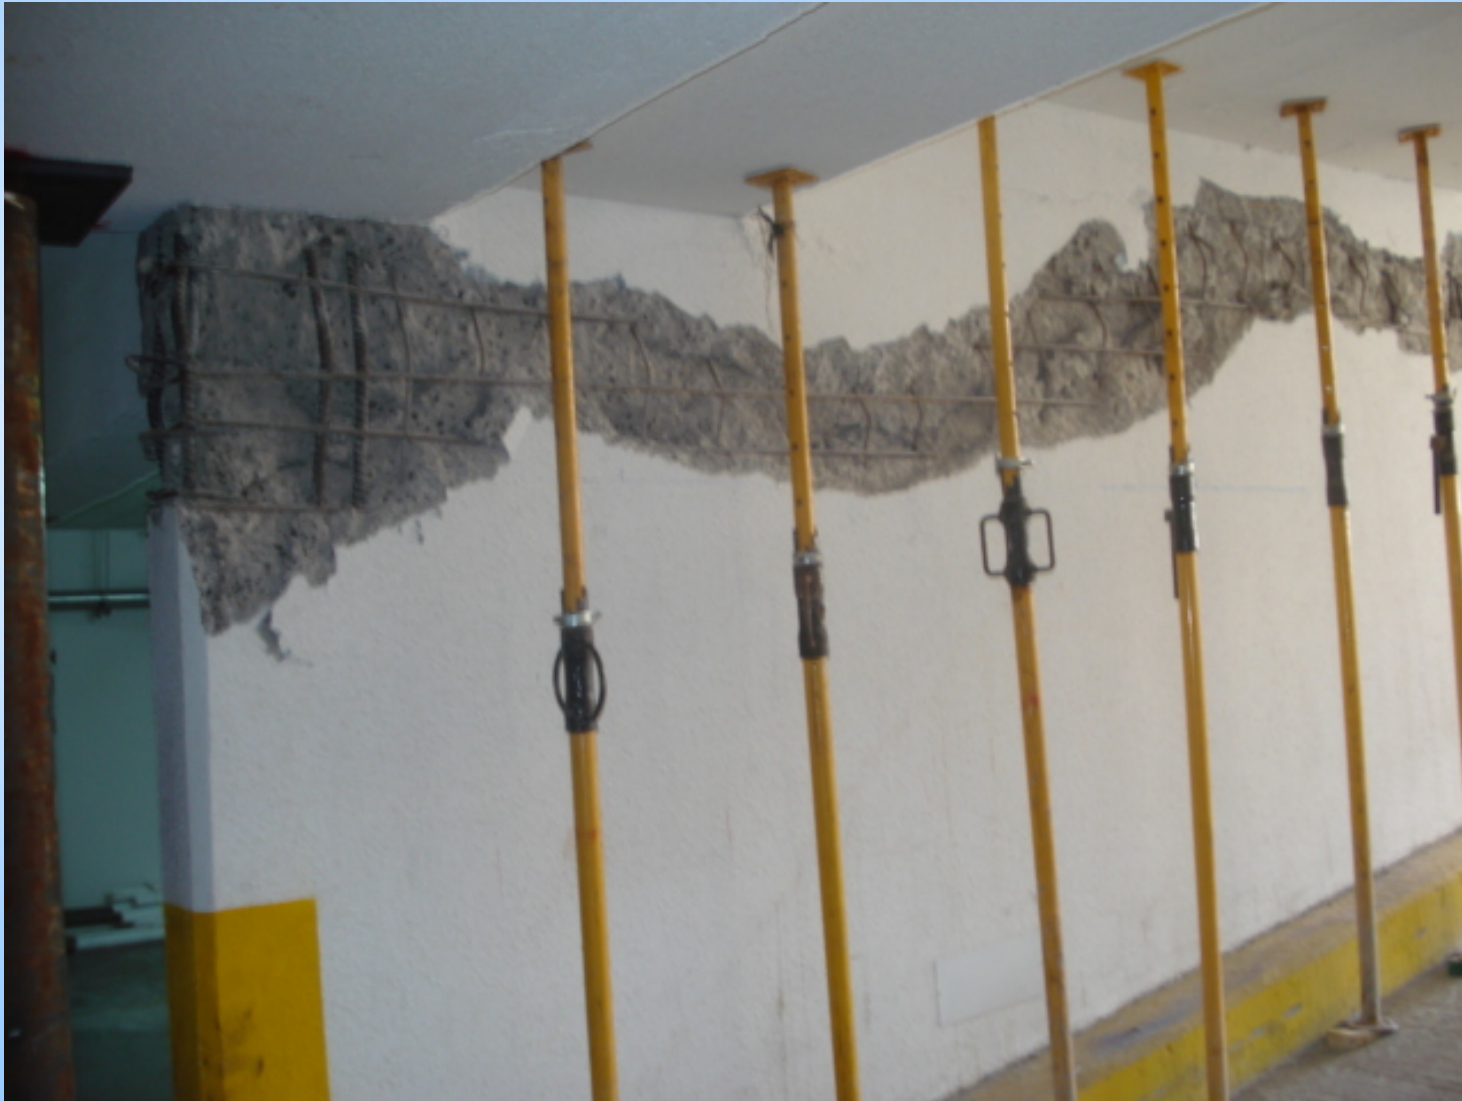
# HORIZONTAL FAILURE STRIPE IN BASEMENT WALLS

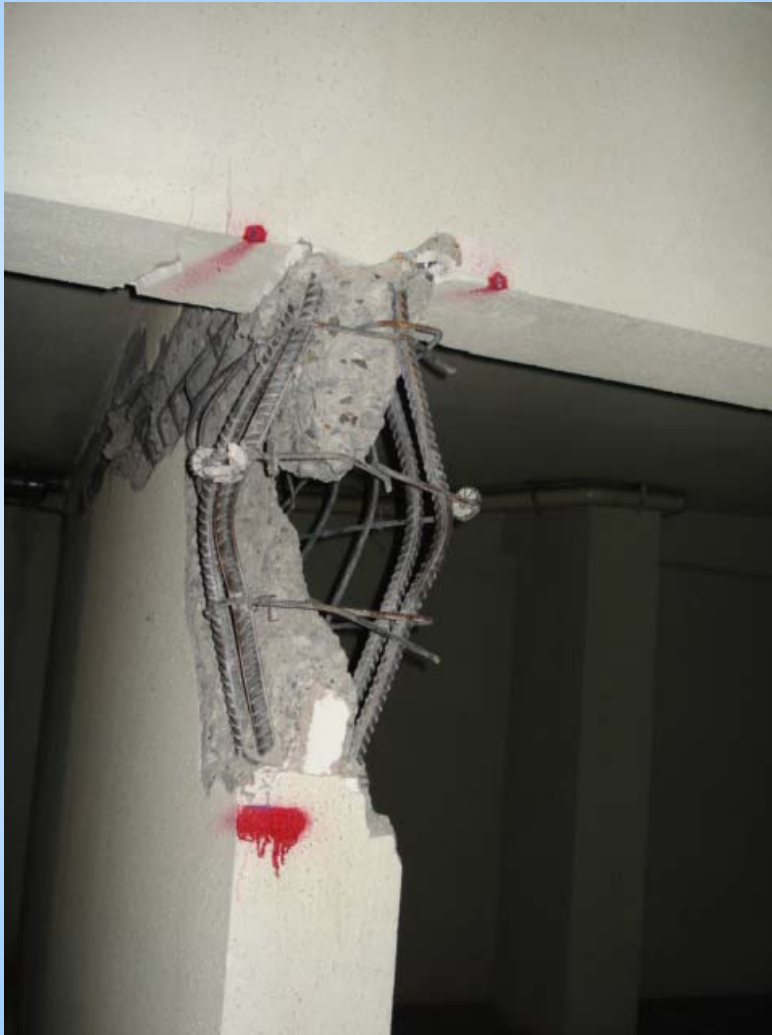
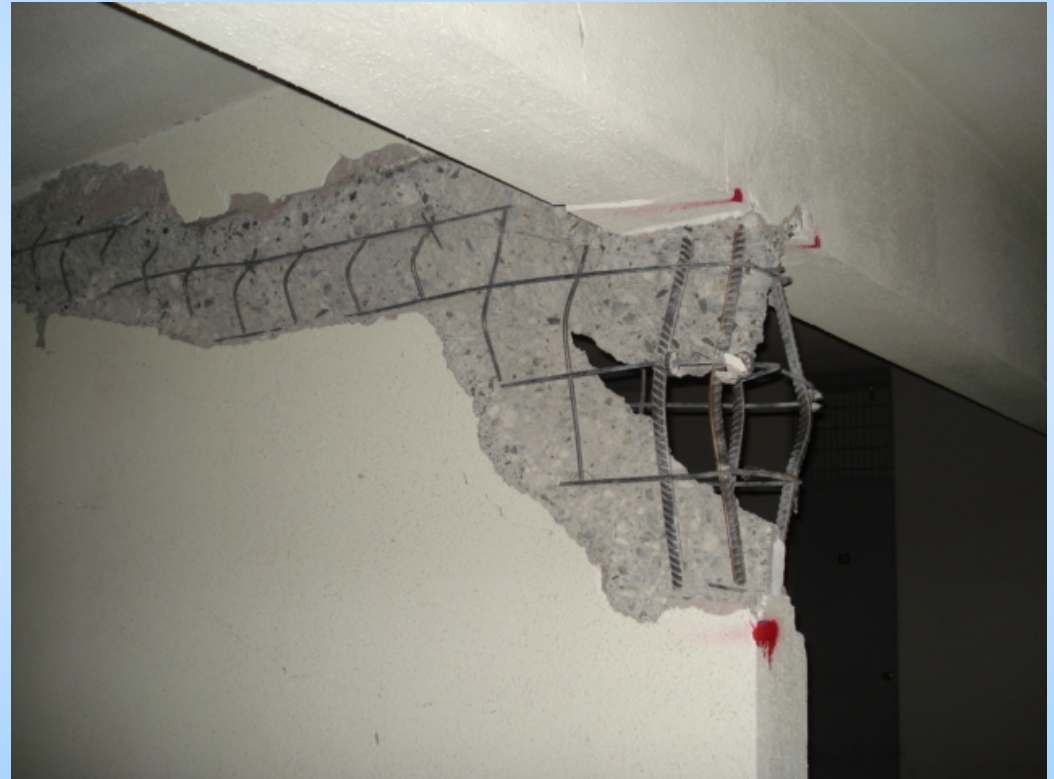
# HEAD OF THE WALL IN THE ZONE OF HORIZONTAL FAILURE STRIPE

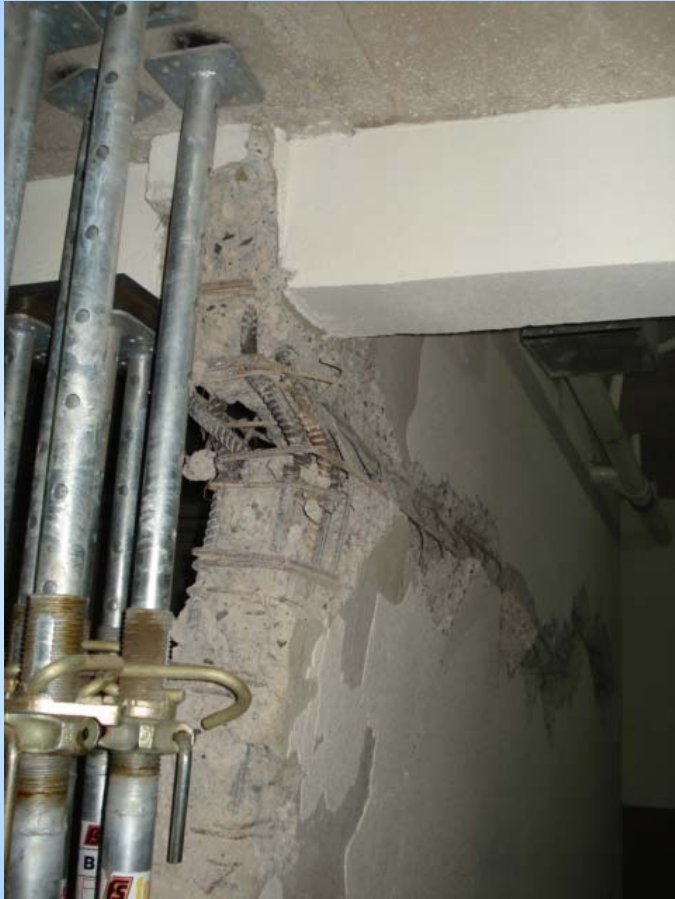
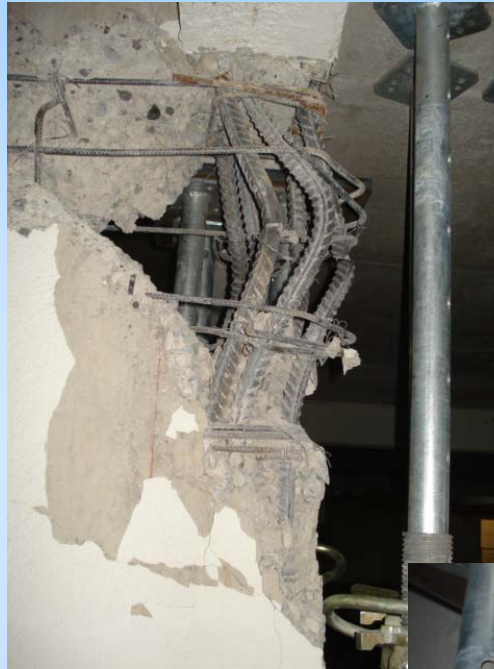
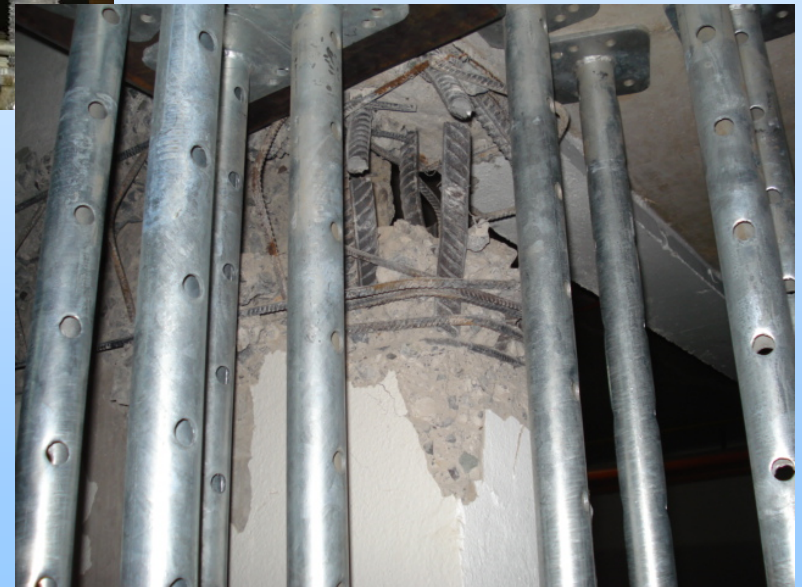
# HEAD OF THE WALL IN THE ZONE OF HORIZONTAL FAILURE STRIPE

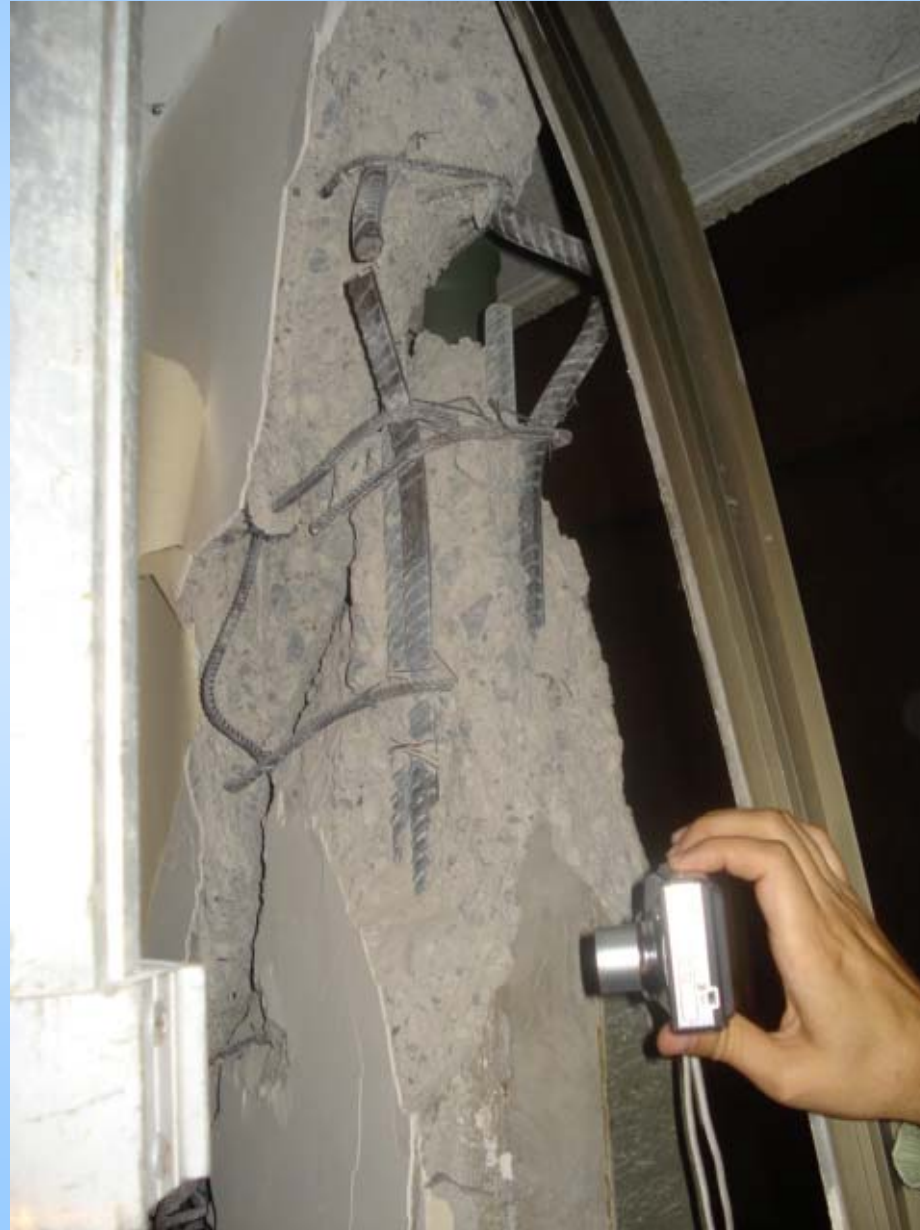
# HEAD OF THE WALL IN THE ZONE OF HORIZONTAL FAILURE STRIPE

**CABEZAL DE MURO FALLADO INCEPIENTEMENTE:  
CON FALLA HORIZONTAL INCIPIENTE, MOSTRANDO GRIETA  
HORIZONTAL ,DESCASCARAMIENTO EN EL CABEZAL Y PANDEO  
DE BARRAS VERTICALES (EDIFICIO DECLARADO INHABITABLE)**

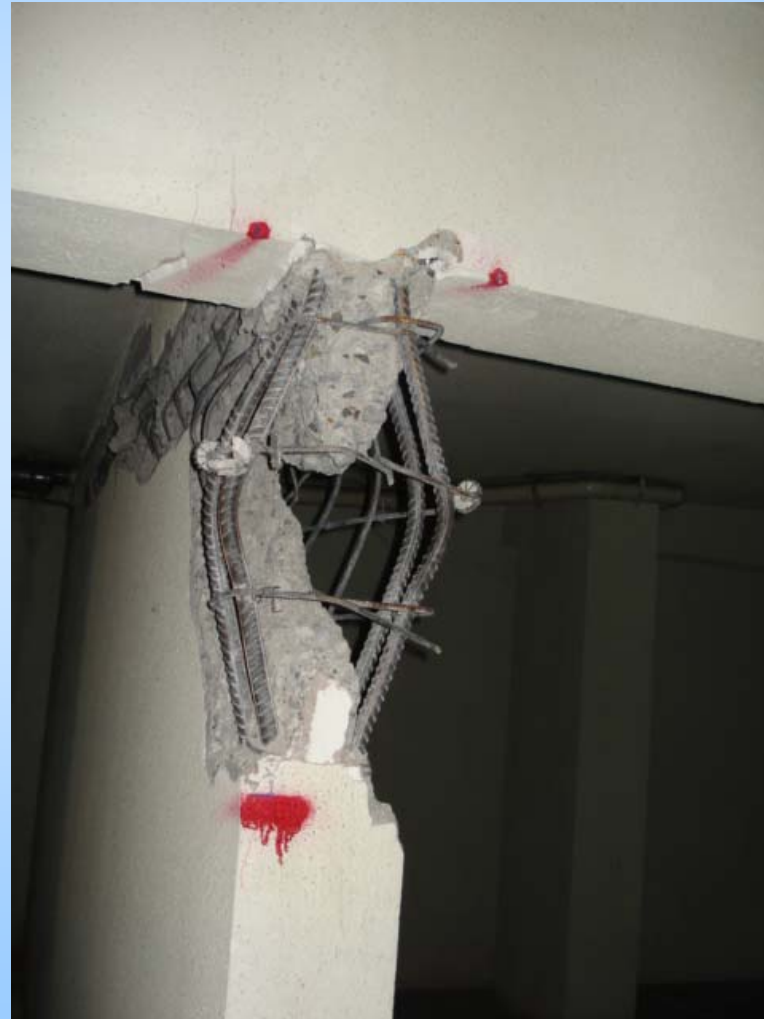
# FAILURE WITHOUT COMPRESSION WITHOUT COVER SPOILING

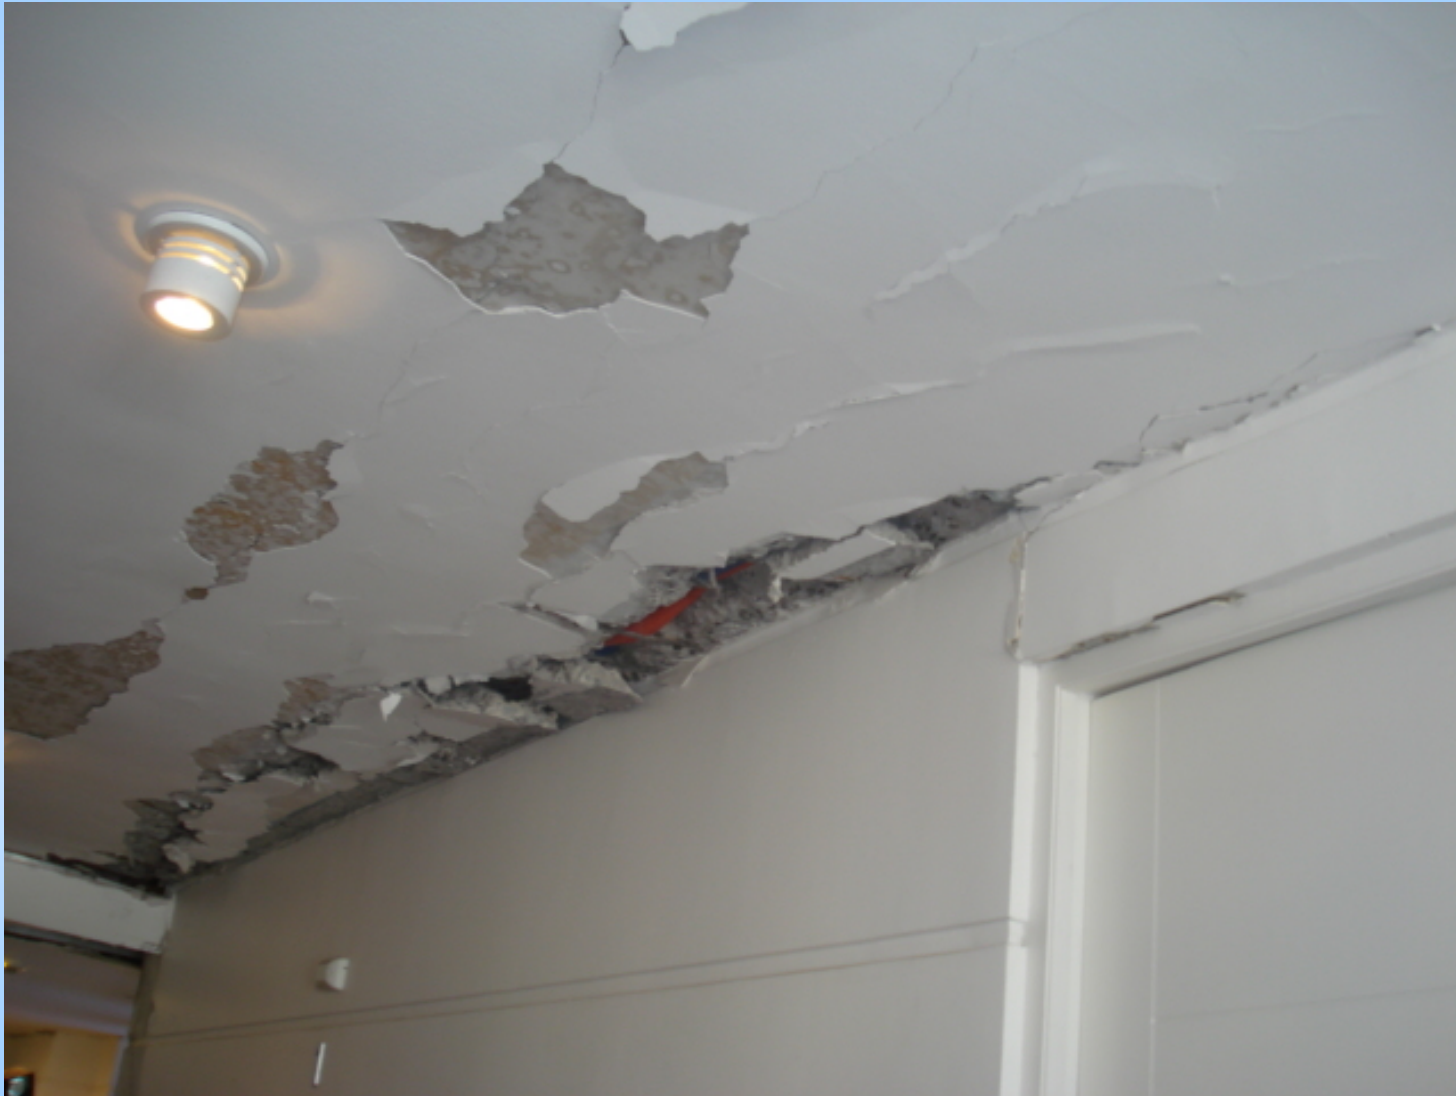
# FAILURE IN UPPER SLABS

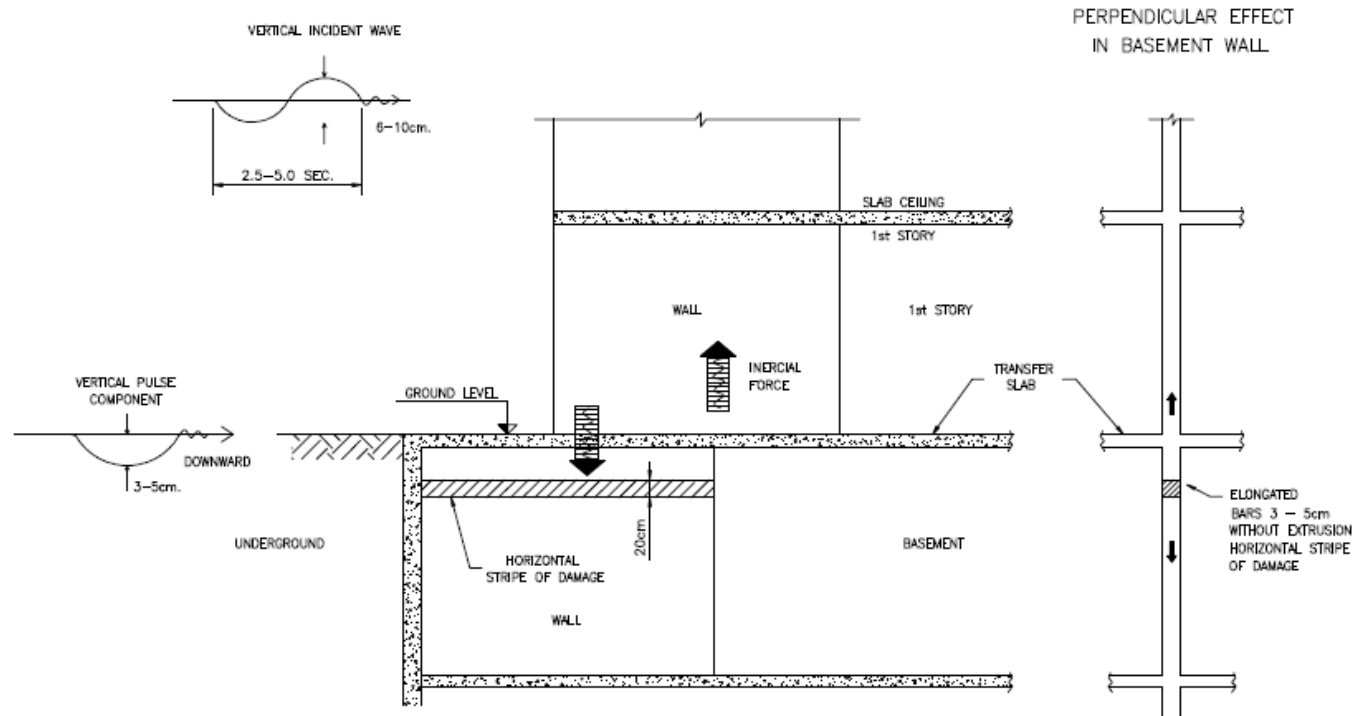
SHEAR WALL FAILURE  
OF TALL BUILDINGS  
BY SEISMIC WAVE PROPAGATION

NEGATIVE VERTICAL PULSE (DOWNWARD)  
EFFECT IN THE WALL PLANE OF THE BASEMENT  
ELONGATION OF VERTICAL BARS  
OF 3 TO 5cm. IN THE HORIZONTAL  
STRIPE OF DAMAGE

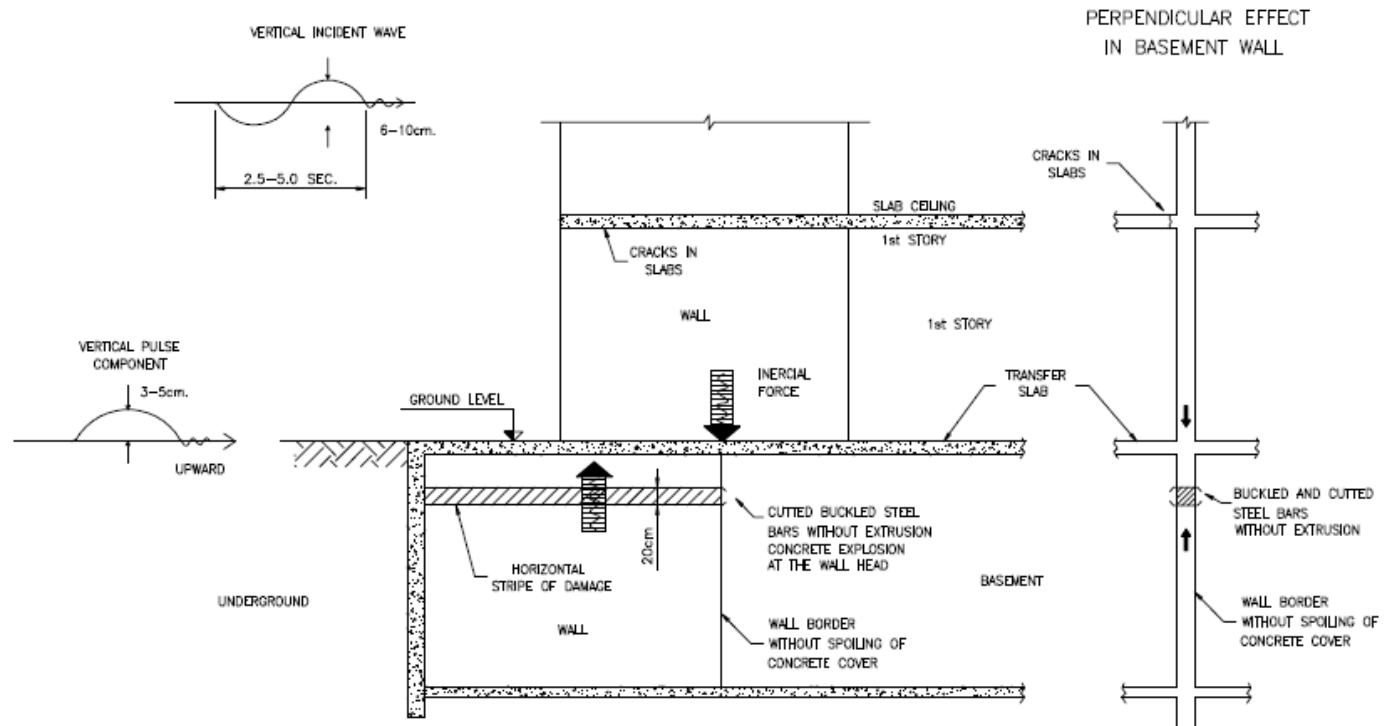
SHEAR WALL FAILURE  
OF TALL BUILDINGS  
BY SEISMIC WAVE PROPAGATION

SECOND STAGE  
POSITIVE VERTICAL PULSE (UPWARD)  
EFFECT ON WALLS AND SLABS

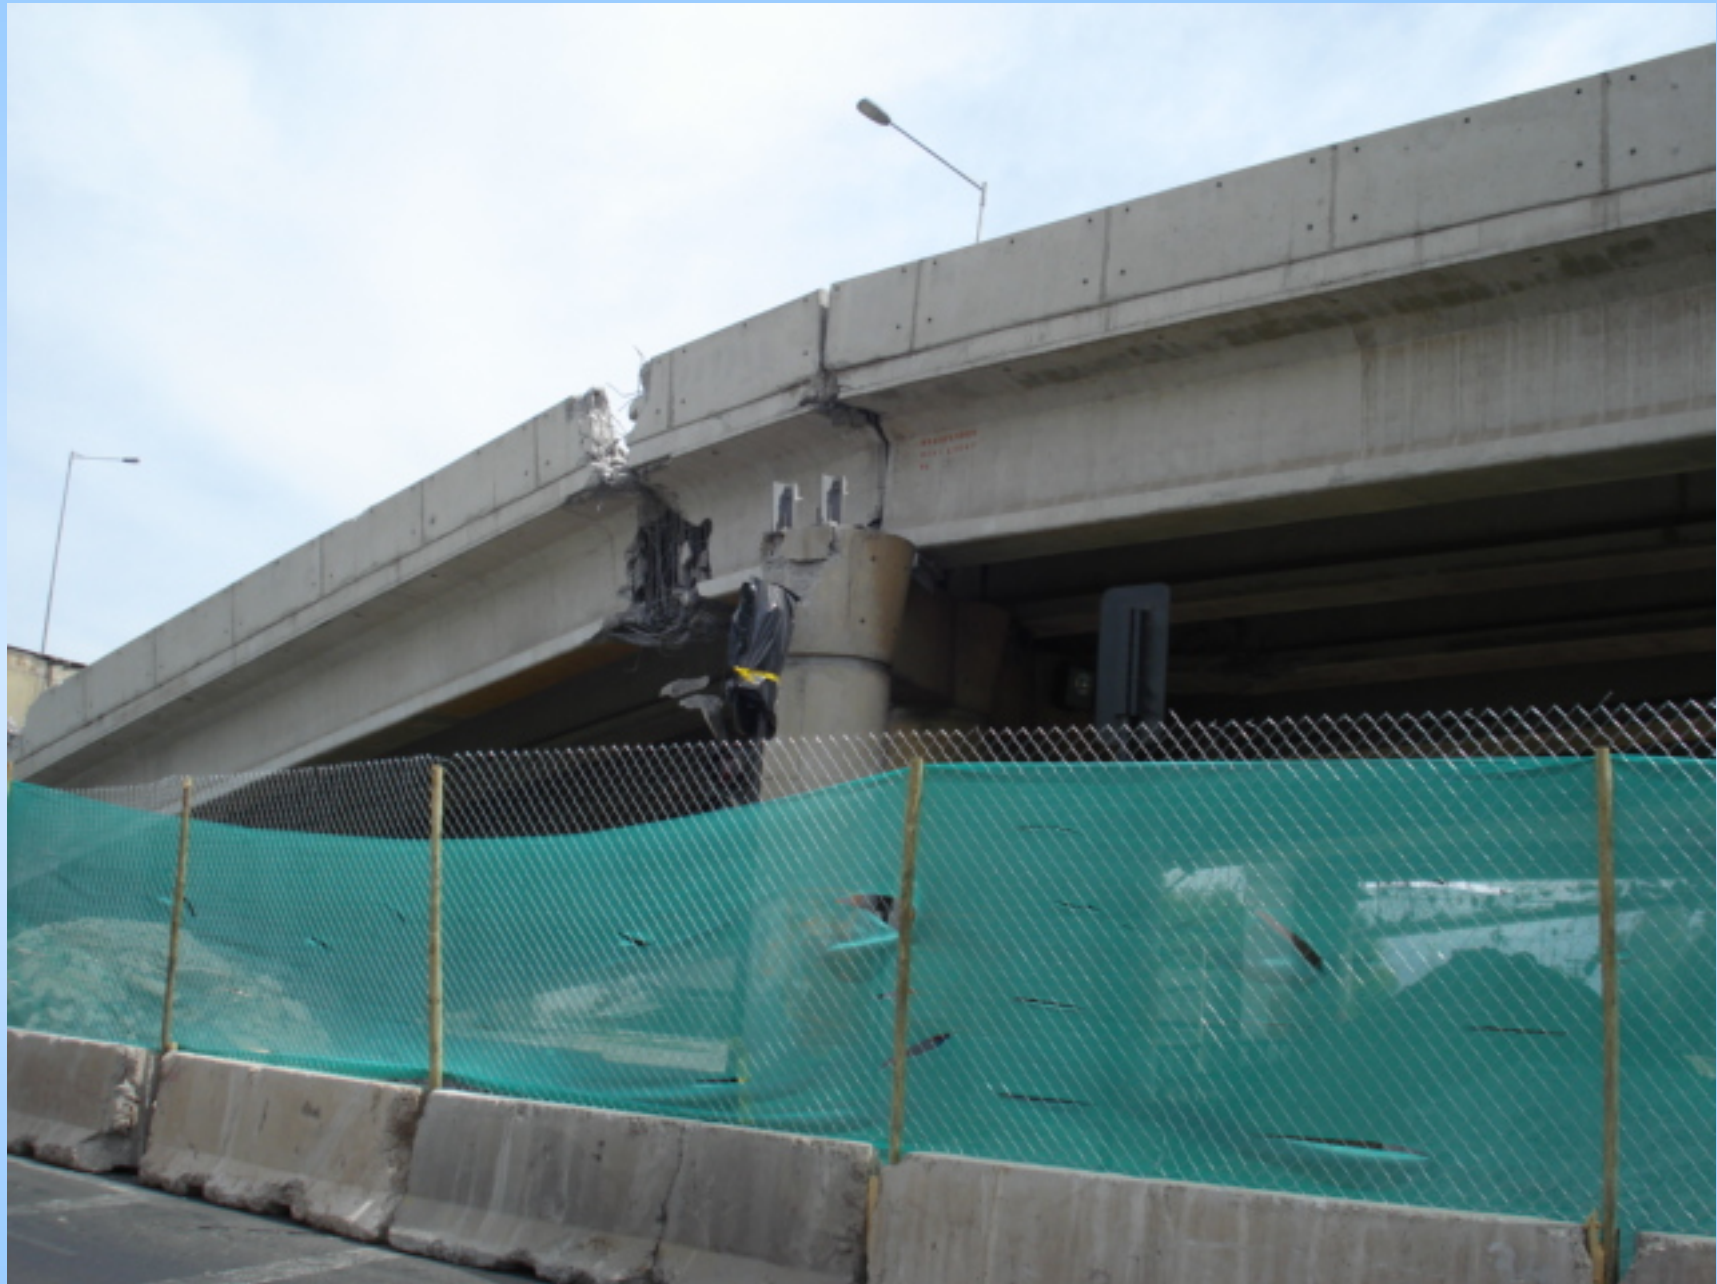
- FEW BRIDGES DO NOT DESIGN ACCORDING TO CHILEAN CODE COLLAPSE

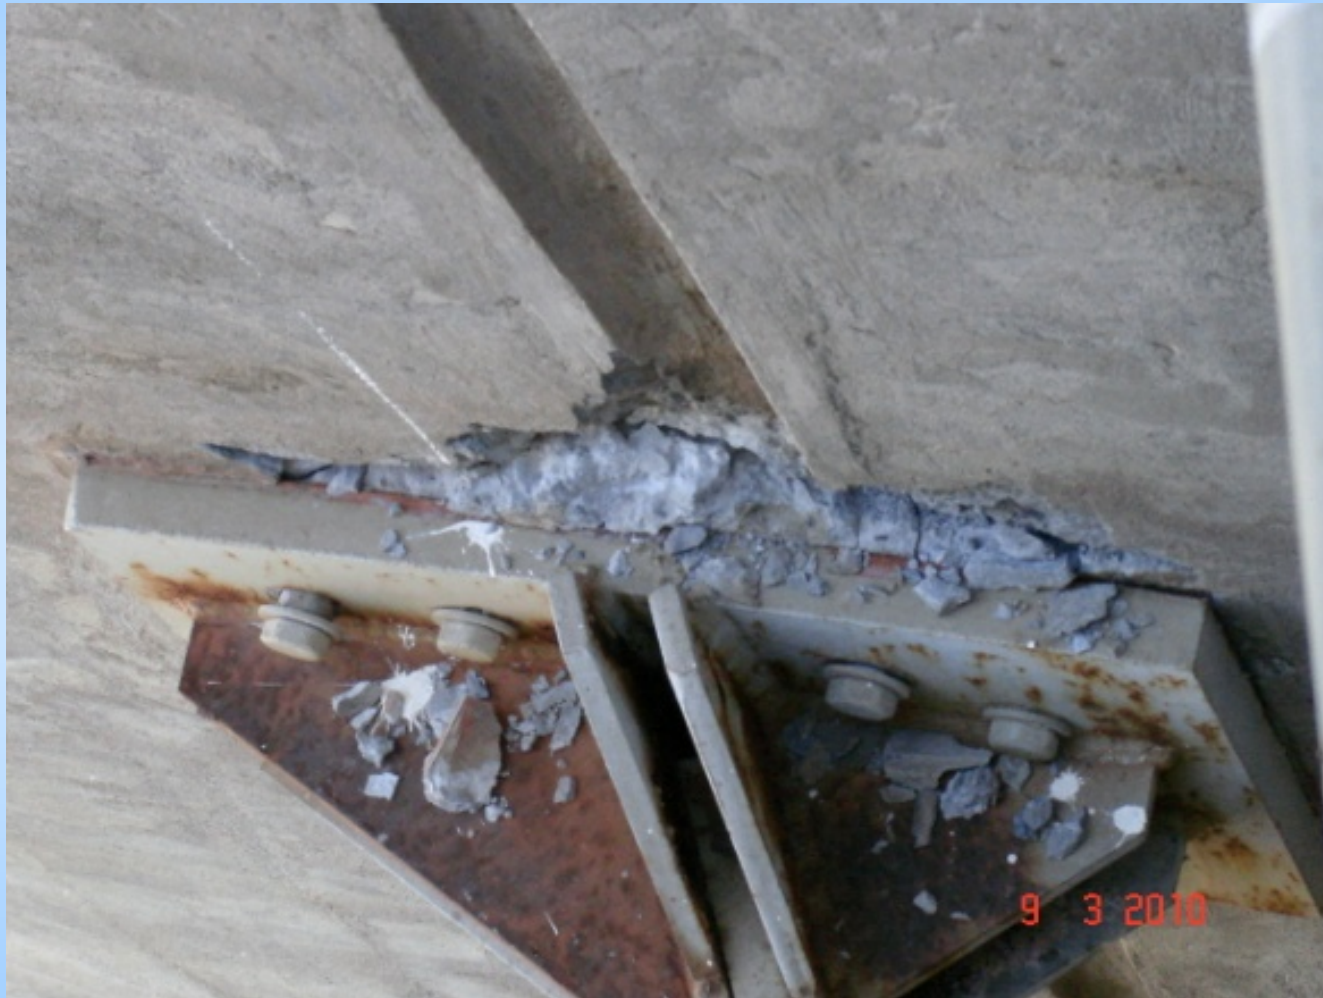
RESEARCH NUCLEAR REACTOR LO AGUIRRE - SANTIAGO  
UNDAMAGED (PGA = 0.3 g).  
CONNECTIONS BETWEEN MAIN AND SECONDARY BUILDINGS

LOOSE CONCRETE IN ANCHOR BOLTS
