**Some remarks on the earthquakes in L'Aquila,  
Haiti and Chile. Seismology and damages**

Luis D. Decanini  
*Sapienza, Universita di Roma  
Dipartimento di Ingegneria Strutturale e Geotecnica  
Roma  
ITALY*

**Trieste, May 13 2010**

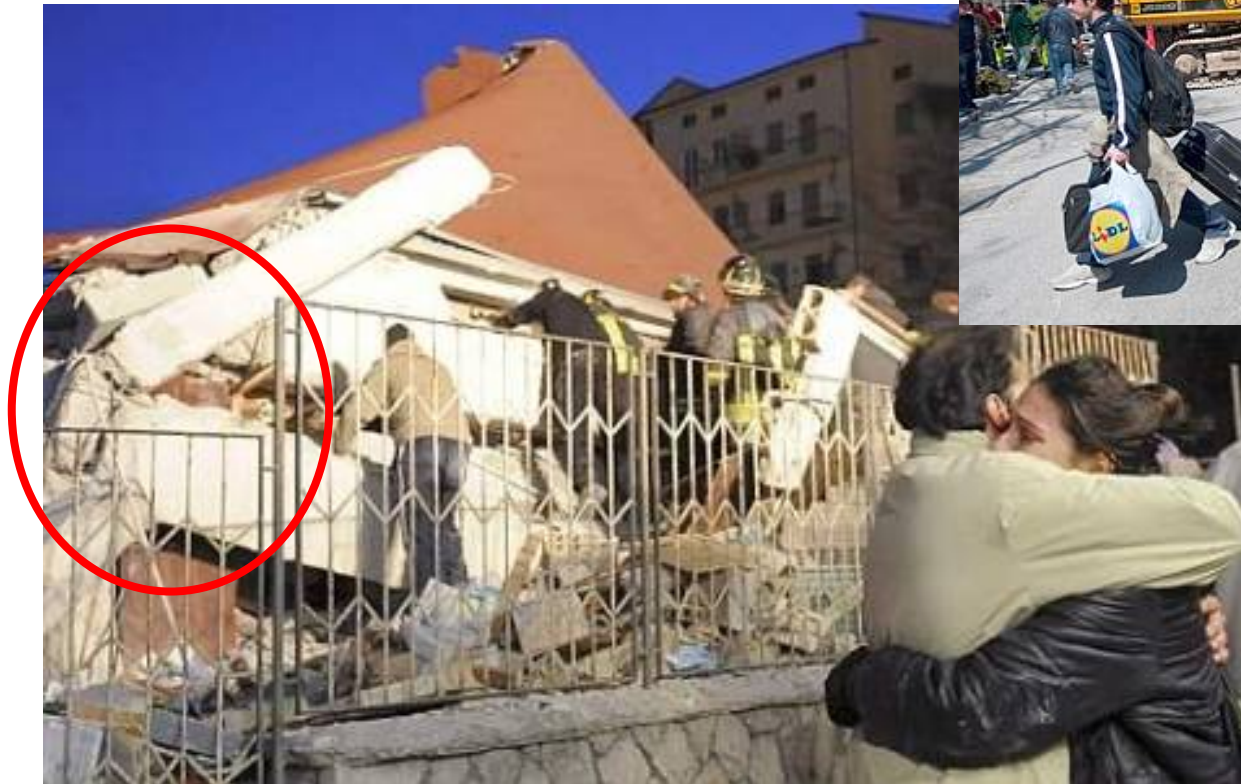
Edificio in via XX Settembre 123

Weak columns - Strong beams

Complete collapse (Corriere,  
Radio Sound City)

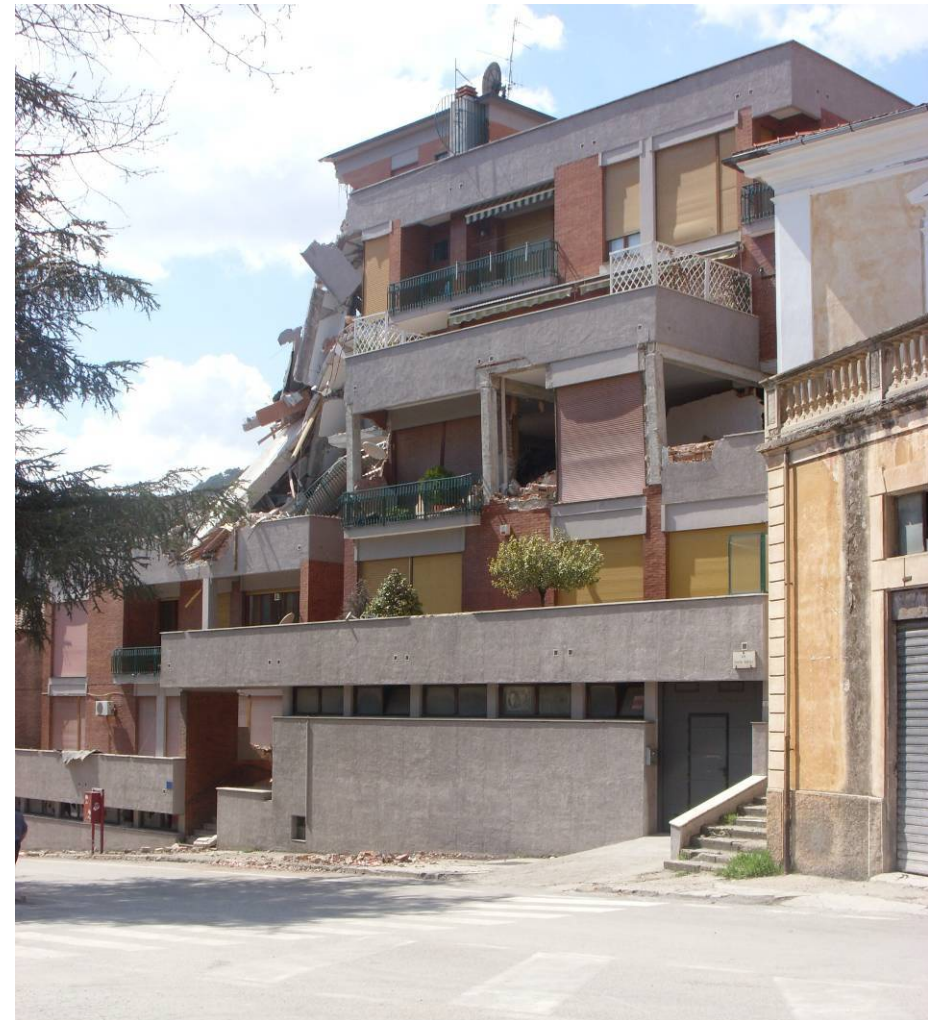
Building in via Porta Napoli

Abrupt change of strength and stiffness in elevation

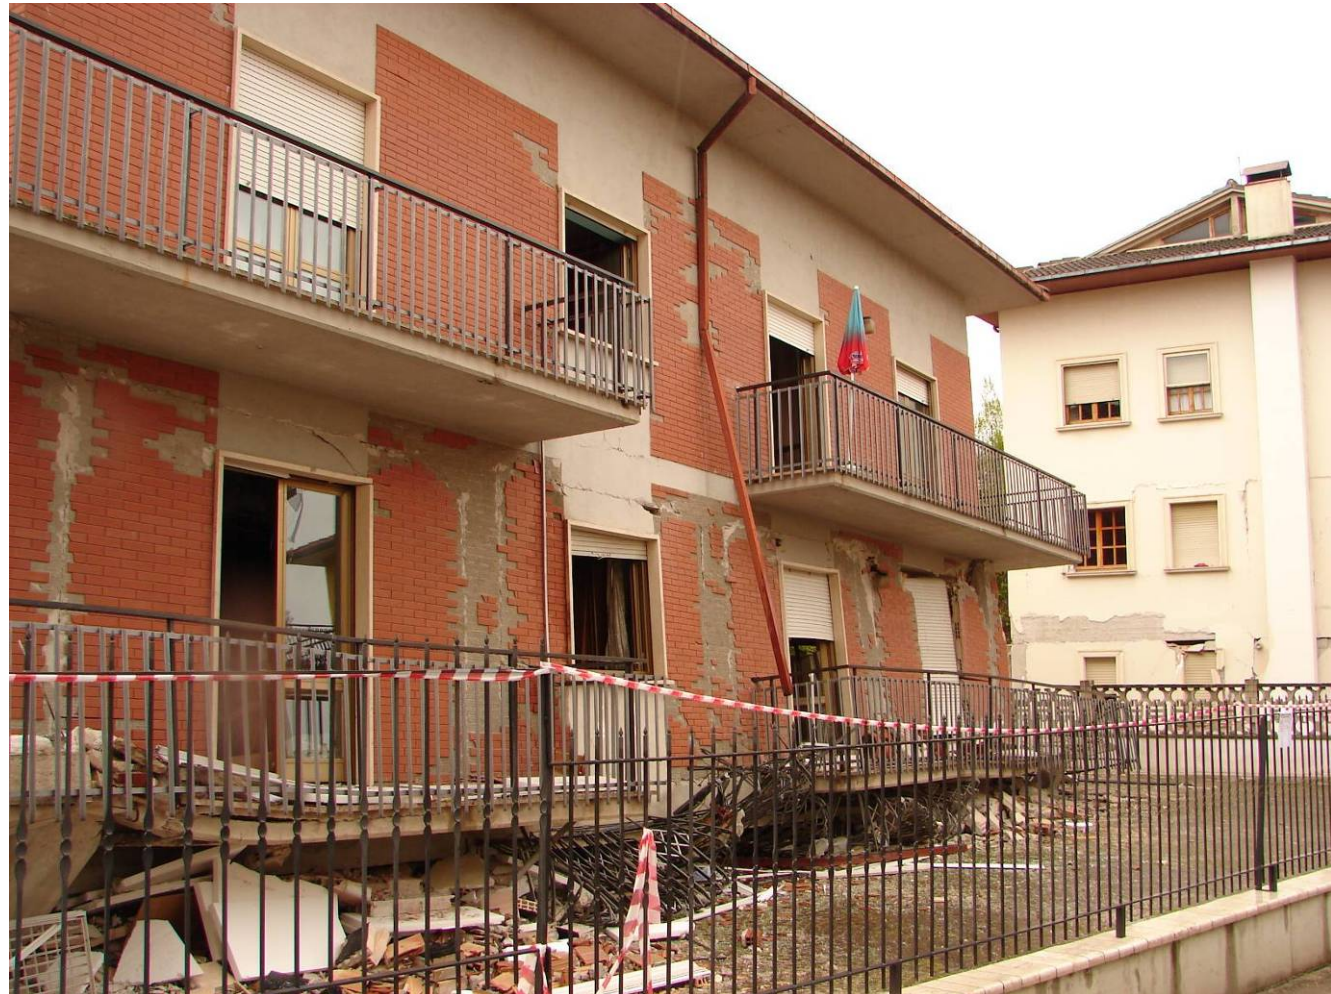
Building in via Milonia I

Soft storey

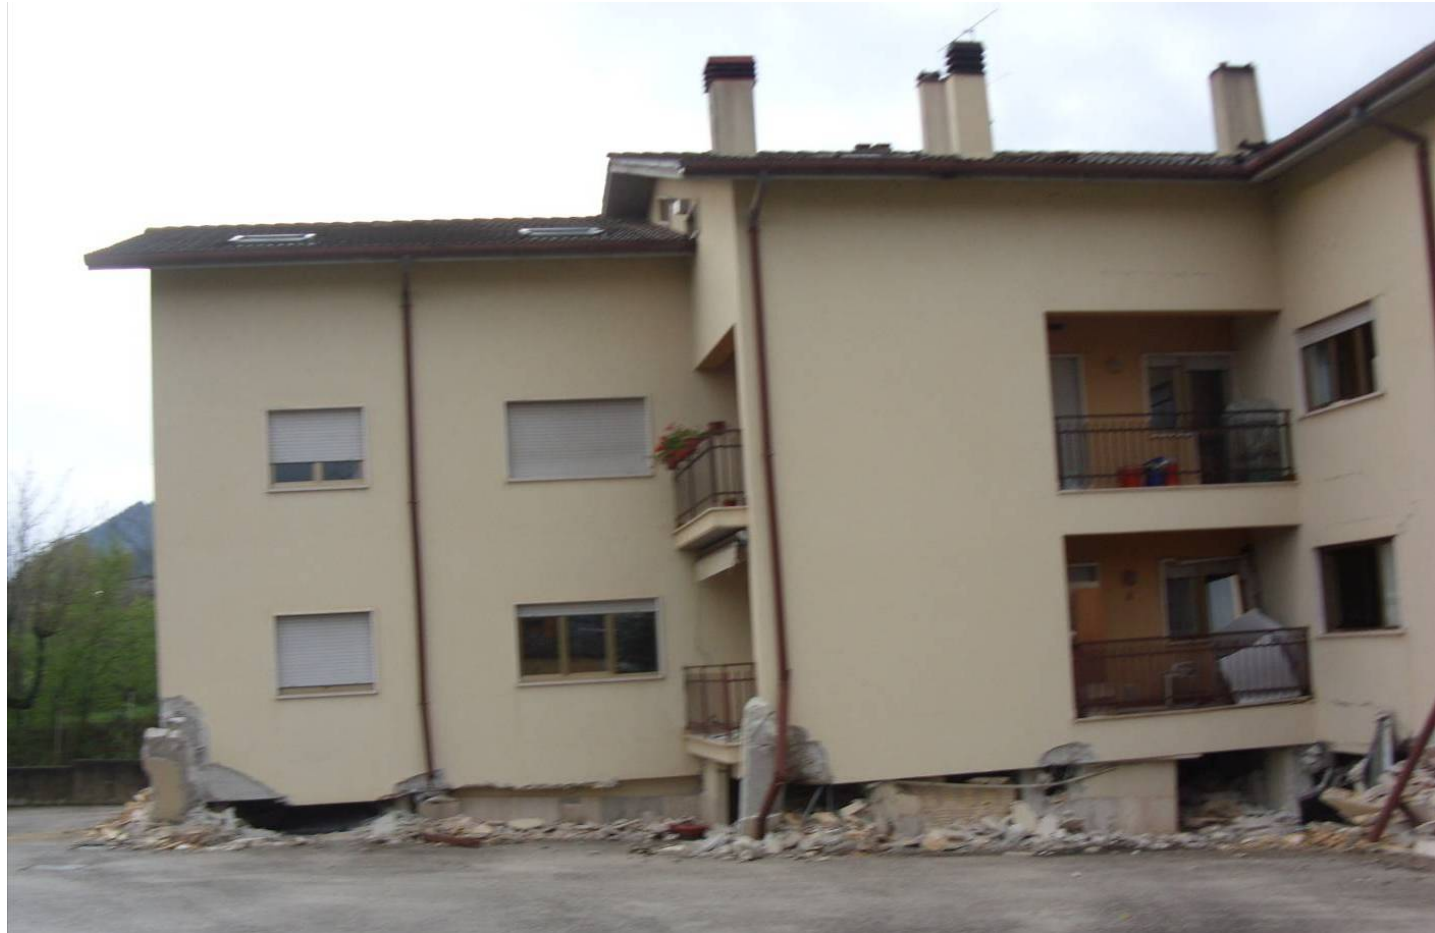
Building in via Dante Alighieri 2  
After earthquake

Soft storey

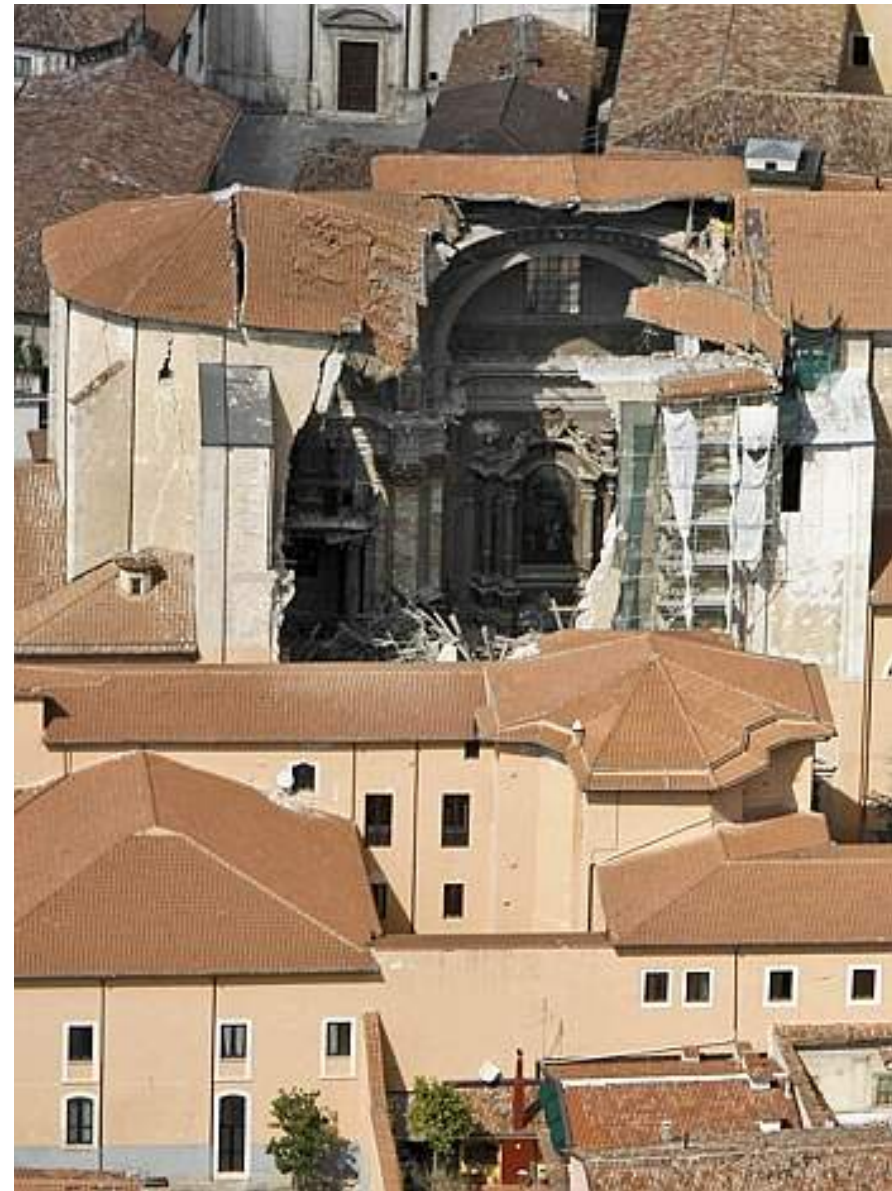
## Cathedral

Collapse of roof and vault  
of the left transept

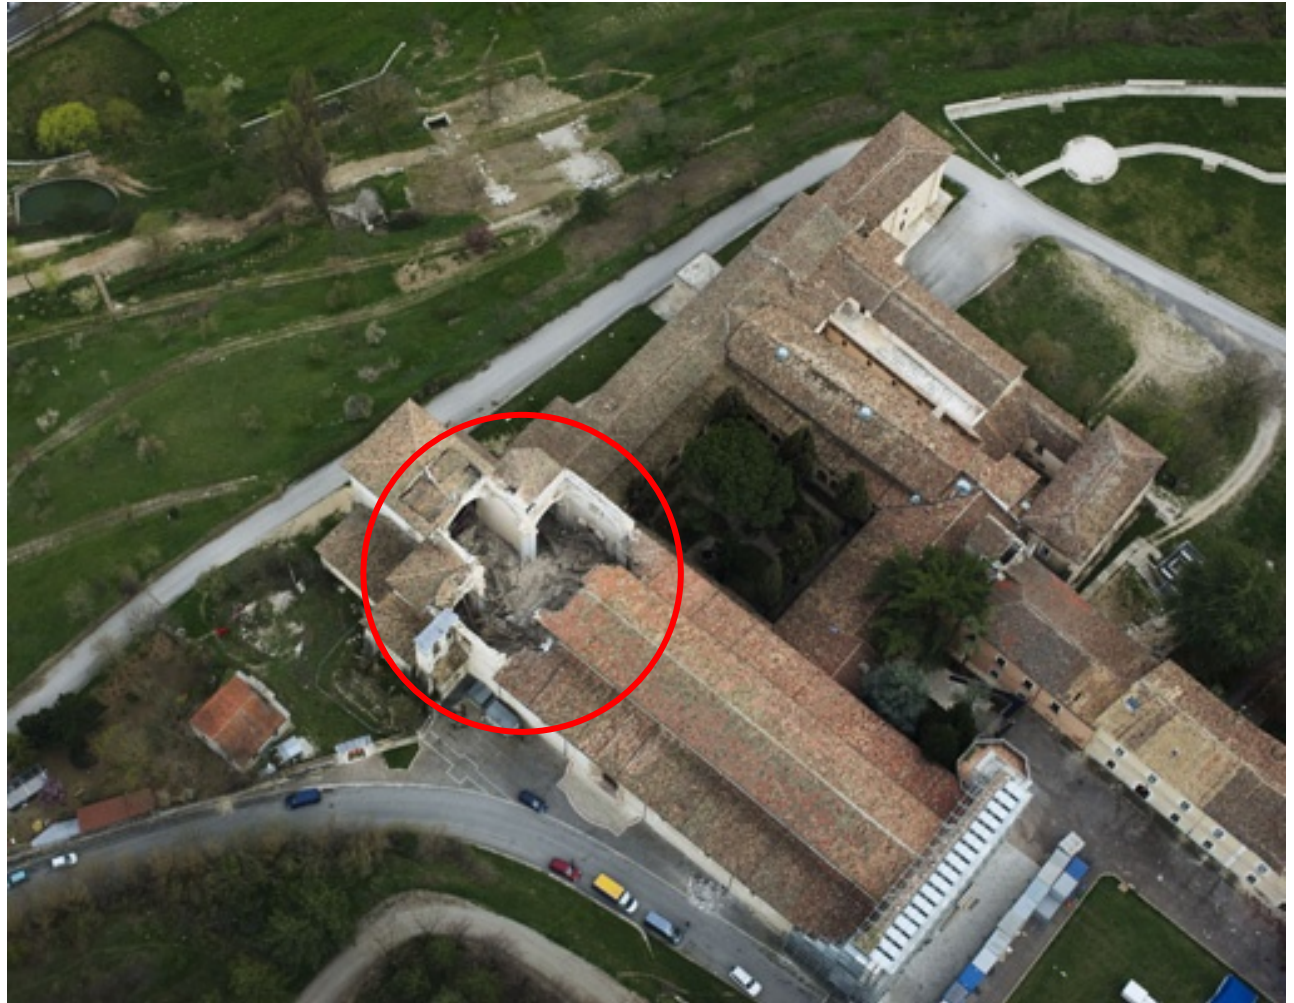
## Santa Maria di Collemaggio

Collapse of  
the transept  
vaults

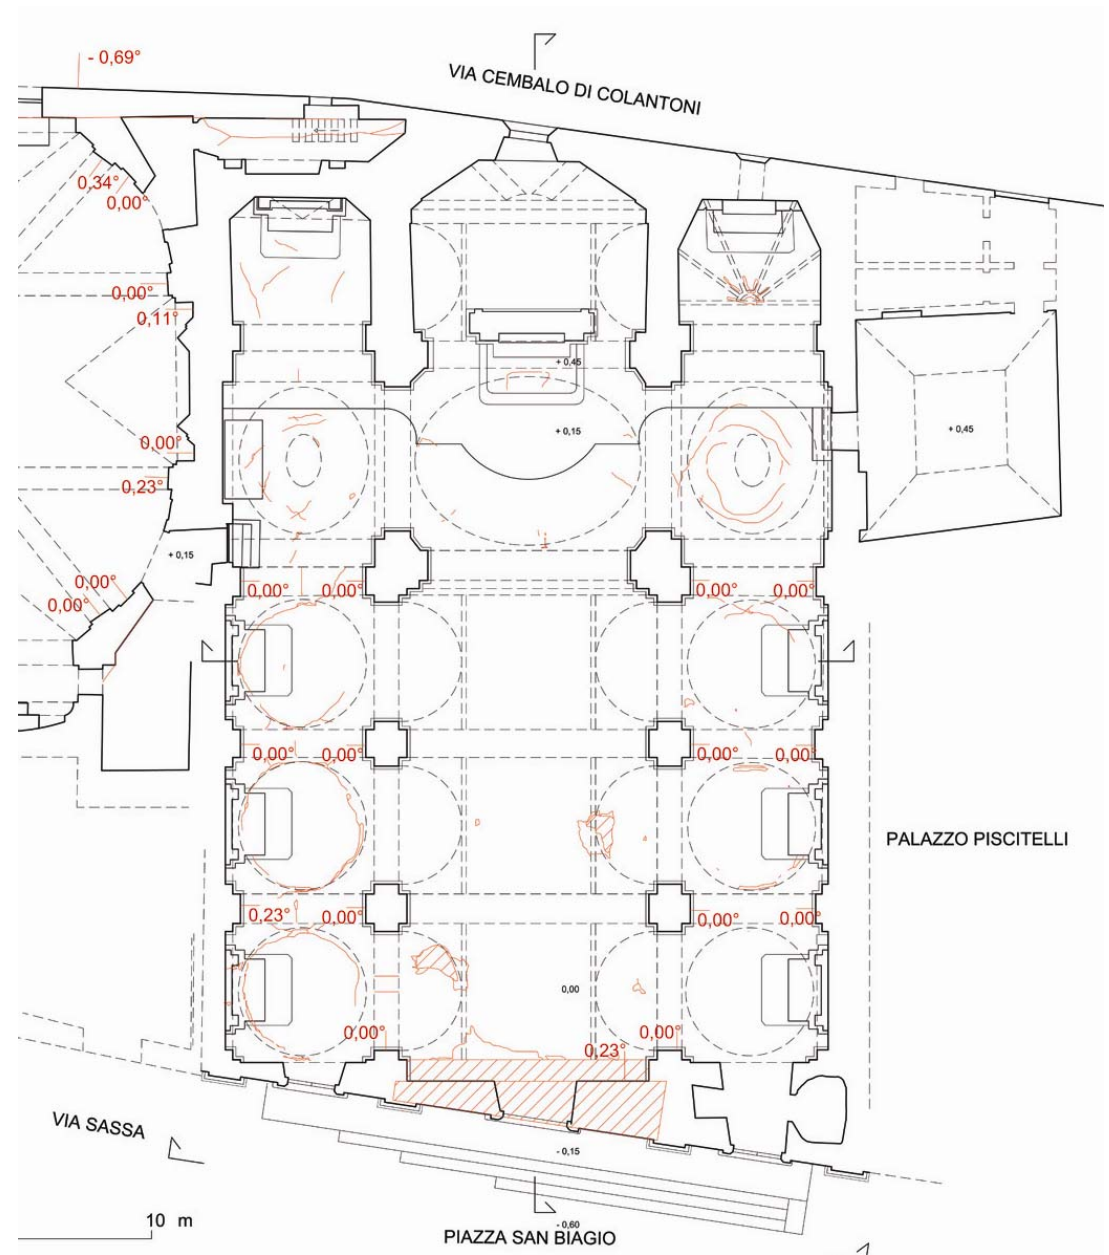
## San Biagio

Extensive cracking  
of the lateral vaults

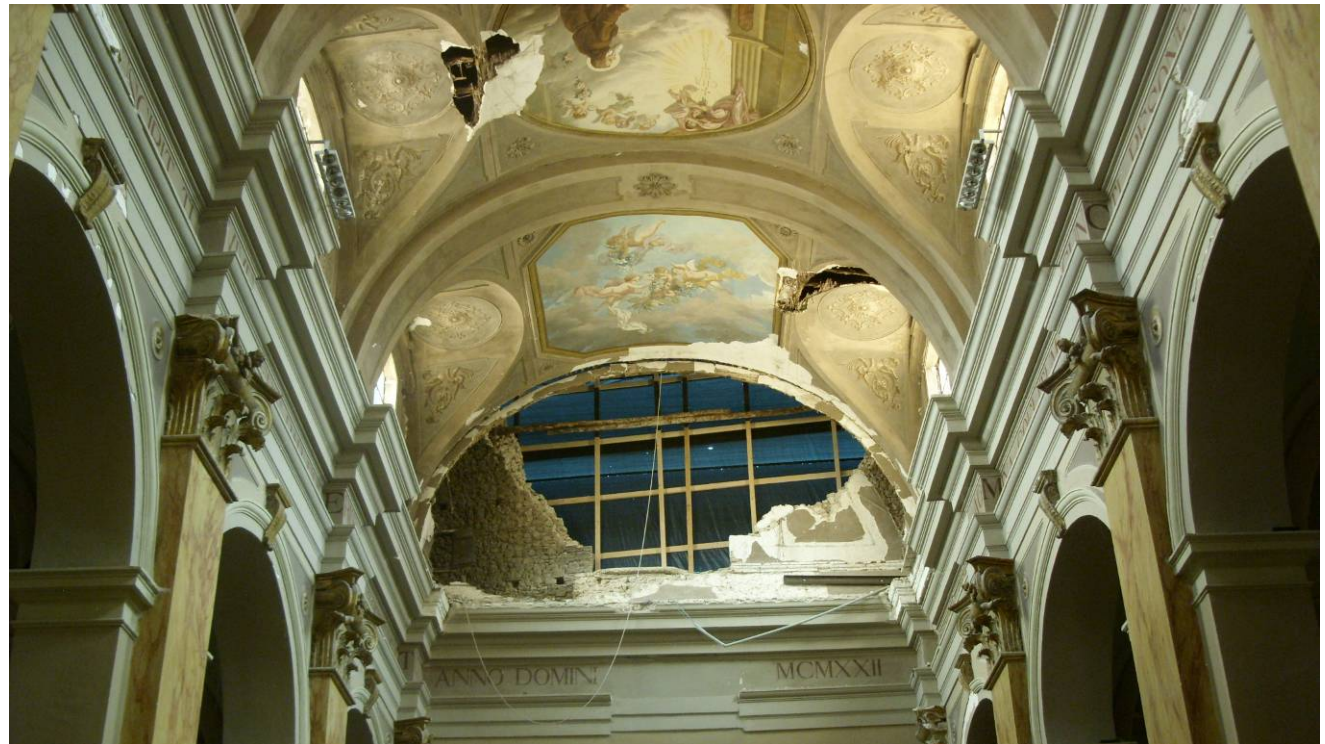
## San Biagio

Internal view of the façade gable collapse and damage to the reed mat vault of the central nave.

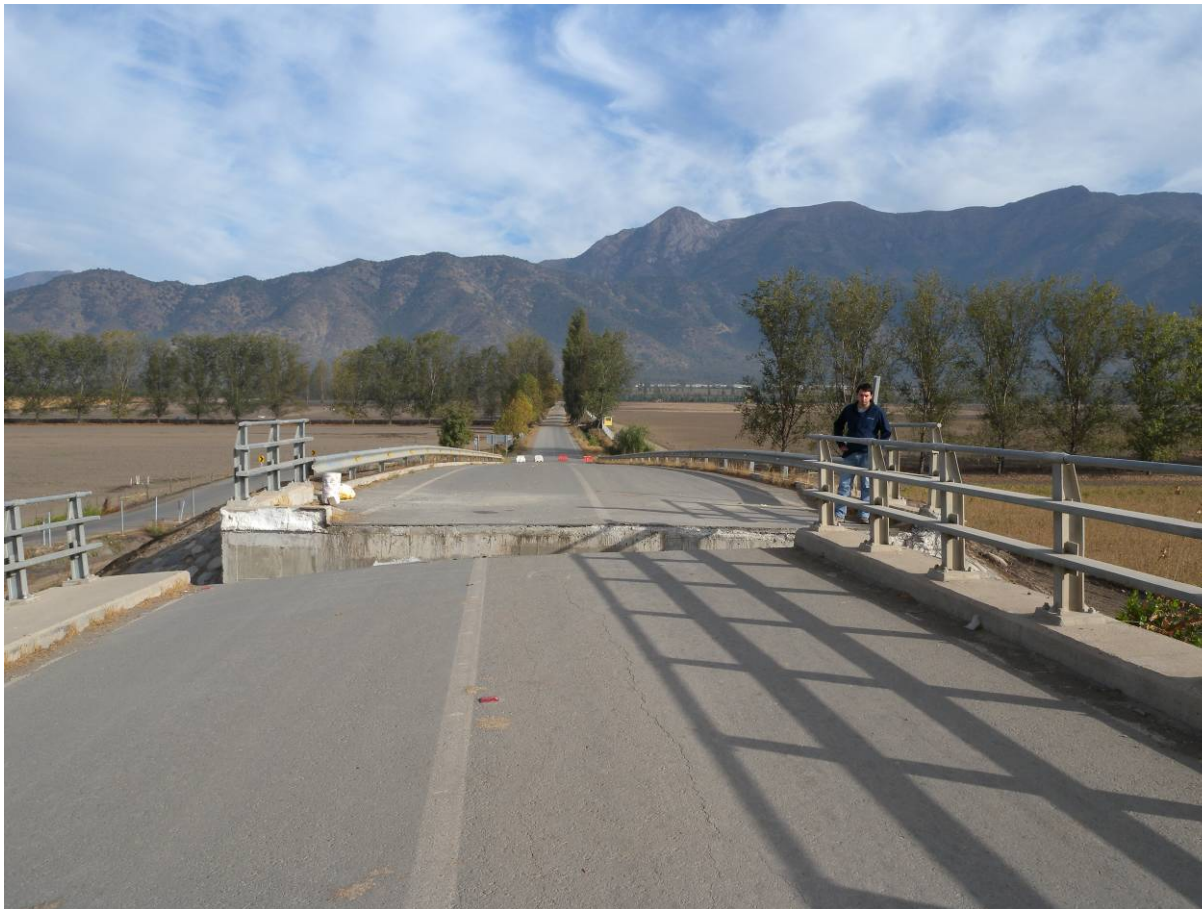
Ruta 5, Paso Inferior de la Merced. Lateral displacement

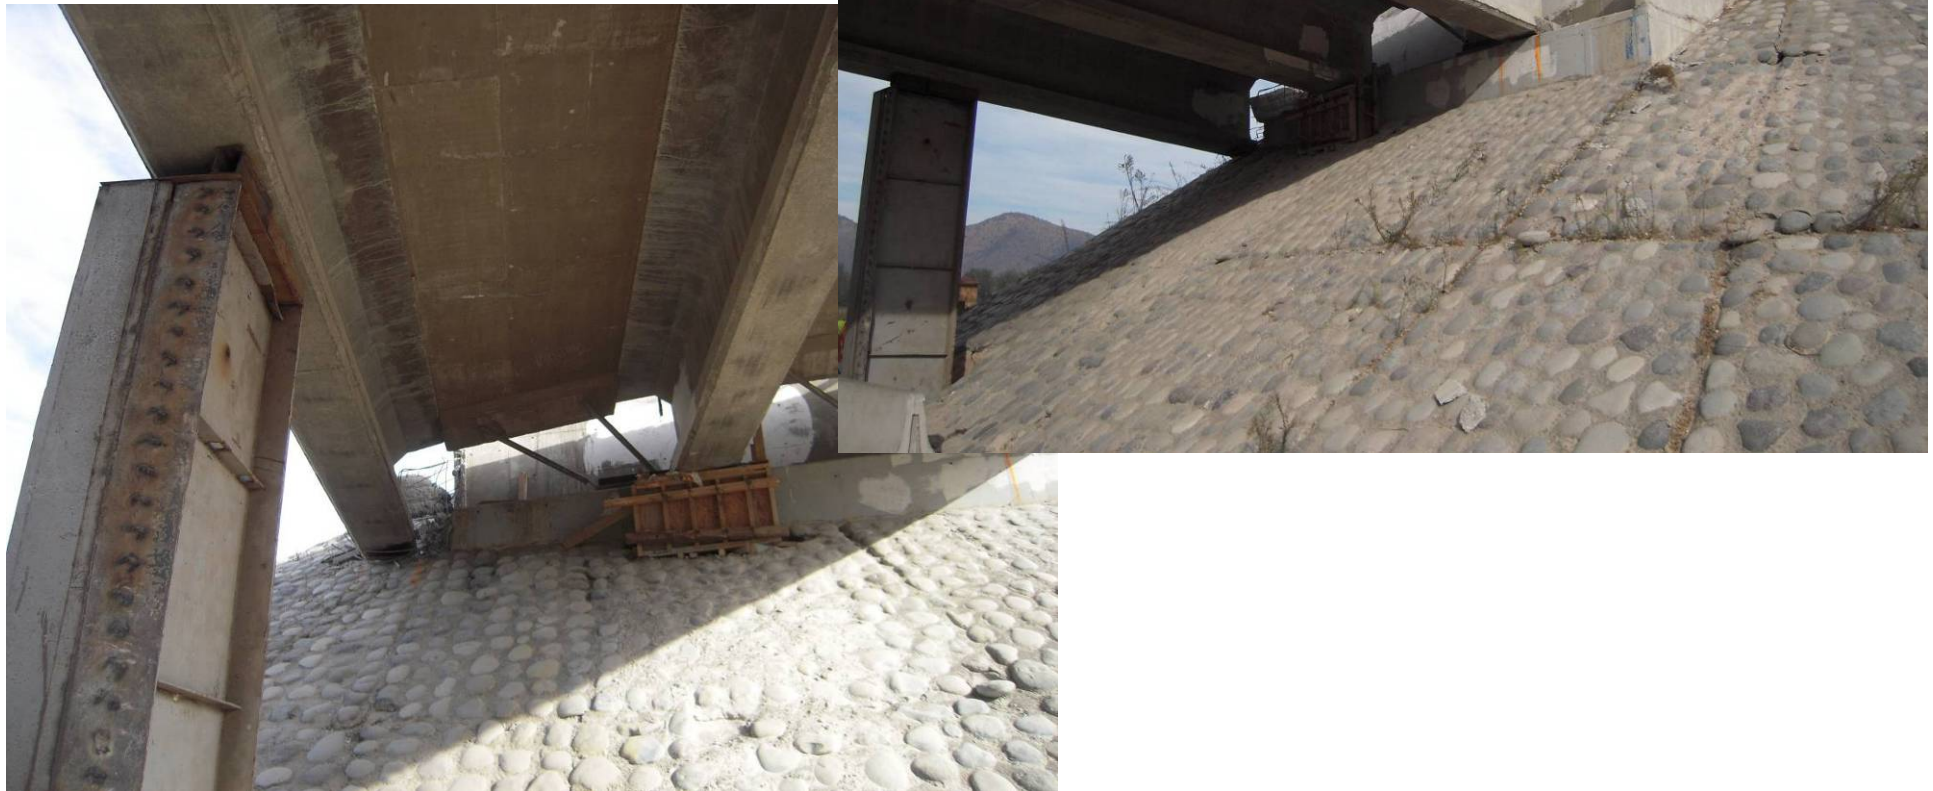
Ruta 5, Paso Inferior de la Merced. Loss of support

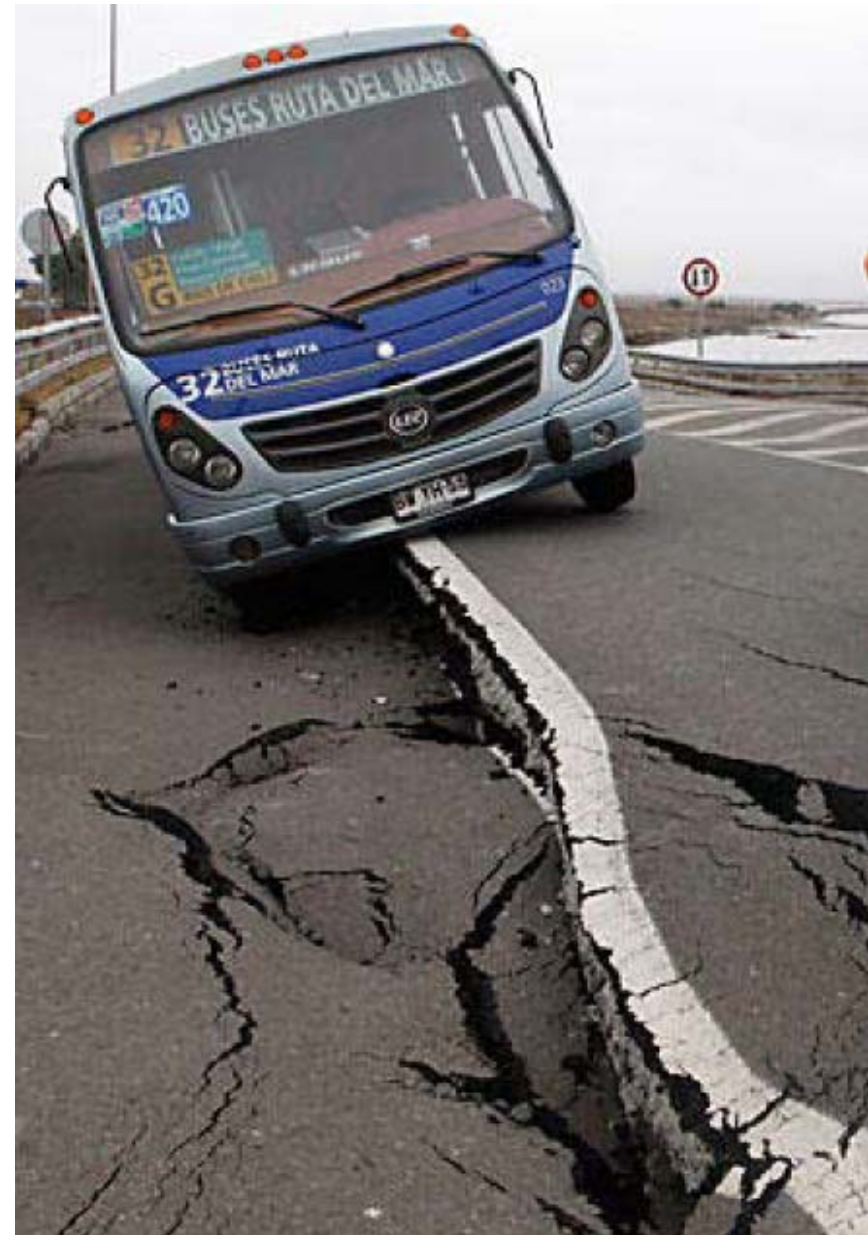
Talcahuano

Lateral spreading and subsidence

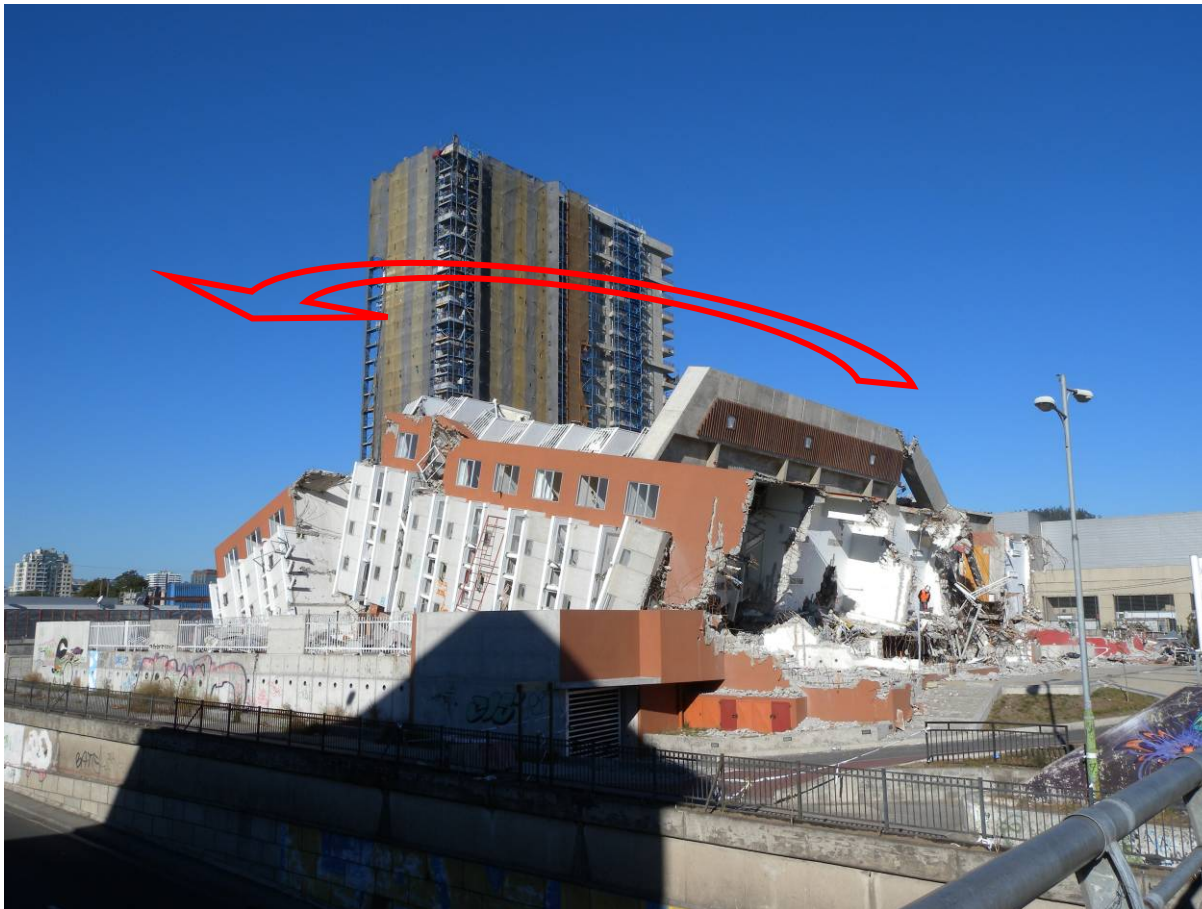
Concepcion, Alto Rio. 8 casualties. Total collapse and overturning.

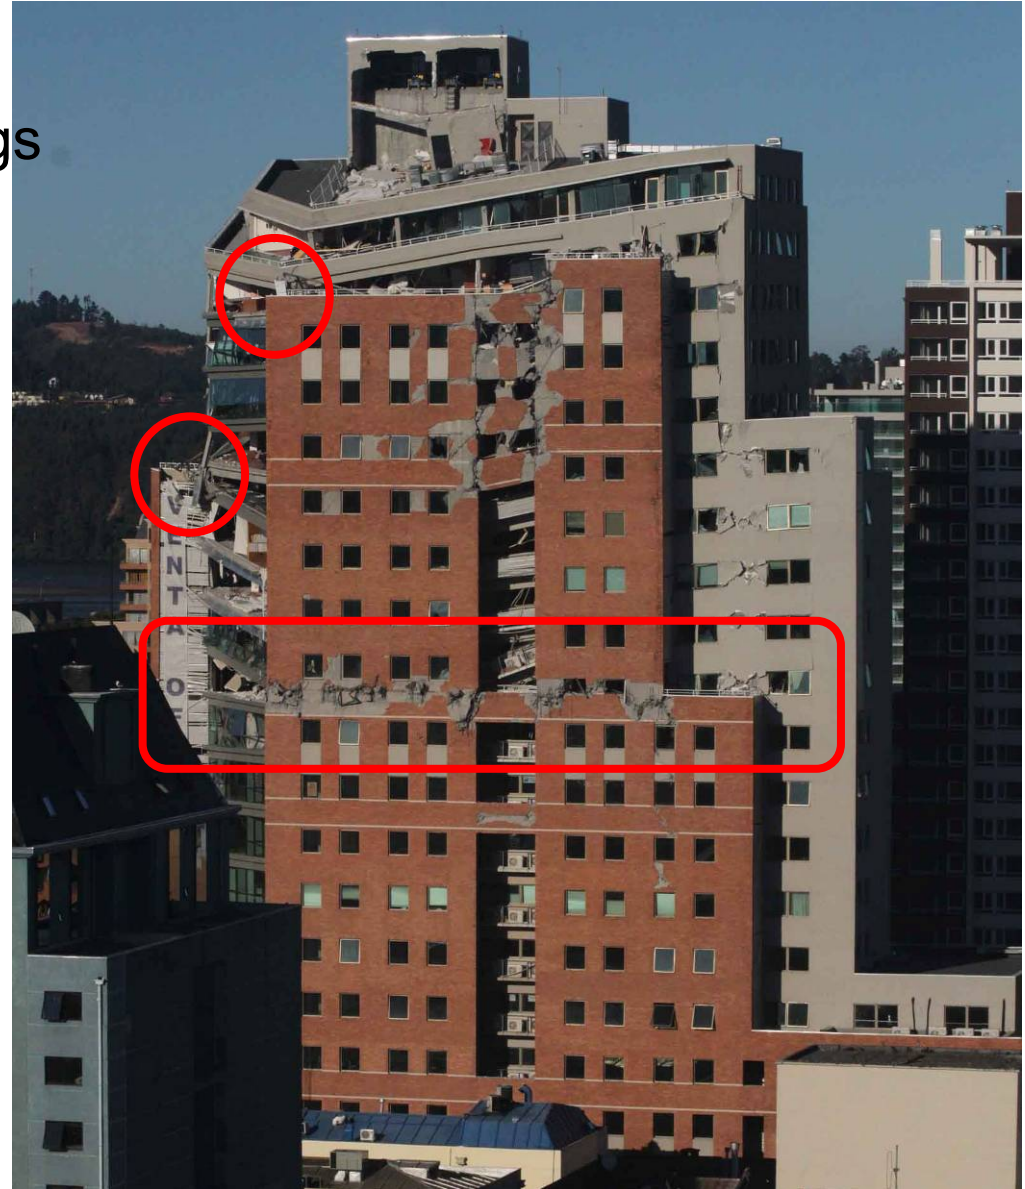
Concepcion, Torre  
O'Higgins.  
Dramatic failure above the  
10th floor due vertical  
stiffness discontinuity

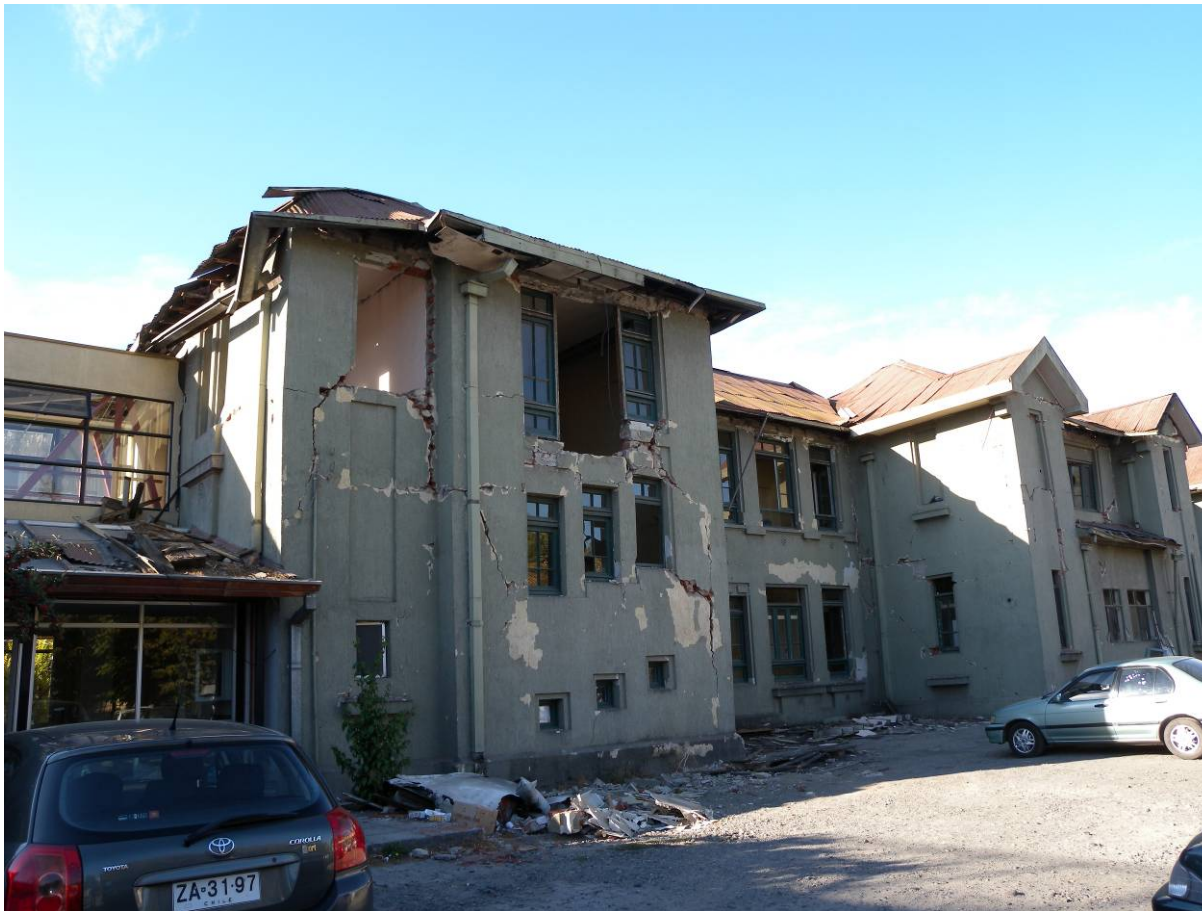
Talca, Hospital Viejo, to be demolished

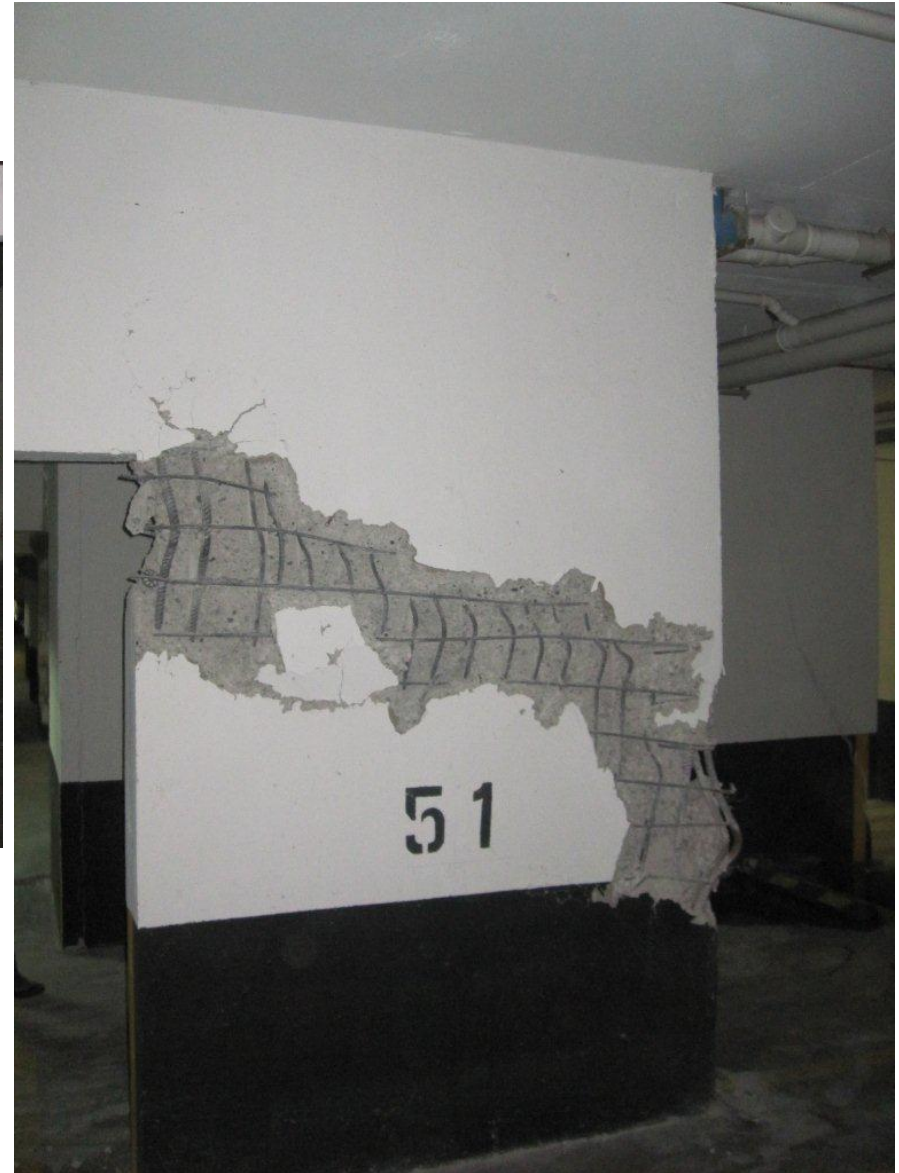
Santiago, Edificio Emerald.  
Severe damage in the  
basement's shear walls.

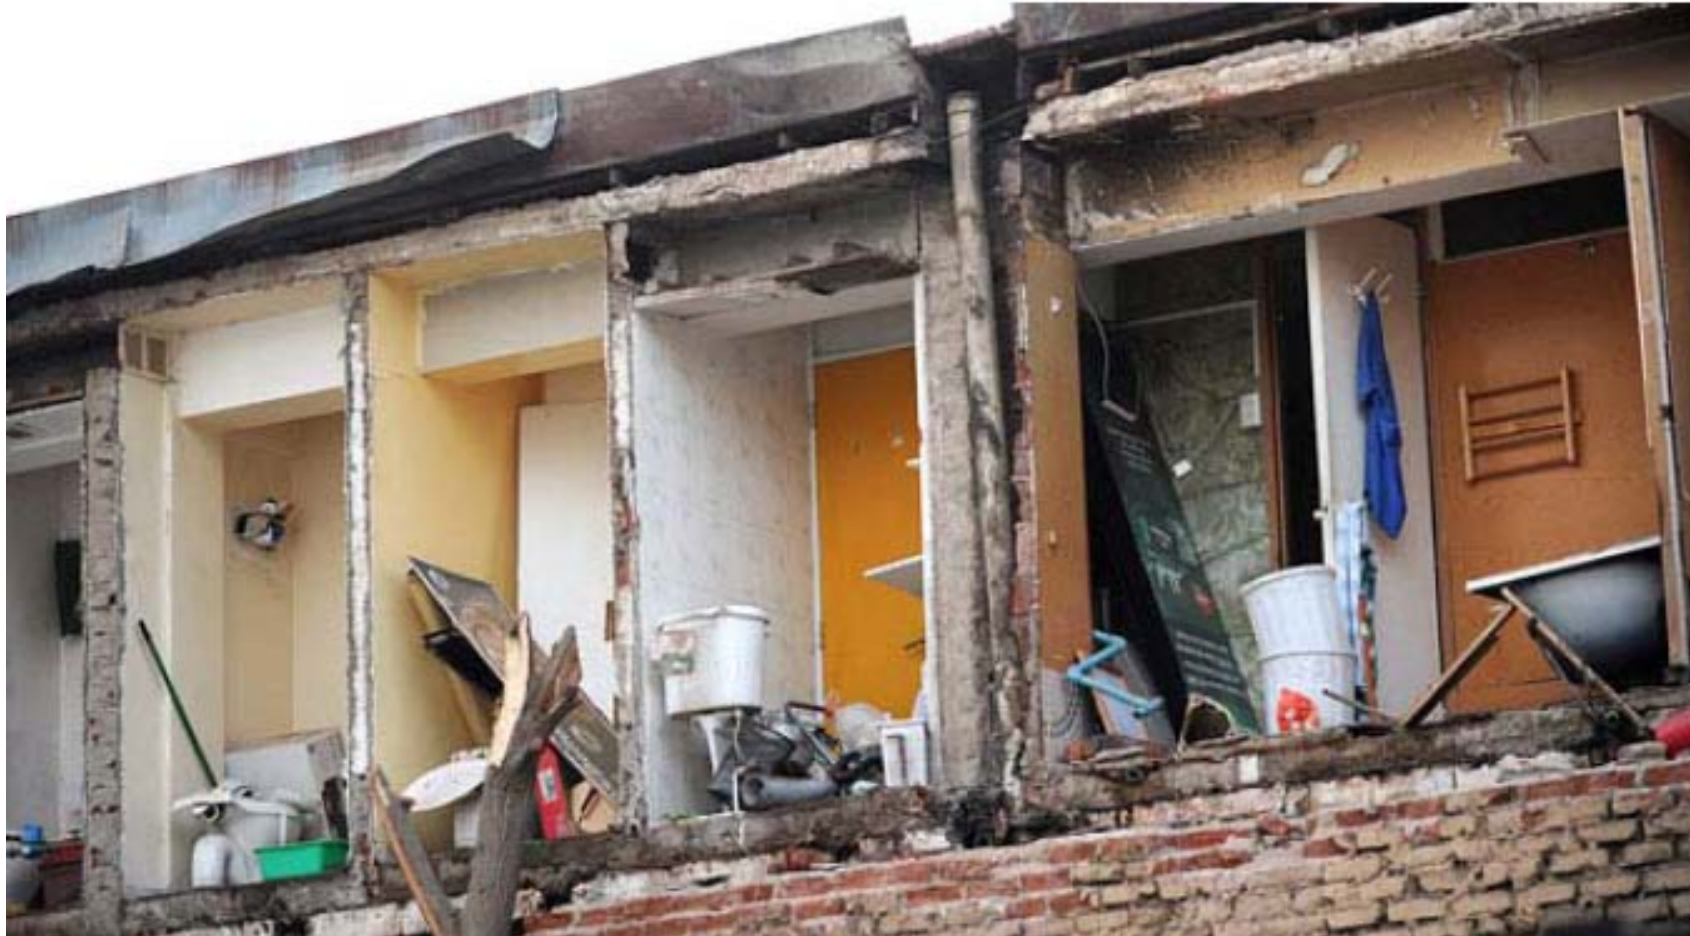
Vina del Mar, Chile – URM, overturning of façade in upper storey

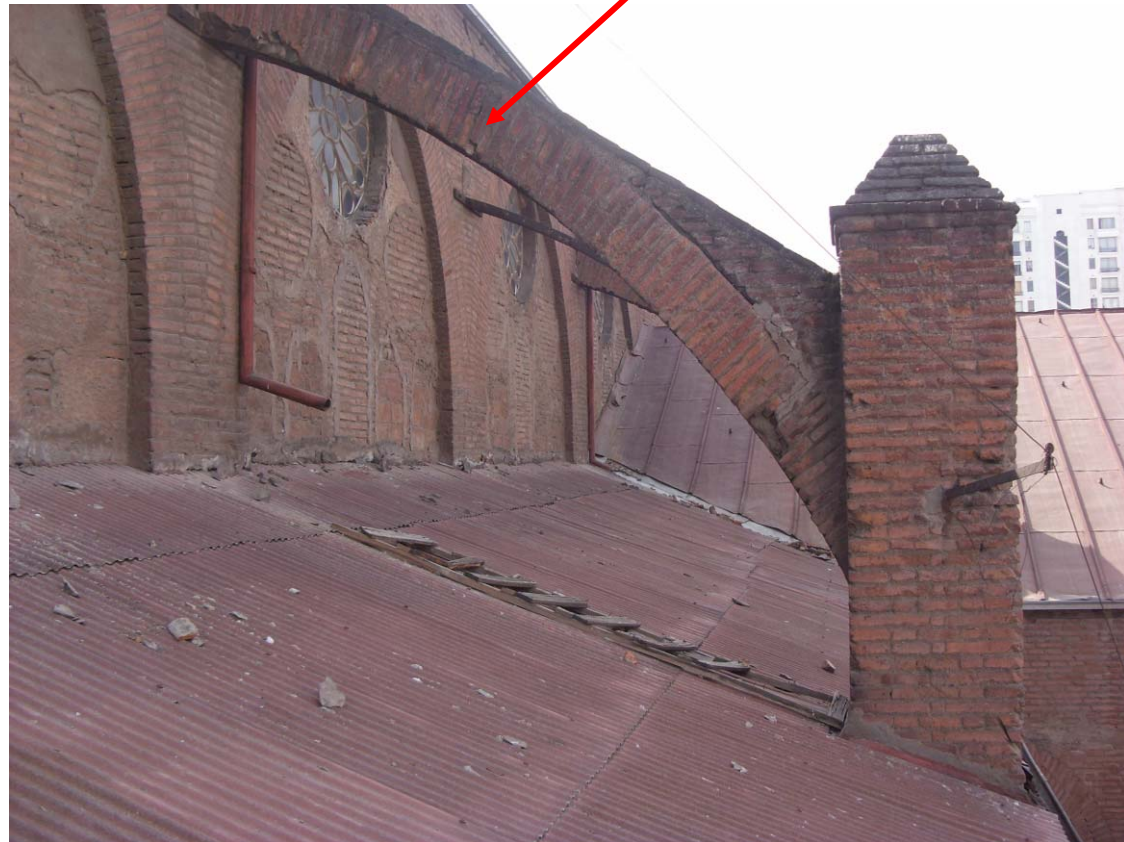
Built 1856-1878;  
altars and  
sculptures came  
from Italy.  
In 1985 statues and  
the timber parapet  
of the chancel  
collapsed.  
The façade seems  
to have moved  
away from the  
naves. Damages in  
the sacristy.  
Collapse of the  
Virgin statue in the  
façade.

Flying buttress with  
metallic support

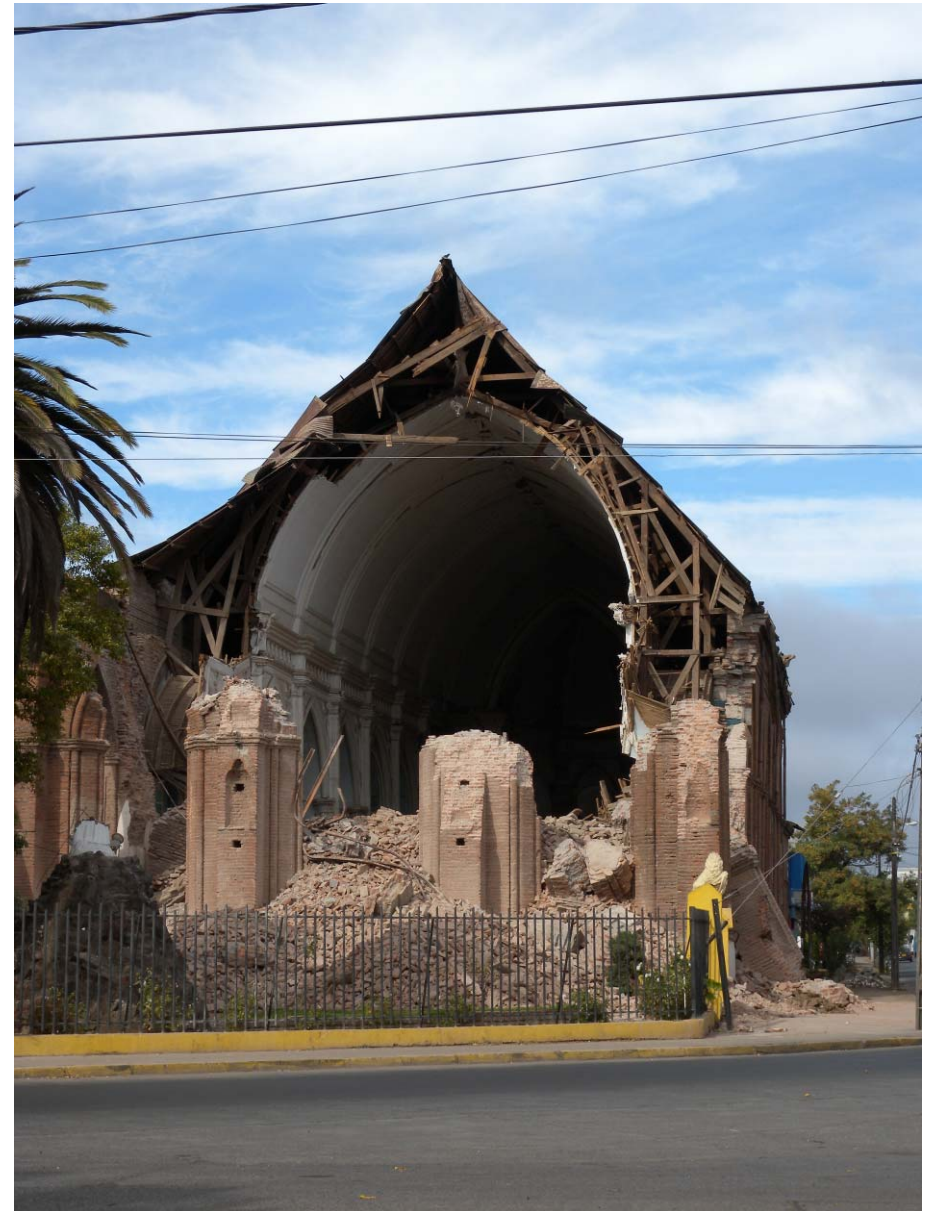
Curicò, España con Las Heras

Severe damages and  
partial collapse.

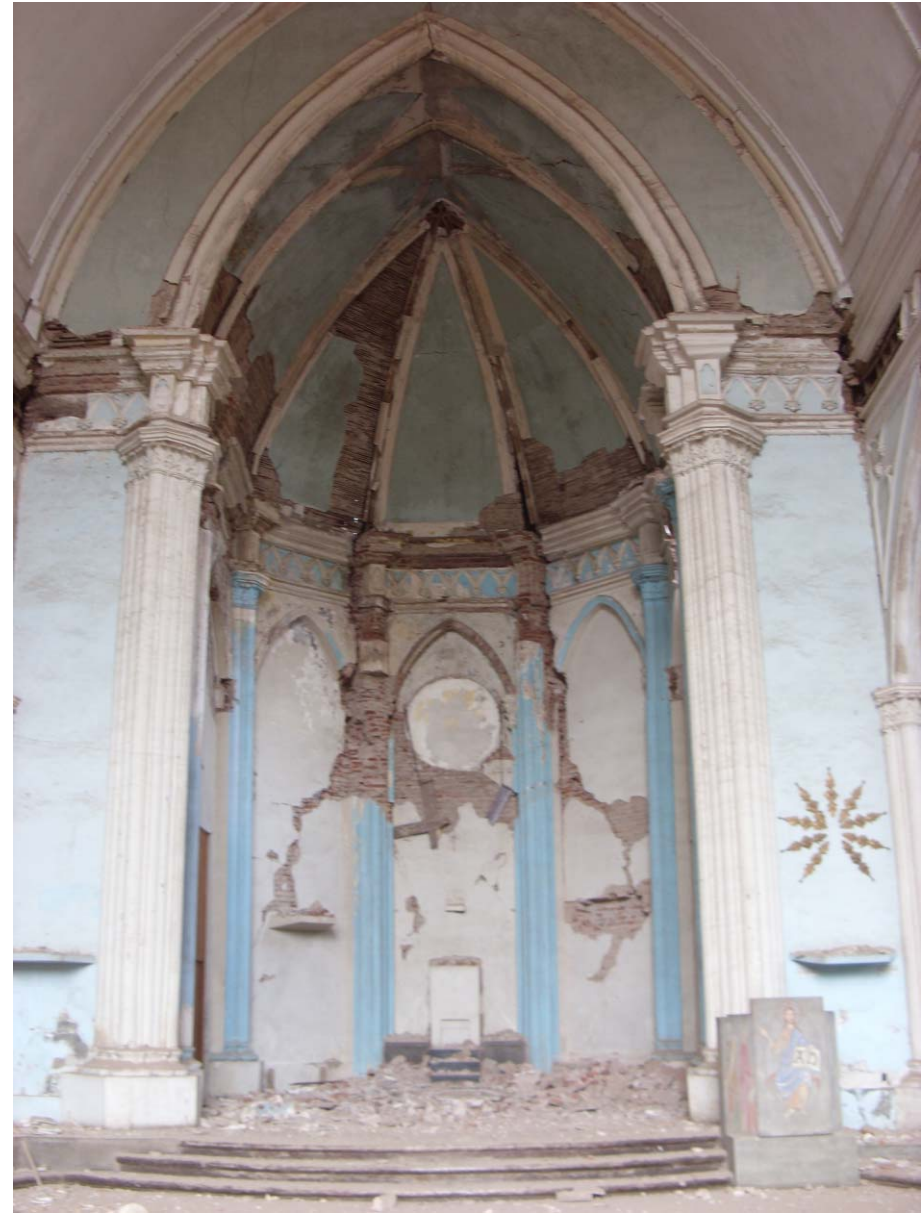
Curicò, España con Las Heras

Brick masonry walls,  
timber false vault.  
Severe damages
