# Case histories of radiotherapy accidents & clinical consequences

Ben Mijnheer

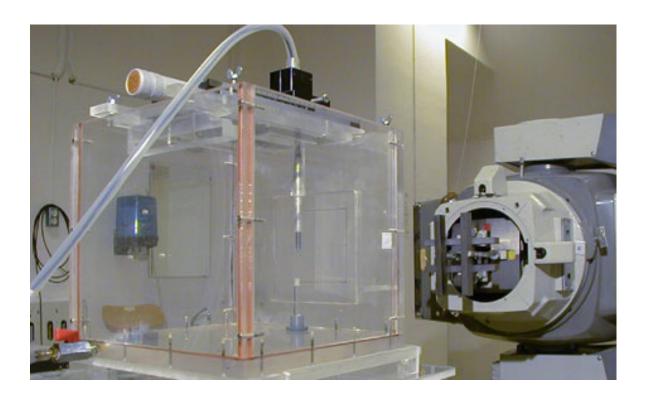
2/2/88. OP culibration of New Source Beeter Farmer 2570 with porte in water tank at depth 5.0. Water truk outs is dimensions (perspess) = 32 = 32 x ~21 cm to water sup T = 293 P = 760.3 SSD = 800 mm, 100 × 100 mm FIELD Farmer left on for 45 mins before any " Water trick filled and left to come to room tong overright. Furner readings (0.8 mine): 90,95,90.92,90.90, 90.90, 90.90 -> 90.905 (0.4 mins) 46.47, 46.40, 46.40, 46.42, 46.42 -> 46.42 Stendy state 0.4 min reading about a 44.48 Steady State Dorante 4.0D at 800 mm, 100x 100 = 2x 293.3 760 0.947 x 100 x 44.48 293 760.3 79.0 = 106.7 clyy/min 1/0.4 = 2.5 not 2 !!! Should have been 133.4 cGy/min Dore effective Times 90.905 - 2 = 44.483 2 = 44.48 = 0.0218 mins

- The physicist has multiplied by the wrong factor (2.0 instead of 2.5) to achieve an equivalent exposure for one full minute. Tragically, this inaccuracy was then not recognised, possibly because the physicist was working on his own and his data may not have been checked
- Commonly afterwards only relative dose calculations are used to calculate the treatment time for an individual patient
- As a result of this calibration error, 205 patients were significantly overdosed (by about 25%) with increased morbidity and possible deaths as a consequence.
- The Institute of Physical Sciences in Medicine performed a National multicentre dosimetric comparison (external audit) and discovered this error

- One clear lesson from this accident is that a calibration of a new cobalt source or linear accelerator must be checked and rechecked (and rechecked...).
- It is certainly possible to cross check a new installation by asking a colleague. It might even be sensible to repeat the calibration of a new source a month after its first use in case of contamination with other isotopes which might have unexpected patterns of decay.
- Participate in an external audit, e.g. the IAEA TLD audit system

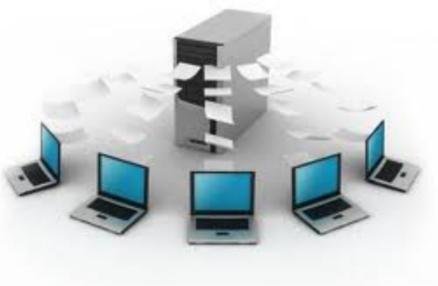
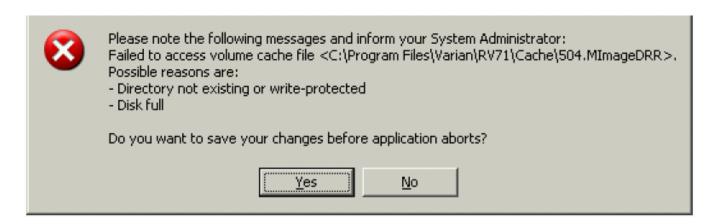
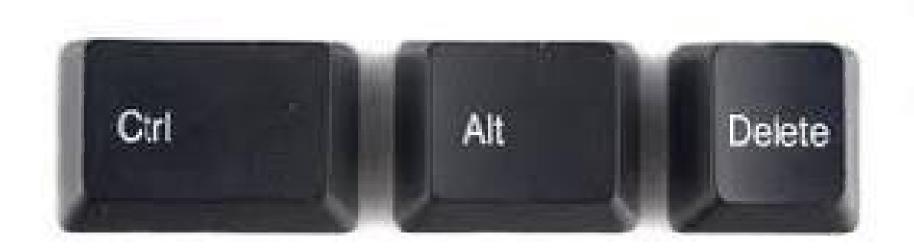
#### The transaction error message displayed

- "Save all" is started; all new and modified data should be saved
- In this case, data to be saved included
  - actual fluence data
  - a DRR
  - the MLC control points

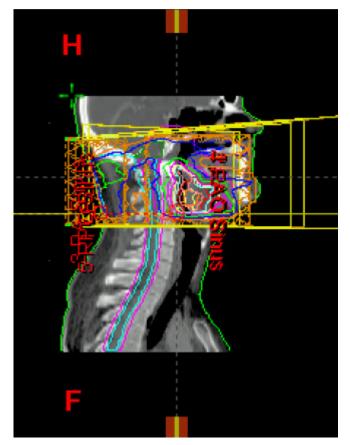
- Monday March 14, 2005, 11.a.m.
  - Within 12 s, another workstation, WS1, is used to open the patient plan. The planner would have seen this:

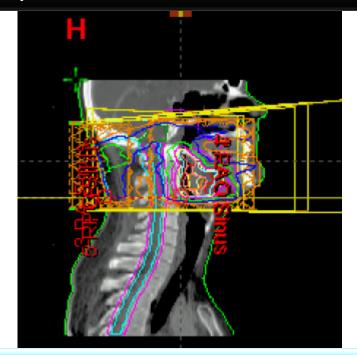
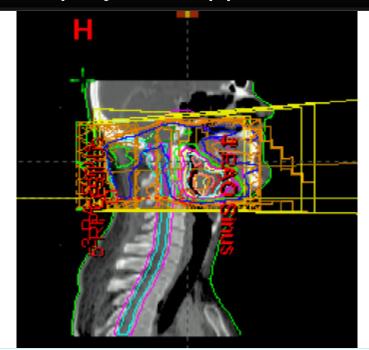
No MLC control point data is included in the plan, neither required for dose calculation, display and approval !!!

The sagittal view should have looked like the one to the right, with MLCs

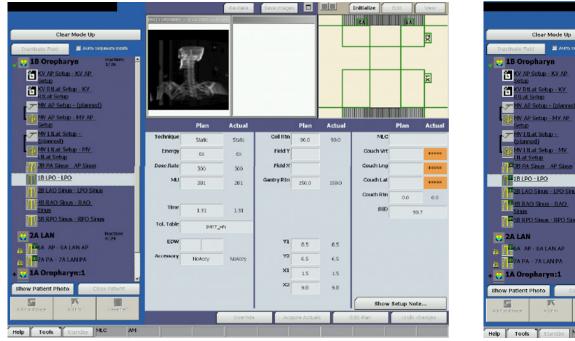
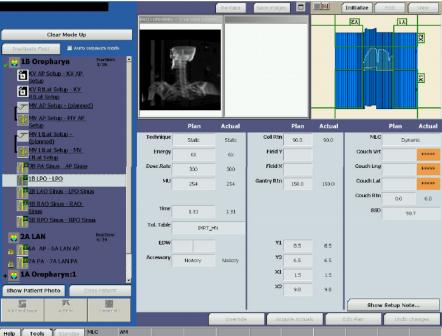
- Monday March 14, 2005, 1 p.m.
  - The patient is treated. The console screen would have indicated that the MLC is not used during treatment:
