FUKUSHIMA ACCIDENT

Katsumi Yamada

The Accident at Fukushima Nuclear Power Stations and Lessons Learned

Joint ICTP-IAEA Course on Science and Technology of SCWRs, Trieste, Italy, 27 June - 1 July 2011

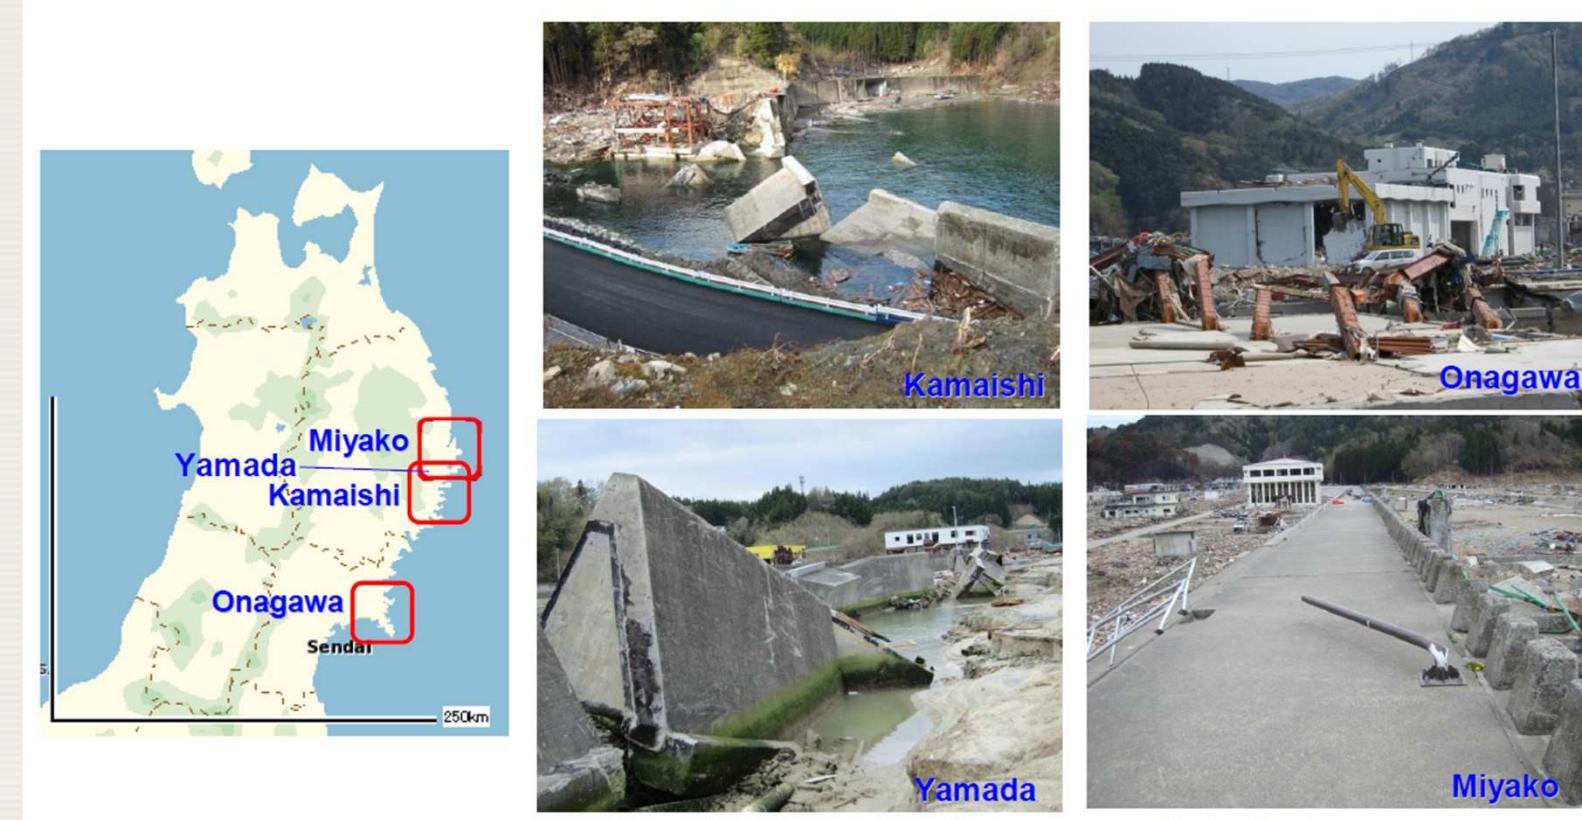
Damages of Seawall and Harbor Installation

Destruction by tsunami scouring

Destruction by wave pressure
