**Joint ICTP/IAEA Advanced Workshop on Earthquake Engineering  
for Nuclear Facilities**

**Equipment Fragility Evaluation by Vibration Test**

Hiroshi Abe  
*Japan Nuclear Energy Safety Organization JNES  
Seismic Safety Division  
Tokyo  
Japan*

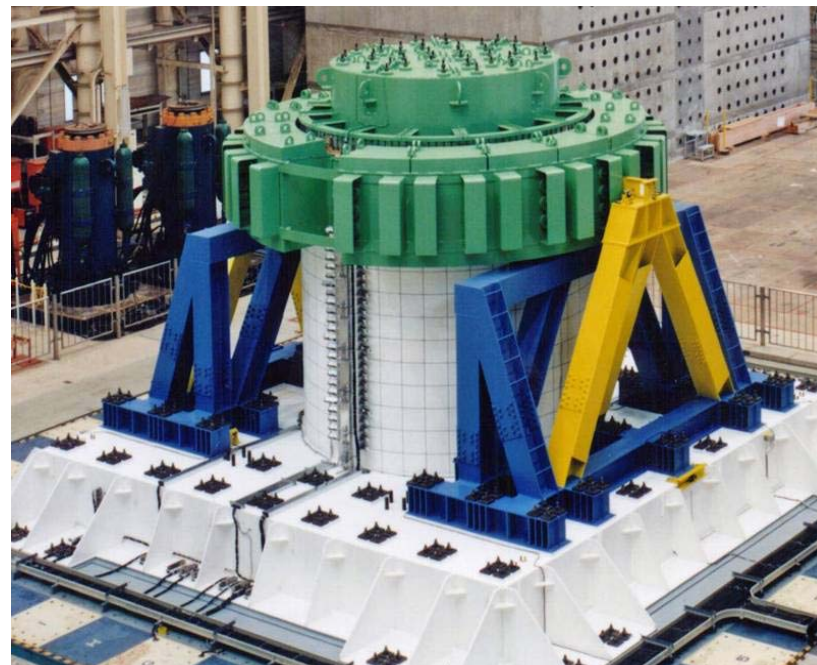
**Pre-stressed Concrete Containment**  
( Scale :1/10, Total Weight: 757ton  
Height: 6.53m,Outer Dia.: 4.6m )

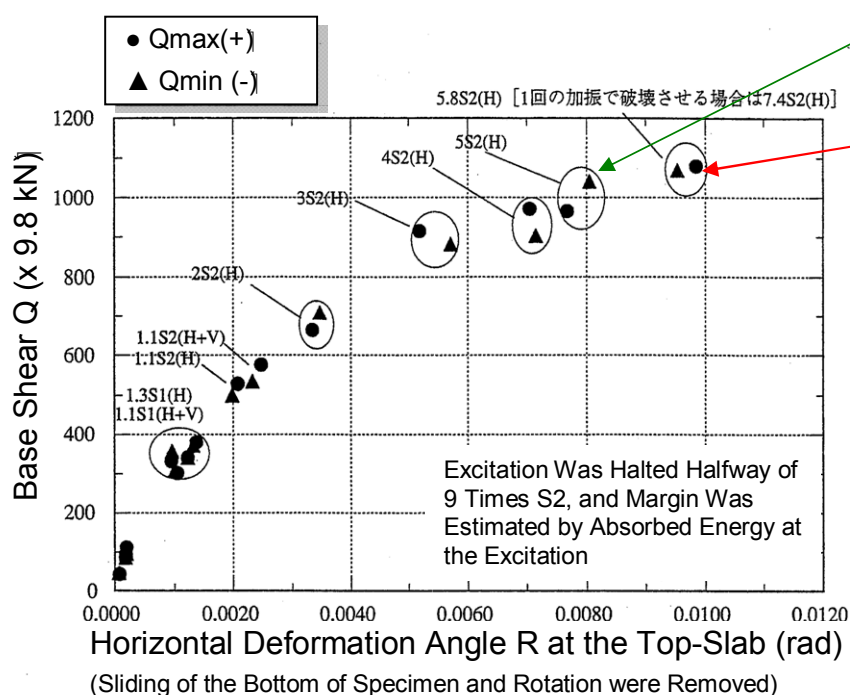
Load to Deformation Relation  
Through Excitation History  
(RCCV )

- No leak up to 5 Times S2 Excitation

- Shear Failure during 9 Times S2 Excitation and Liner Failure

- Evaluation by the amount of energy absorbed only by 9 Times S2 Excitation :

Failure at 5.8 Times S2

( Equivalent One Excitation Margin Evaluated by Energy Absorbed through Excitation History )

- RCCV : 7.4 Times S<sub>2</sub>

- PCCV : 6.1 Times S<sub>2</sub>

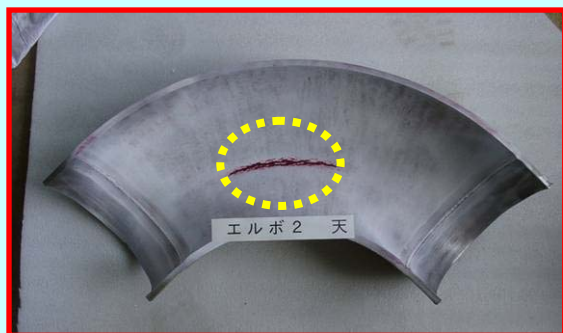
Piping Ultimate Strength Test  
(Excitation by 8.5 Times Allowable Level Input )

**Fatigue Failure during Fifth  
Excitation**

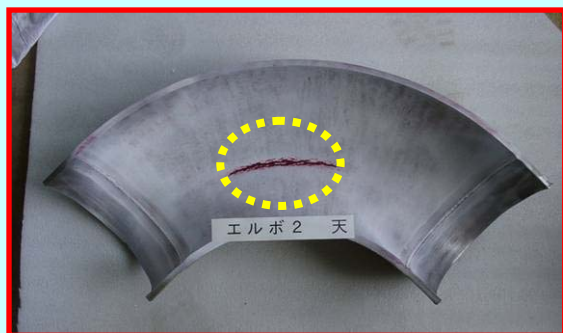
Piping Ultimate Strength Test  
(Excitation of 8.5 times of the  $IV_{AS}$  Allowable Stress Level)

## Fatigue Failure during Fifth Excitation

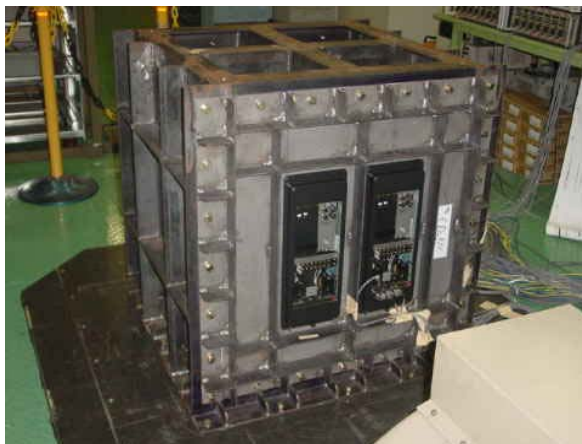
### Element Test (Differential Relay)

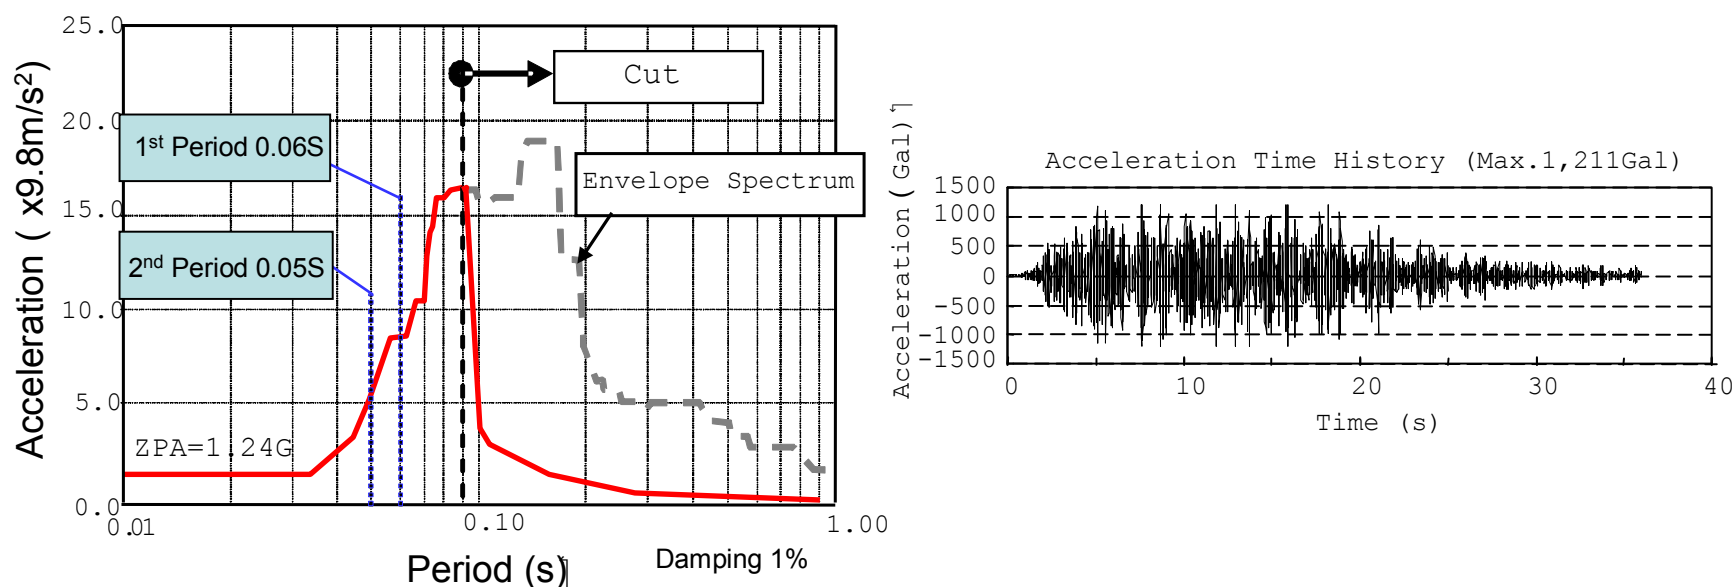
**Input Motion : Synthetic Wave which Envelope Design  
Spectra of BWR and PWR in Japan and Filtered  
Long Period Ingredient more than 0.9 Second  
Max. Acceleration : 3G**

Basic Horizontal Input Motion

( Envelope of Design Spectra of BWR and PWR )

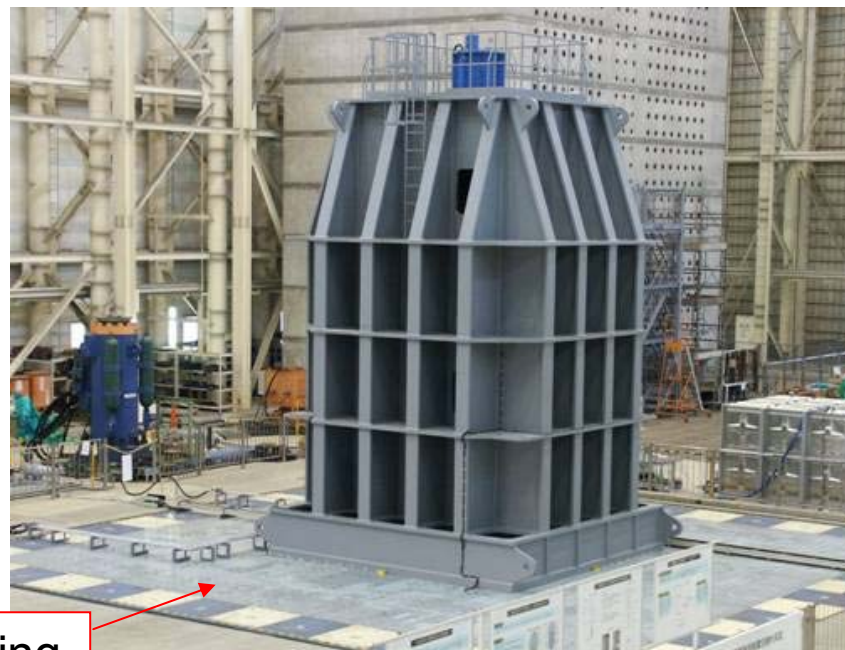
**BWR Specimen**

( Height : Above Shaking Table : 9.3m , Under  
Shaking Table : 4.2m )

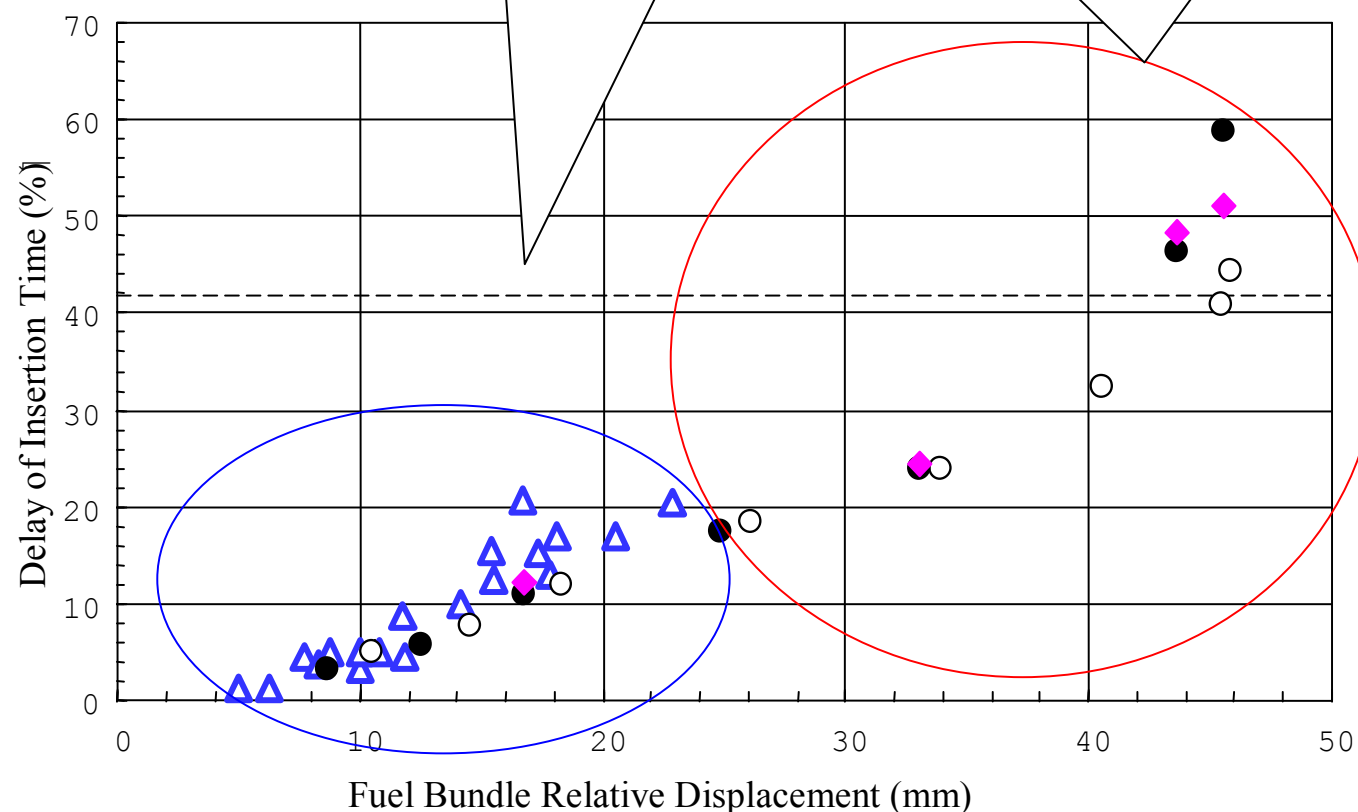
- Tested up to  $3.3 \times S2$

- No Abnormality in the Test

Delay Time of CR Insertion vs. Relative Displacement of Fuel Bundle ( PWR )
