**Advanced School on Non-linear Dynamics and Earthquake
Prediction**

MEGIDDO EARTHQUAKES

Shmuel Marco, Amotz Agnon, Israel Finkelstein and David Ussishkin

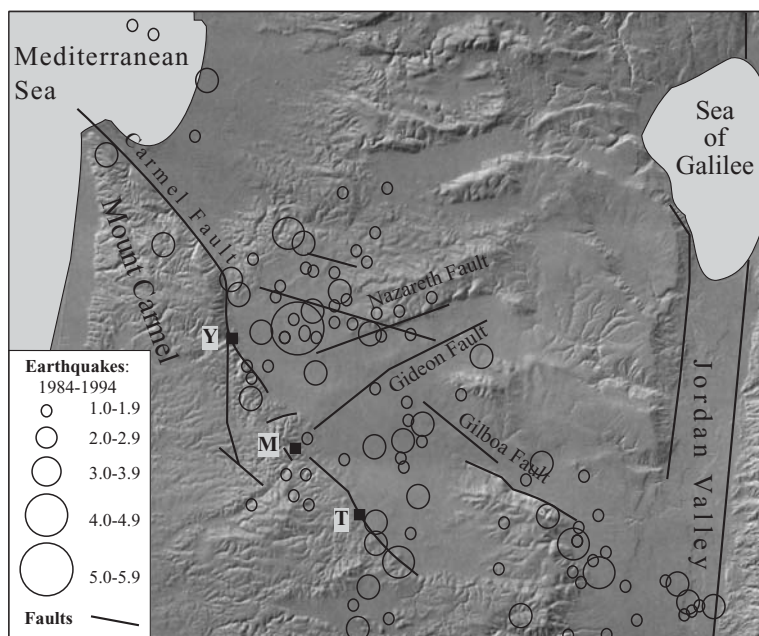
Fig. 31.1: Location of faults near Megiddo and recent earthquake epicenters in the vicinity of the Carmel Fault. (Y, M and T refer to Yoqne'at, Megiddo and Ta'anach respectively.) Earthquake data from the Geophysical Institute of Israel (www.gii.co.il).

Megiddo owes its strategic advantage to the Carmel fault zone, an active branch of the Dead Sea Fault system. Mount Carmel rises southwest of the fault whereas northeast of it the Jezreel Valley subsides. The uplift of Megiddo where the main fault branches off to the Gilboa Fault gave those who commanded it control of the Jezreel Valley as well as of the international road connecting Egypt with Syria and Mesopotamia which descends into the valley near the site. The topographic relief is only one-fifth of the structural displacement accumulated across the fault (Rotstein *et al.* 1993), about 2 km of rock layers having been eroded from Mount Carmel. Achmon and Ben-Avraham (1997) studied the anomaly of the gravity field across the fault and verified that it is deep rooted (Fig. 31.1). A left-lateral component of movement (the valley moves in a northwesterly and the mountain in a southeasterly direction) is also inferred from analyses of earthquakes (Hofstetter *et al.* 1996) and offset stream channels (Achmon 1986). The recent activity of the fault is evident in the steepness of the cliffs, the displaced stream channels and the frequent microearthquakes (Fig. 31.1). In the past few decades a few earthquakes were even felt at nearby settlements and in the city of Haifa. On November 23, 1989, the Israel Geophysical Institute reported a very weak earthquake of local magnitude 2.1 (www.gii.co.il) directly beneath Tel Megiddo.

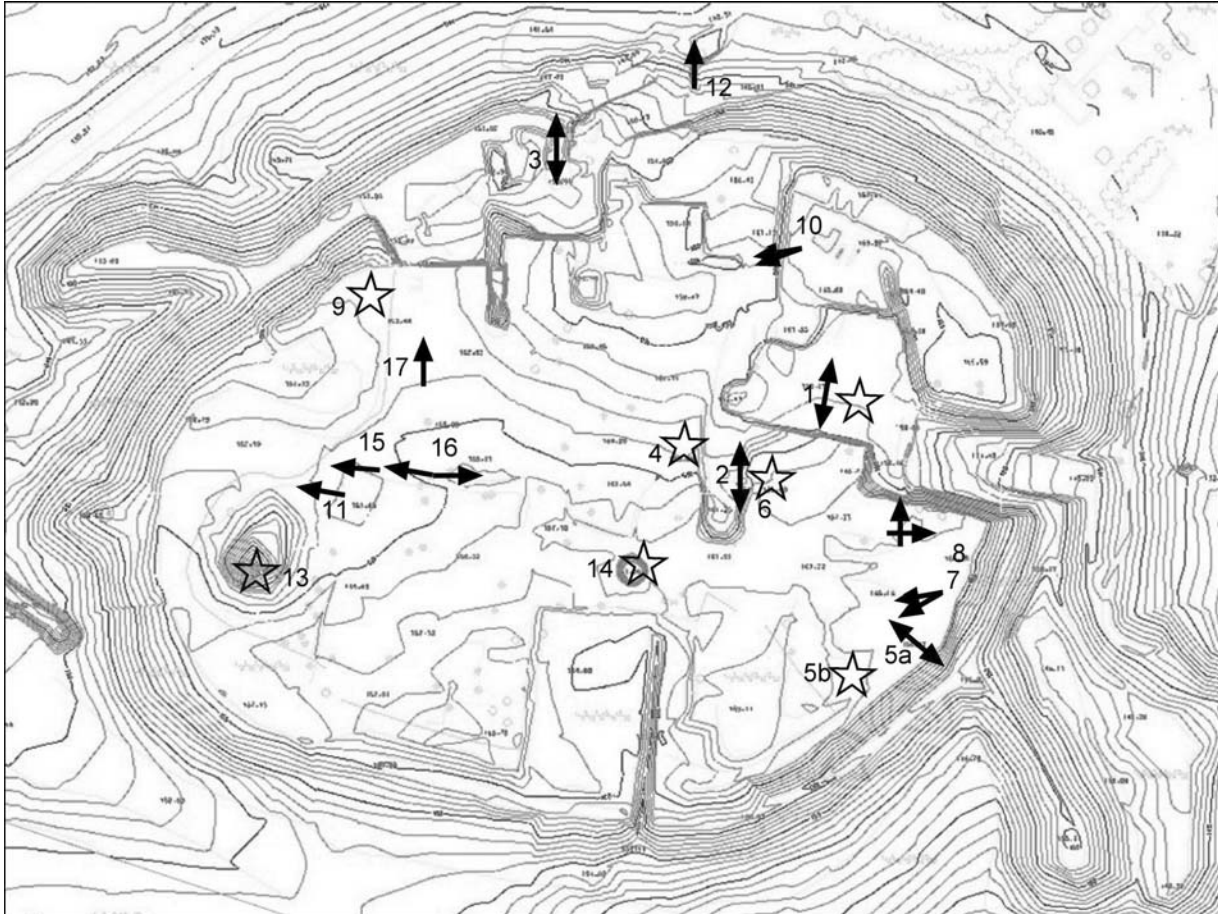
Fig. 31.2: Location map of deformed structures at Megiddo. Arrows indicate direction of shaking. Stars mark deformation that cannot be associated with a particular sense of movement.

TABLE 31.1: DEFORMED STRUCTURES SUSPECTED AS EARTHQUAKE-RELATED DAMAGE AT TEL MEGIDDO (SERIAL NUMBERS INDICATE LOCATION ON MAP IN FIG. 31.2)

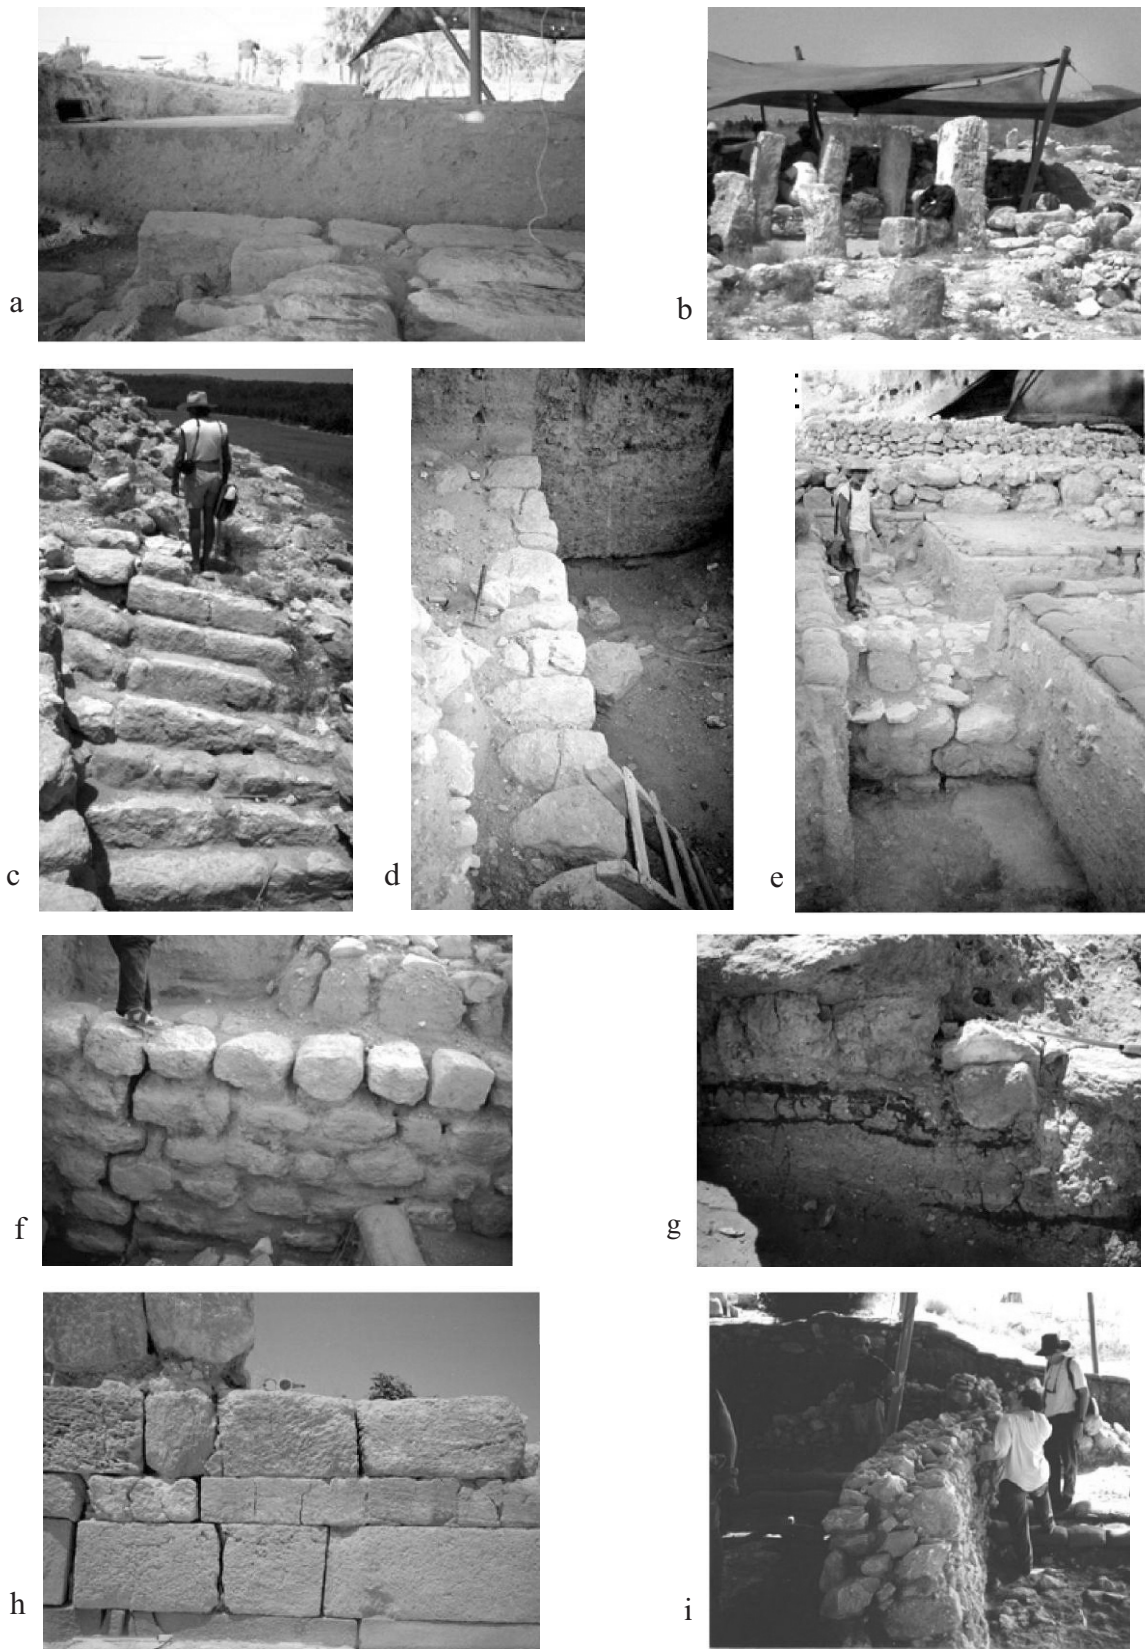
| <i>No.</i> | <i>Description</i> | <i>Cause</i> | <i>Date of structure</i> |
|---|---|--|--|
| 1 | In Area J, the monumental walls of the Level J-4 temple are fractured in several places along their strike (Fig. 31.3d) as well as perpendicular to the strike (Figs. 31.3e-f). The overlying walls of the EB III temple 4050 are not fractured. | Probably catastrophic horizontal shaking. | Early Bronze I, Level J-4 (Stratum XVIII), end of 4th millennium BCE. |
| 3 | Extension cracks in the Late Bronze gate. Ashlar stones in courses in the middle of the walls (sandwiched between other courses) are fractured in opening mode. Horizontal sliding of the fragments occurred everywhere in the same direction, sub-parallel to N-S trend of the wall (Fig. 31.3h). The gate has no foundations, a fact that could have made it particularly vulnerable to seismic vibrations. | Probably catastrophic horizontal shaking. | Late Bronze, probably built in Stratum VIII and continued to function in Stratum VII – 14th- 12th centuries BCE. |
| 4 | Distorted and liquefied sand horizon in the western section of the Schumacher trench, excavated in the early 20th century. (Fig. 31.3g). | Catastrophic shaking. | Seems to belong to destruction of Strata VIIA (12th century BCE) or VIA (10th century BCE), probably to the latter. |
| 5a | A warped wall trending 220° in Area K is tilted to both sides 12°-15°. (Fig. 31.3i.) | Pressure of accumulating earth is unlikely where the wall tilts inward. Probably catastrophic. | Late-Iron I, Level K-4 (Stratum VIA), late 11th-10th centuries BCE. |
| 7 | A group of six pillars in Building 1A (Lamon and Shipton 1939: Fig. 6) are all tilted 8°-11° to the west (265°-295°). (Fig. 31.3b). | Probably catastrophic horizontal shaking. | Iron II, Stratum VA-IVB, 9th century BCE. |

| <i>No.</i> | <i>Description</i> | <i>Cause</i> | <i>Date of structure</i> |
|---|--|--|--|
| 10 | The south-western corner of Palace 6000 (Area L, Squares D/5, E/4-5) is tilted 3°-5° (top dipping to 250°-260° – Fig. 31.3a). In the northern baulk of Squares D-E/4, a white layer which belongs to the palace's floor make-up is also tilted. Immediately to the east, in the northern section of Square E/4, there are two fissures, each about 10-15 cm wide in the same floor make-up. The fissures are filled with grey unconsolidated soil that contains a few ceramic fragments. The white make-up for Floor 98/L/59 and plaster Floor 98/L/120 – both of the Level L-2 stables – are horizontal | Large scale deformation. Could be either a slow process (because of pressure on the westward slope) or a catastrophic one. | Iron II, Levels L-3 (Stratum VA-IVB), 9th century BCE. |
| 12 | Staircase leading from the Iron II gate complex to a water system/reservoir (Loud 1948: Fig. 389, Square H/10) is tilted 9°/000°. The staircase is built on a steep slope. (Fig. 31.3c). | Could be either a slow down-slope slide or a catastrophic process. | Iron II, Stratum IVA, 8th century BCE. |

Fig. 31.3. Photos of earthquake damage at Megiddo. Numbers in Table 31.1; a) No. 10; b) No. 7; c) No. 12; d-f) No.1; g) No. 4; h) No. 3; i) No. 5a.

At Megiddo, the only cases of structural damage that can be related to earthquakes with high certainty are the extension fractures in the walls of the Level J-4 temple and in the Late Bronze gate complex (Fig. 31.3h). However, the features of the overall damage provide important support for the interpretation of the damage as earthquake-related. Most of the observations suggest either E-W or N-S shaking directions (Fig. 31.2). We consider the fairly uniform pattern of the inferred direction of shaking as an indication for earthquake-related damage. The observed liquefaction (Fig. 31.3g), which is a typical earthquake-induced feature, may be regarded supportive evidence, but unfortunately its age is not absolutely clear.
