In-situ XRF analysis as a diagnostic analytical tool in the conservation field

A.G. Karydas, V. Kantarelou

Outline and the PROMET analytical campaigns across the Mediterranean

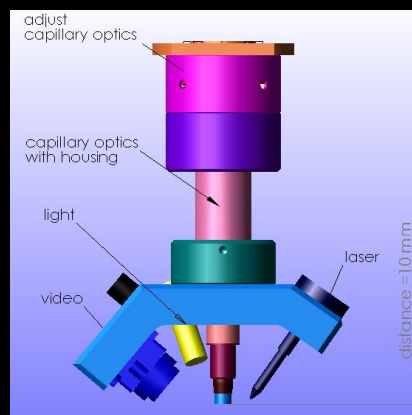
μ -XRF spectrometer: Principle of operation

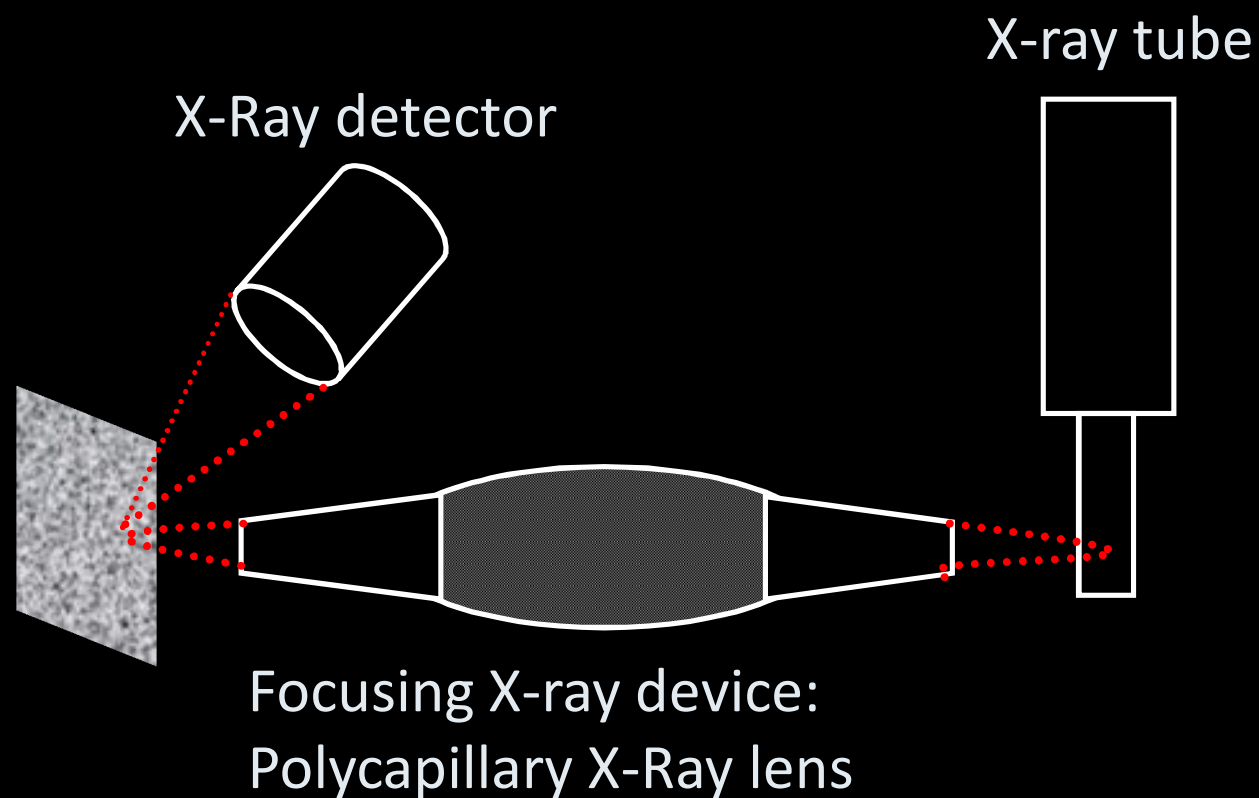
Development and
application of
portable micro-XRF
unit
Customized design of
ARTAX by Bruker
Nano AXS

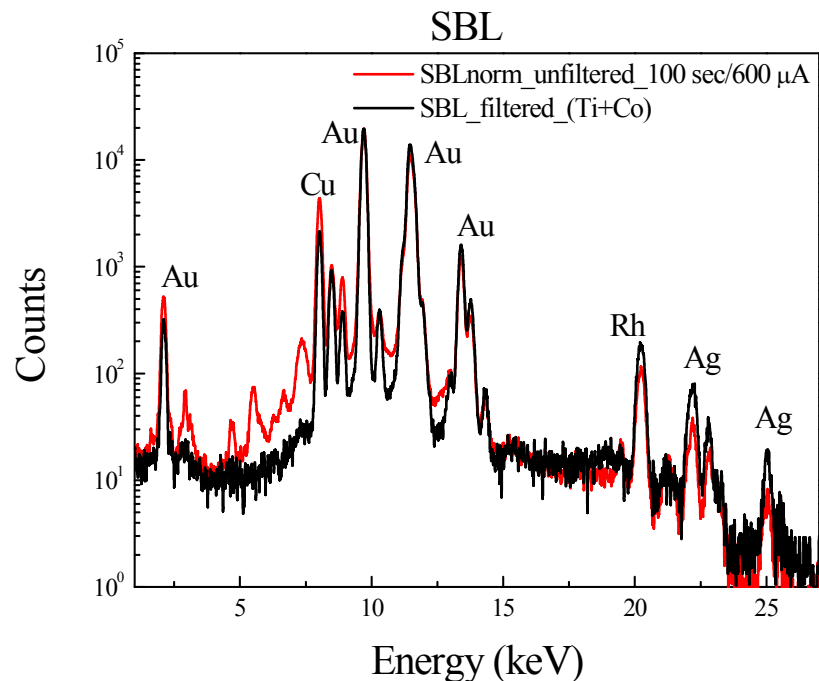
Pitfalls: Interference of XRF signal with diffraction peaks, QC/QA of micro-XRF data

- ✓ Diffraction peaks
- ✓ Heterogeneity at the micro-scale
- ✓ Definition of the scanning area that represents the alloy bulk composition

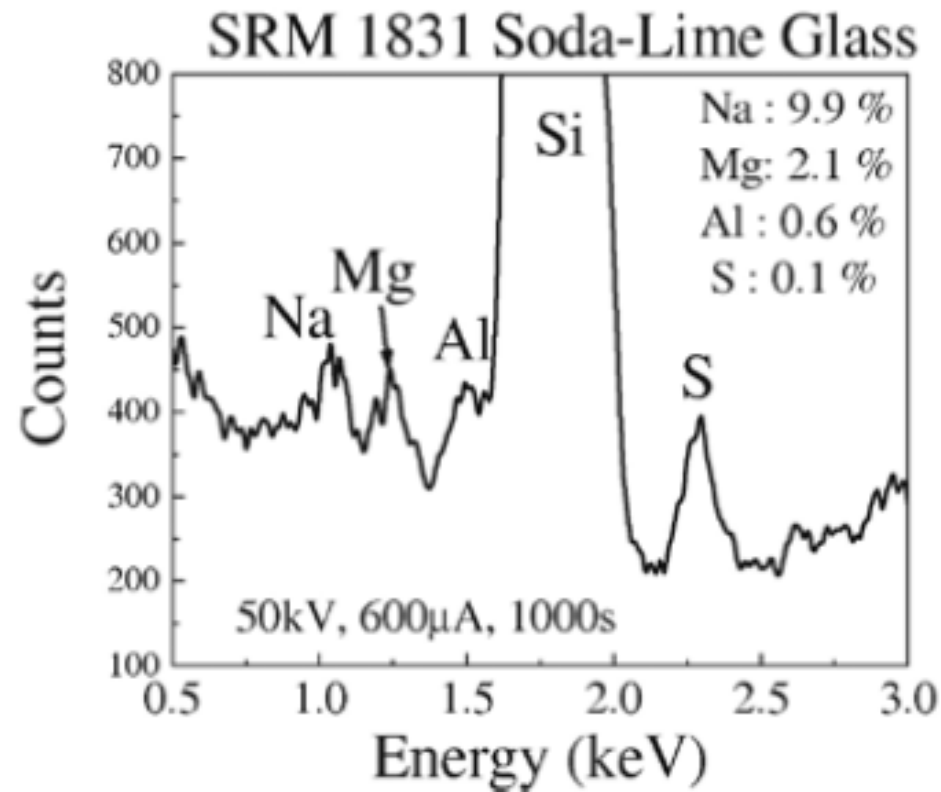
Analytical range using He atmosphere

50kV, 600mA, 100s

The improvement in the intensity of Al-K and Si-K characteristic X-ray lines is significant, 22 and 7.3 times, respectively.

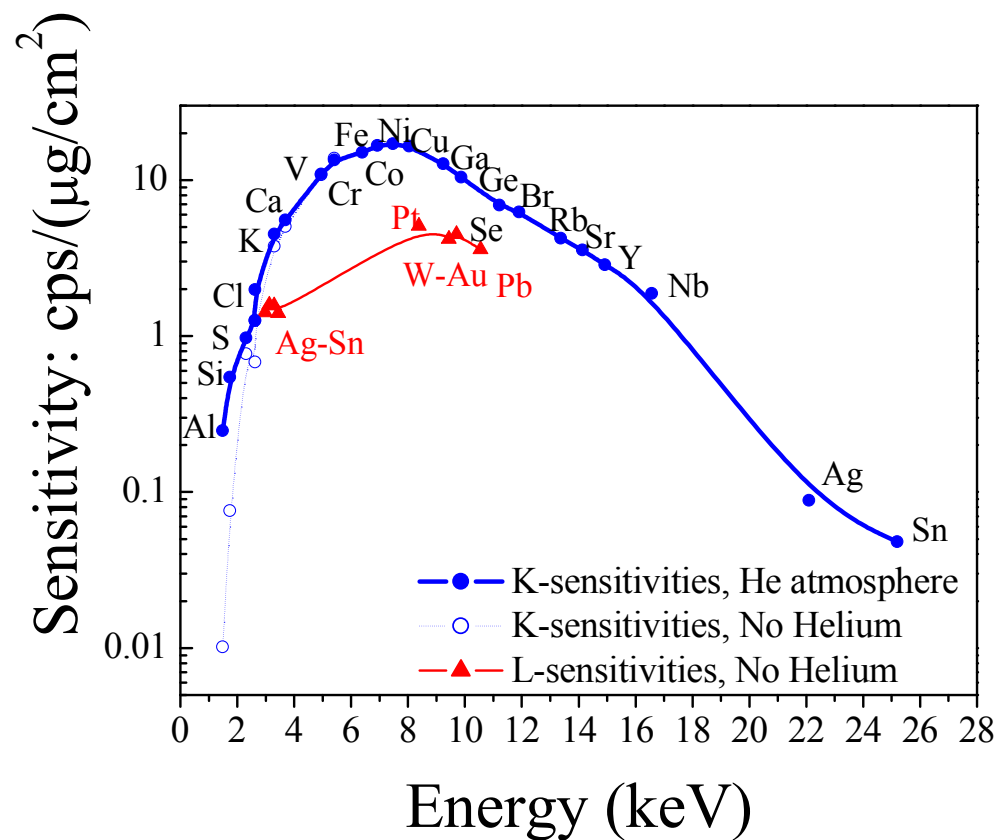
Analytical performance: Elemental sensitivity

Thin Targets $\sim 50 \mu\text{g}/\text{cm}^2$

600 μA
50 kV

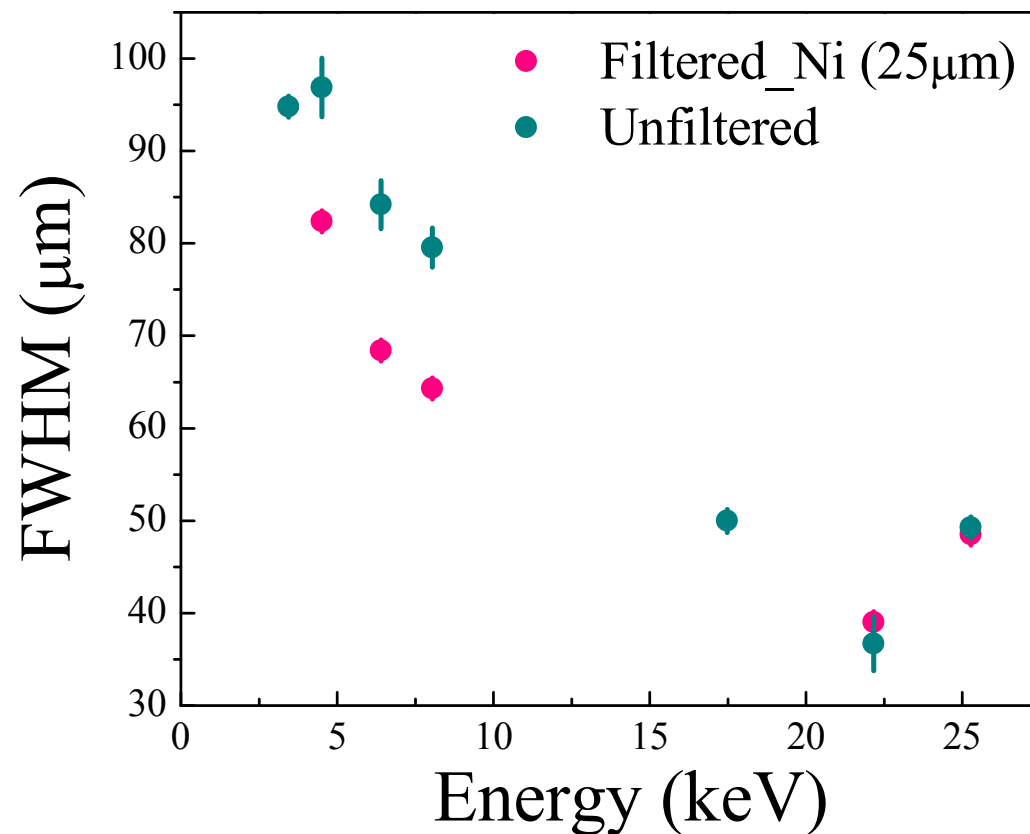
Analytical performance: Spatial resolution

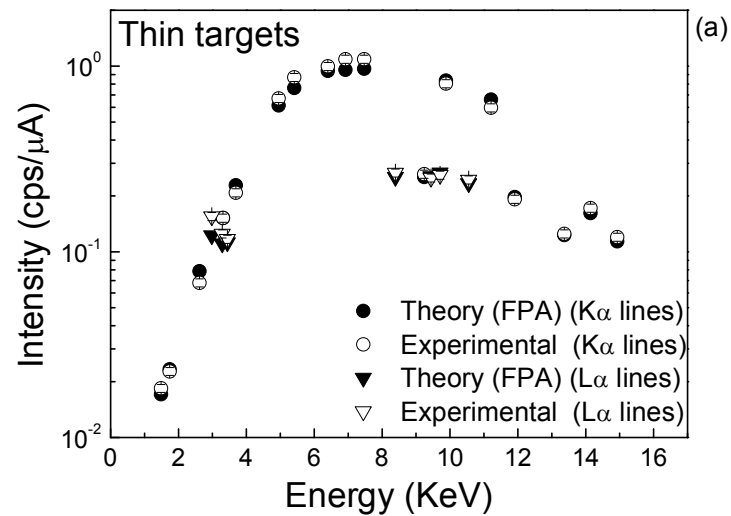
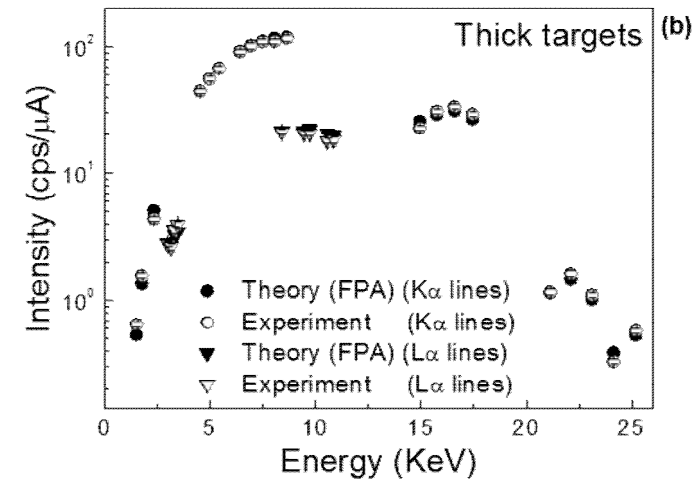
Experimental/simulated pure element thick/thin elemental intensities

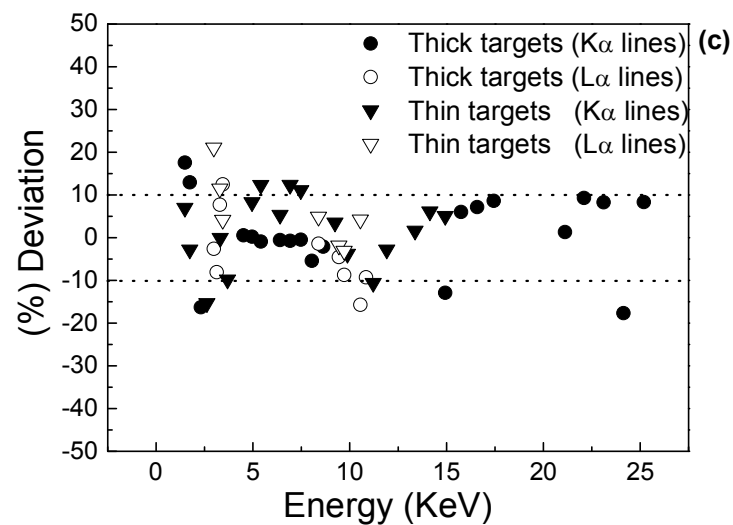
Results of the fitting procedure

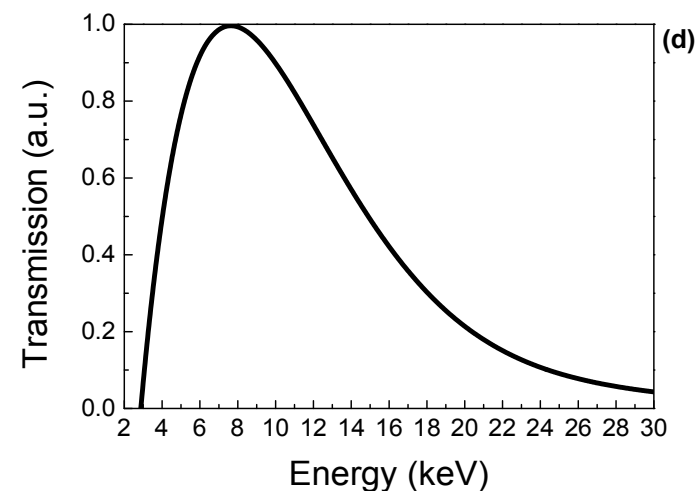
Estimated Lens transmission efficiency

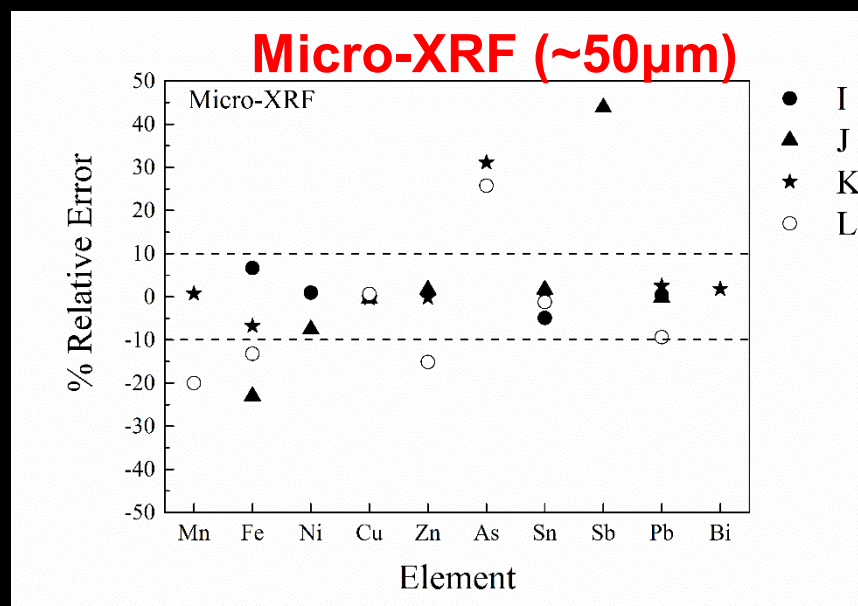
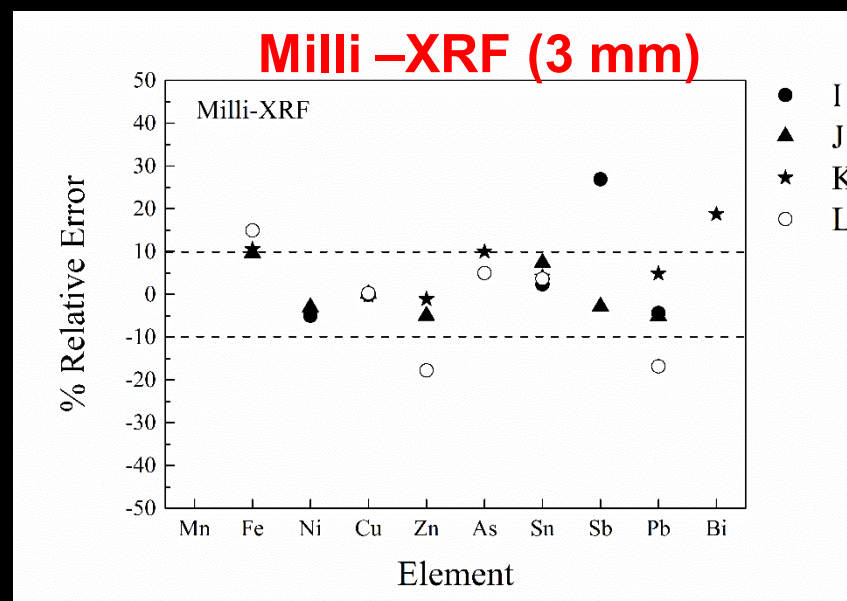
Assessment of micro-XRF analysis accuracy

Validation with respect to Cu based RMs

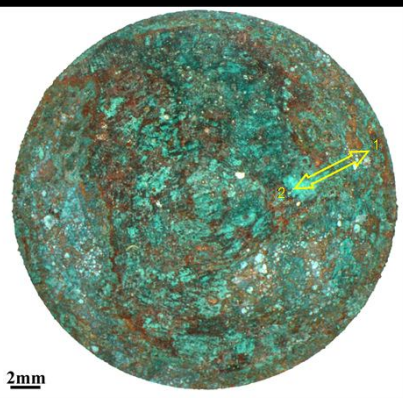
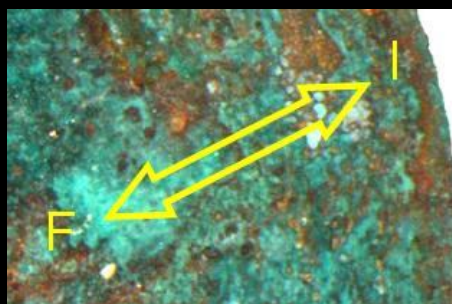
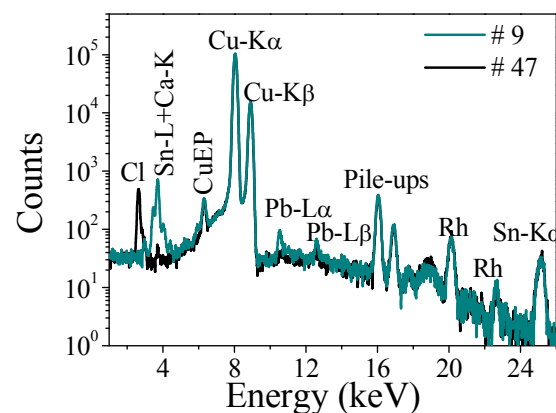
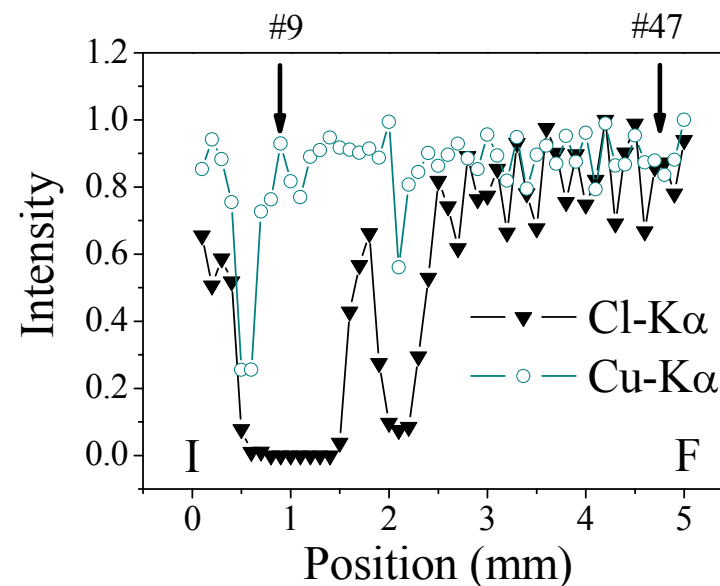
Analysis of Copper coupon corrosion products

Artificially and naturally aged bronze coupon: (Cu: 91.3%, Sn: 7.5%, Pb: 1.0%)

50kV, 600 μ A,
30s/step, 0.1mm/step,
50 measurements

#9 : green area
#47: pale green area

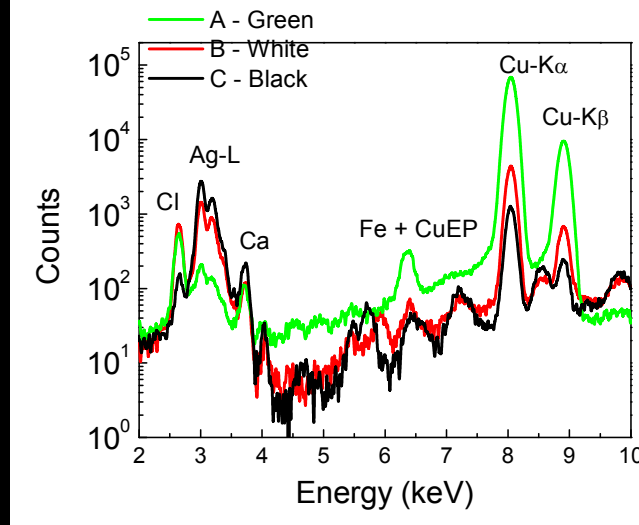
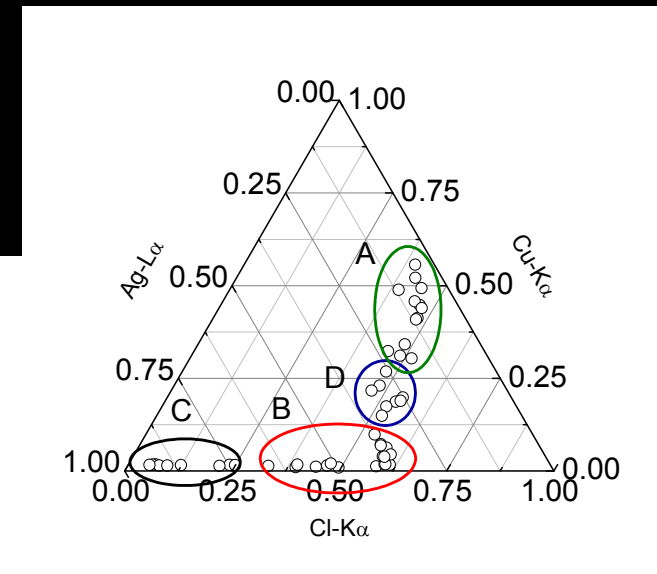
Silver coupon (prepared-characterized by Prof. G. M. Ingo,
Polytechnico of Milano) A – Green A - Pa

Artificially and naturally aged silver coupon:

Ag: 92%
Cu: 6.5%
Pb: 1.5%

50kV, 600μA,
30s/step, 0.1mm/step,
50 measurements

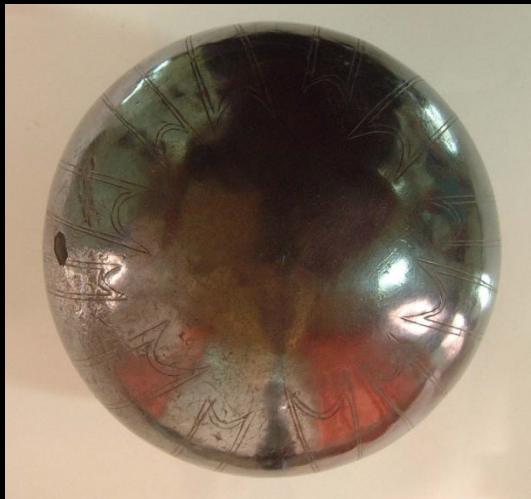
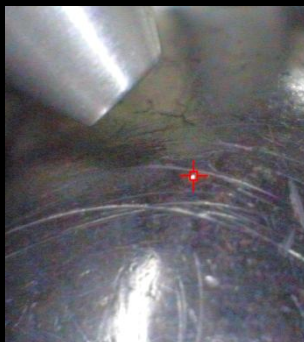
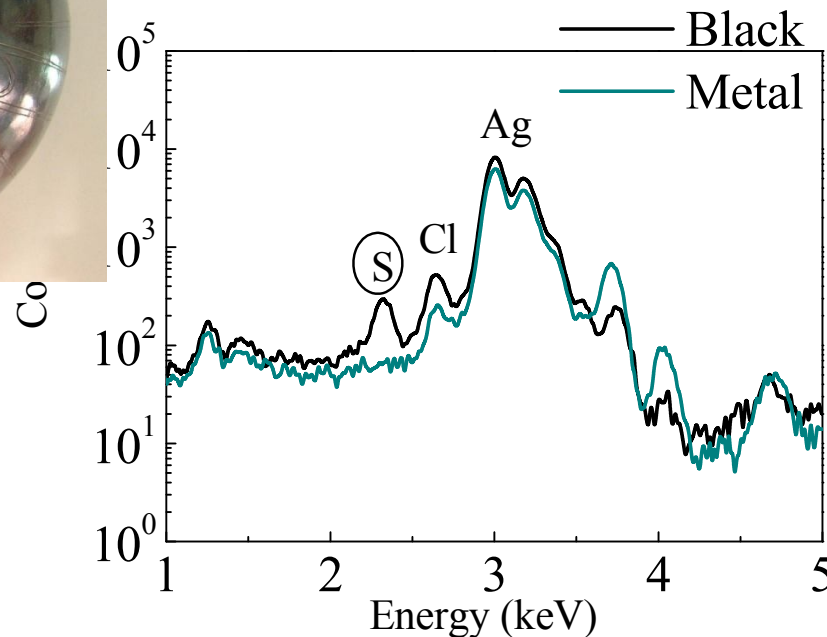
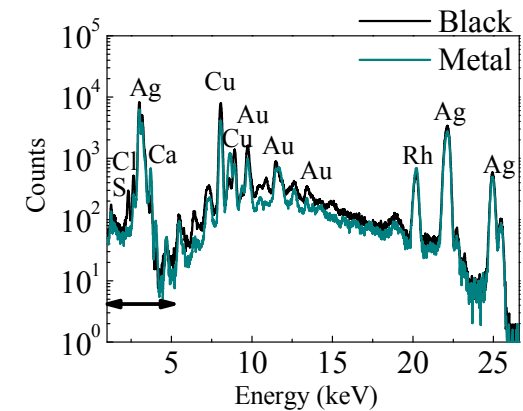
Analysis of silver tarnishing

Silver Bowl 1400 -1300 BC Late Bronze Age

Thickness of the layer: $\sim 0.5 \mu\text{m}$

Tarnish: corrosion mainly caused by the sulfur in the air

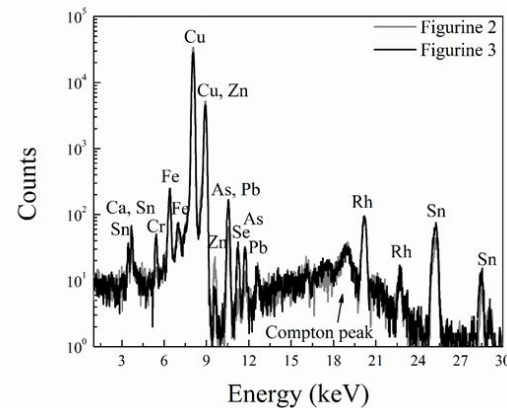
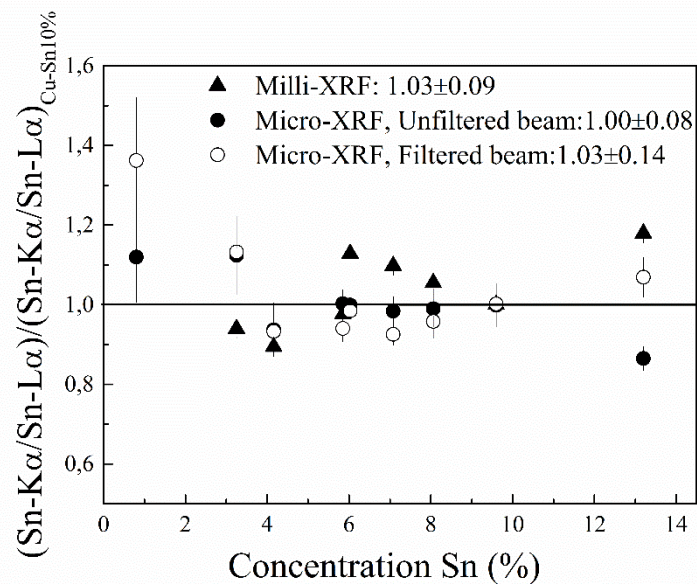
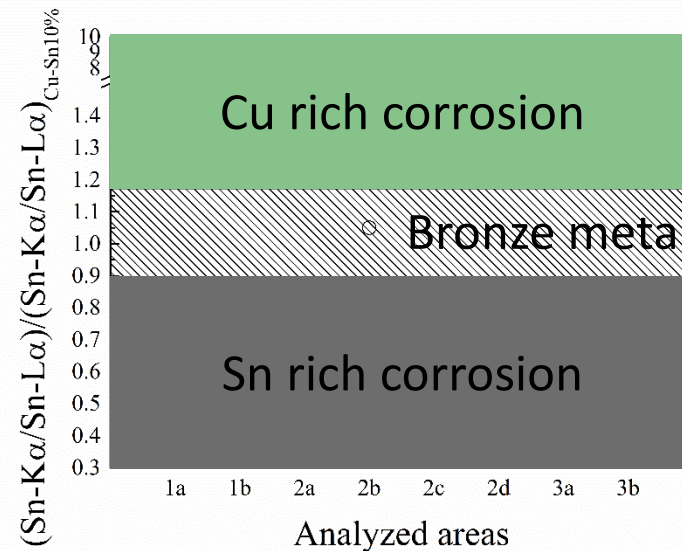
Compositional analysis of bronze metal

$$G_{Sn} = \frac{\left(\frac{I_{Sn}(K_{\alpha})}{I_{Sn}(L_{\alpha})} \right)_S}{\left(\frac{I_{Sn}(K_{\alpha})}{I_{Sn}(L_{\alpha})} \right)_R} = \frac{\mu_R(E_1, E_{K_{\alpha}})}{\mu_S(E_2, E_{K_{\alpha}})} \times \frac{\mu_S(E_3, E_{L_{\alpha}})}{\mu_R(E_4, E_{L_{\alpha}})} \times \frac{(1 + SE_T)_R}{(1 + SE_T)_S}$$

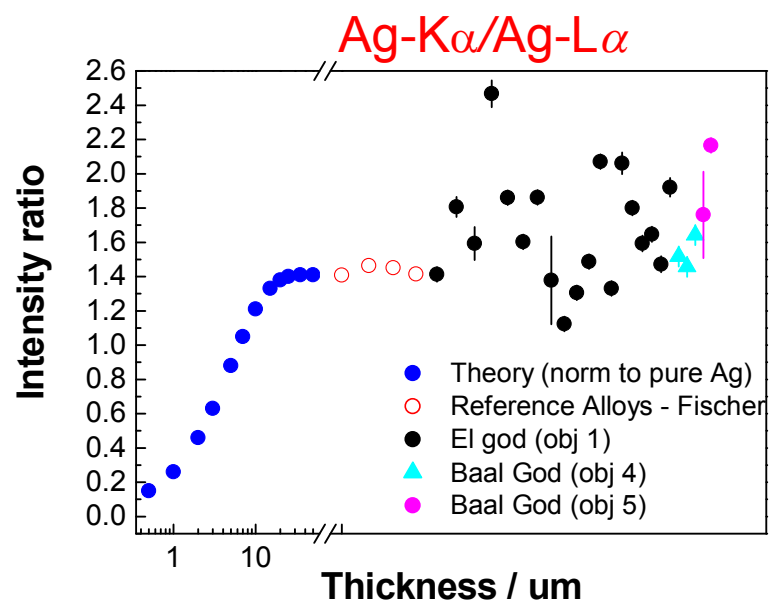
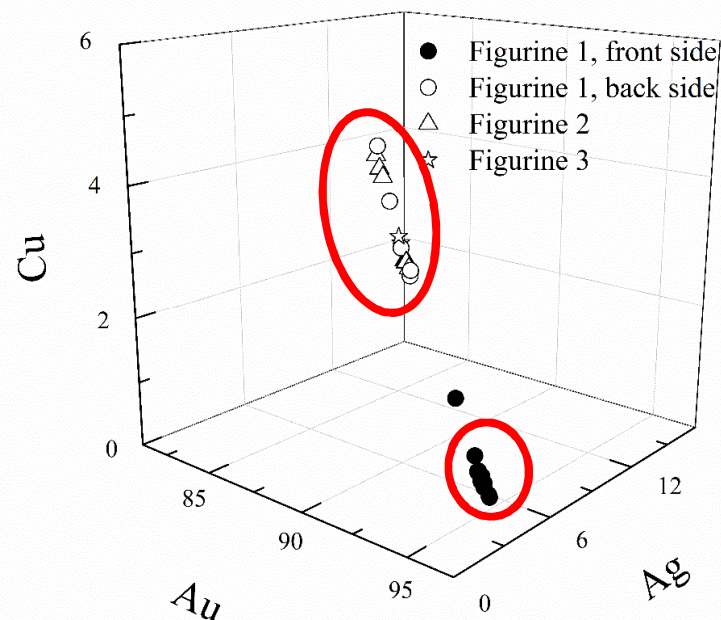
Compositional analysis of gold foil

Thickness of the gold foil > 10 micrometers

Two (2) main compositional groups:
 Ag: **14-15% or 4-5%**
 Cu: generally **<2-3%**

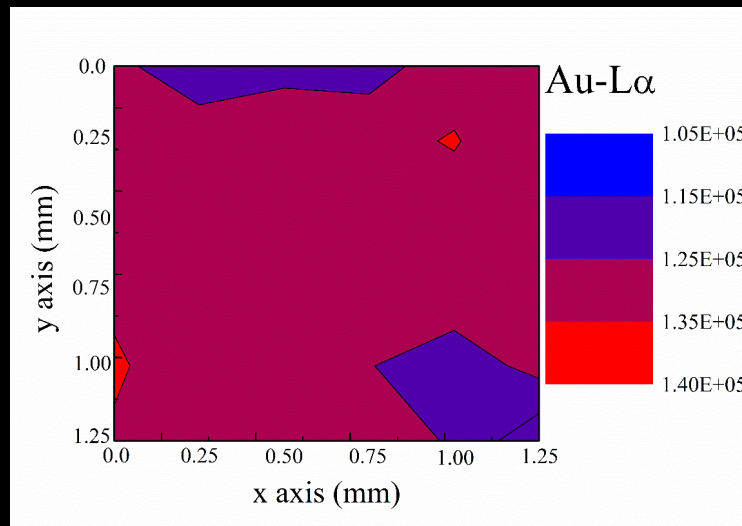
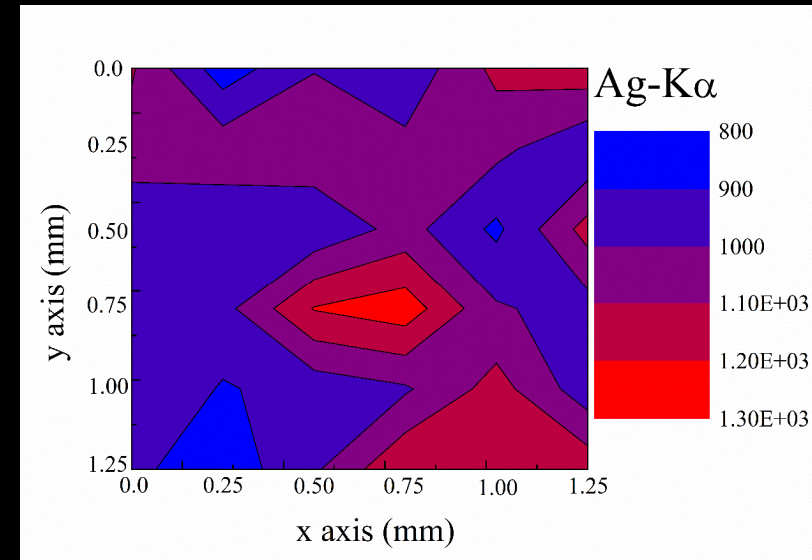
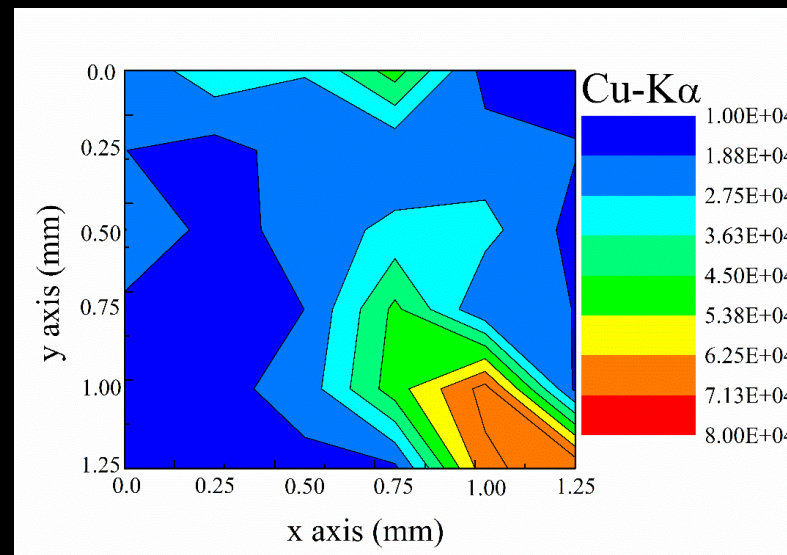
Imaging of the elements distribution on the gold foil

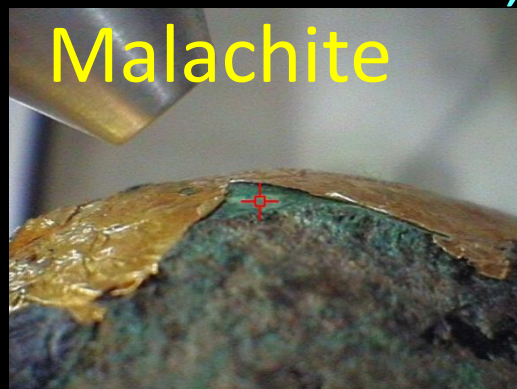
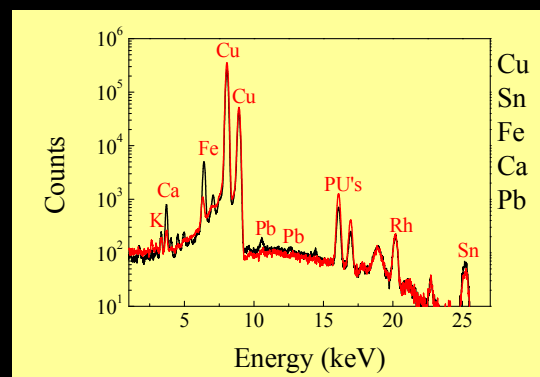
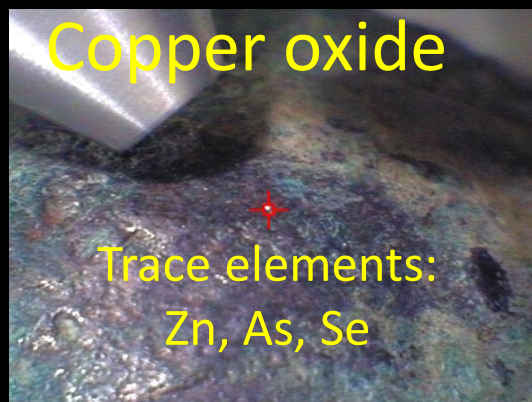
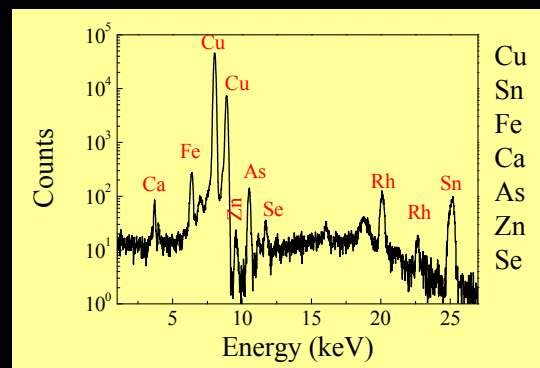
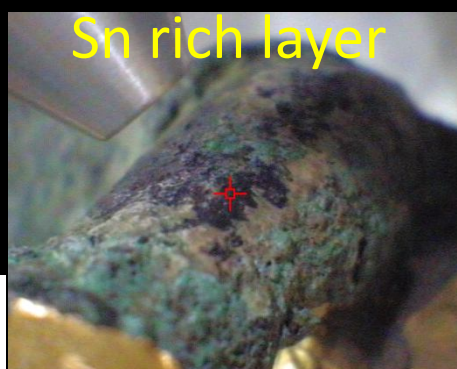
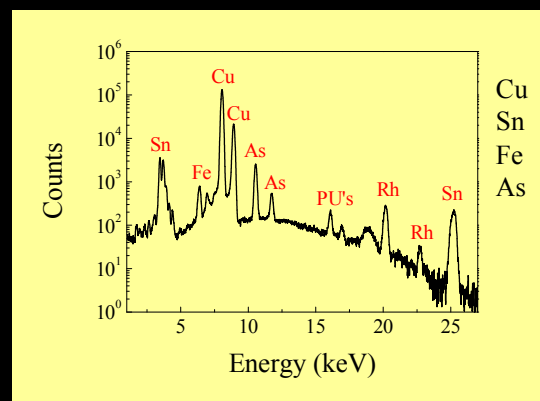
PROMET, Damascus, Syria: Corrosion products

Eail God, Late Bronze Age 1400-1300 B.C.

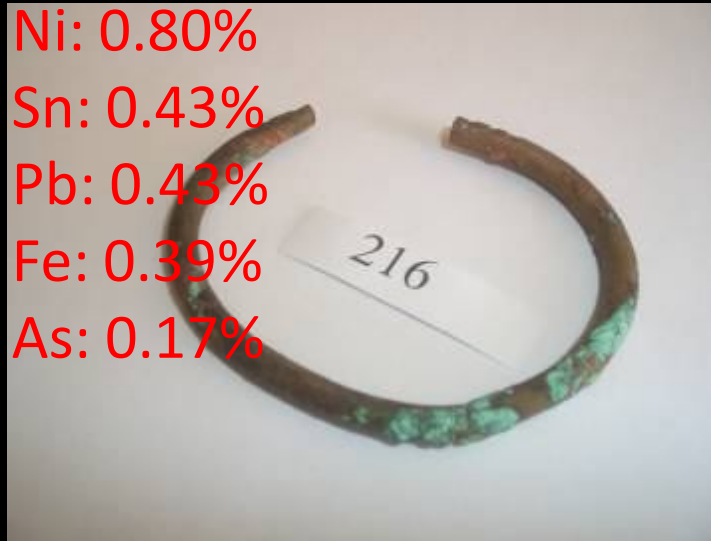
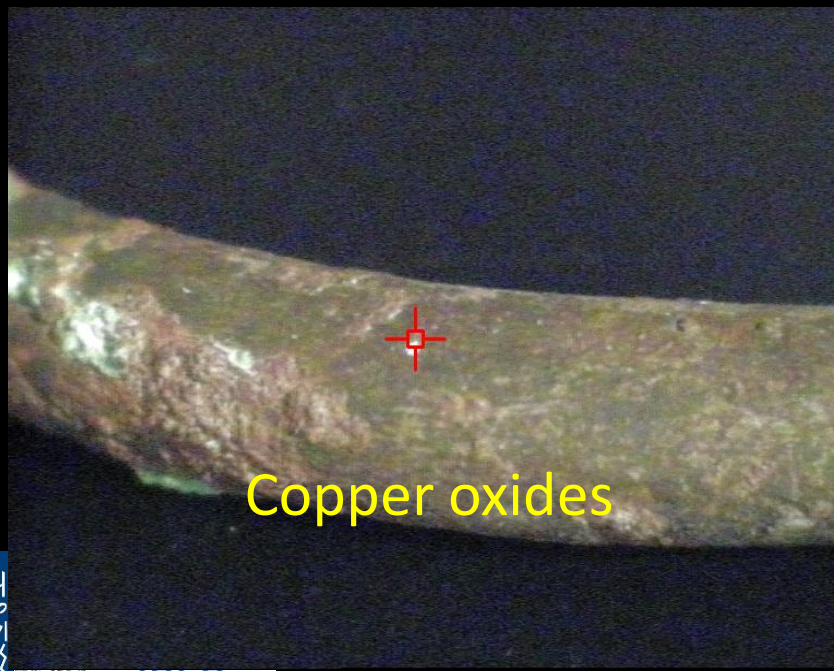
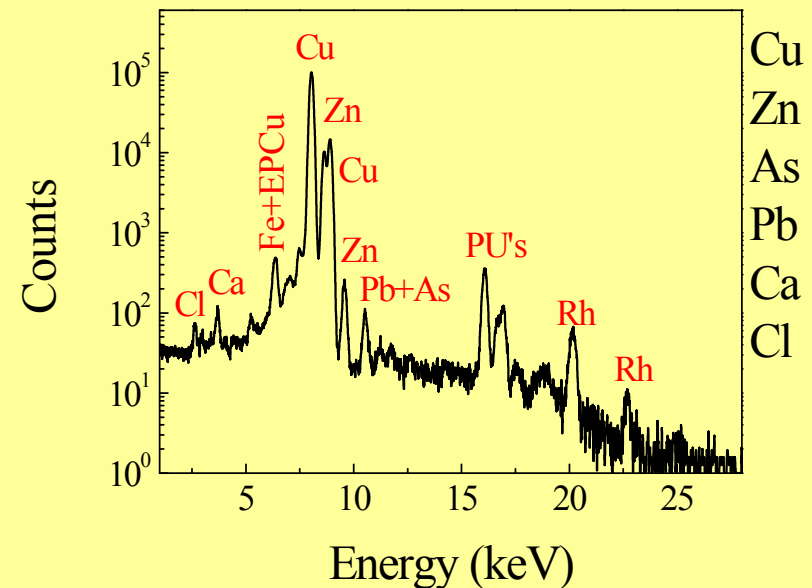
Copper-base bracelet, #216, (Ottoman Period), General + Pitting + Crevice Corrosion, Active corrosion have caused serious crack

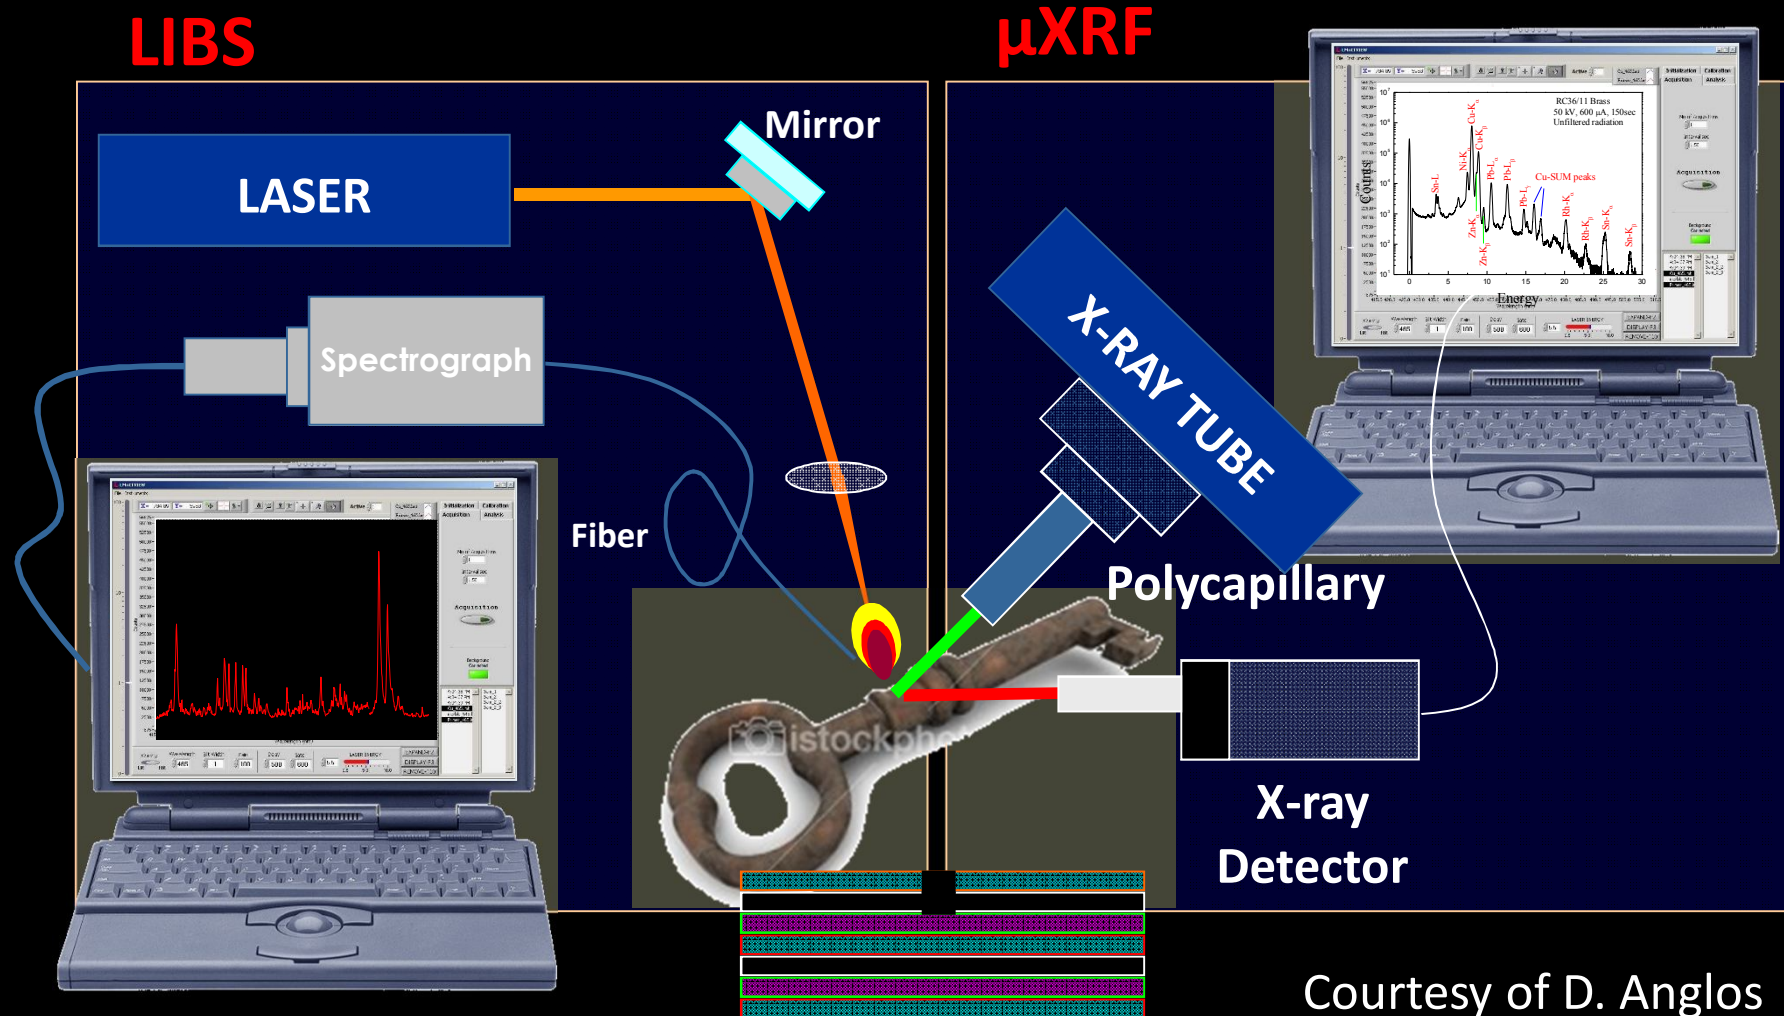
Dynamic combination of micro-XRF and LIBS

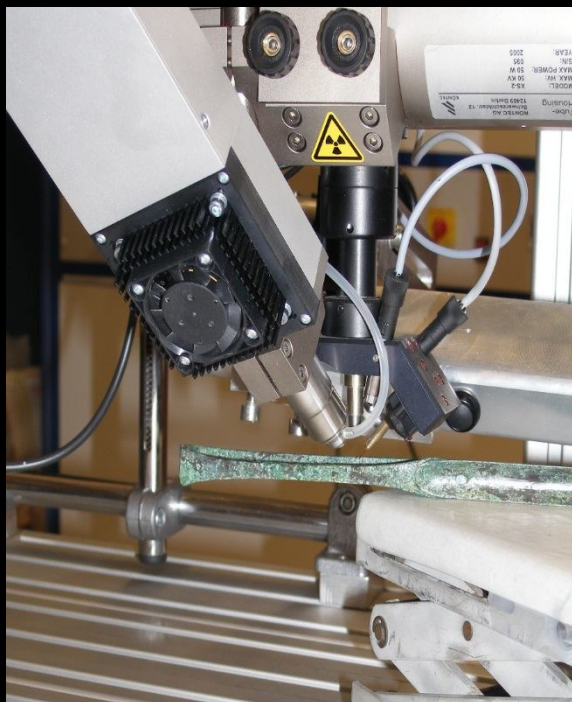
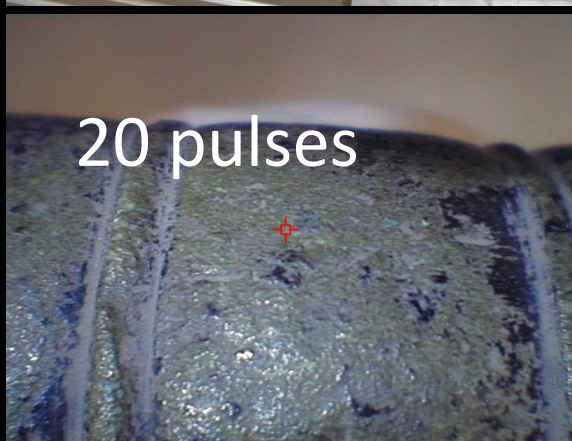
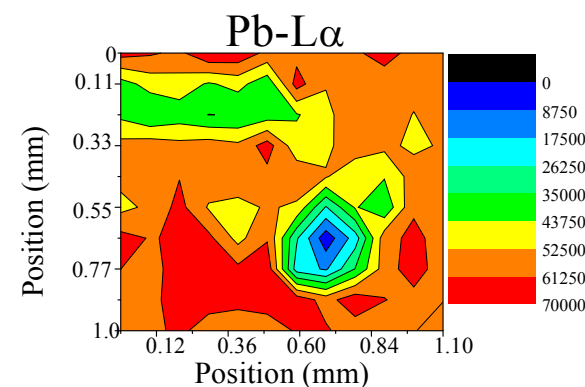
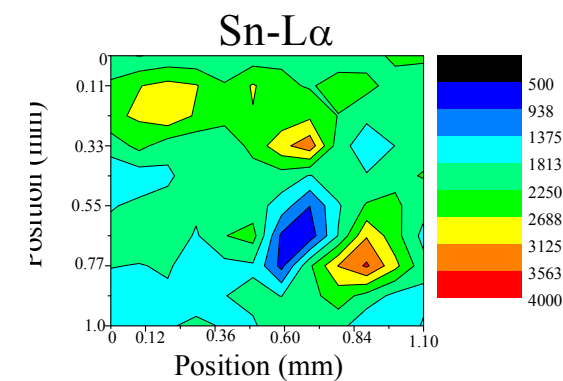
Micro-XRF elemental mapping of the LIBS ablated area

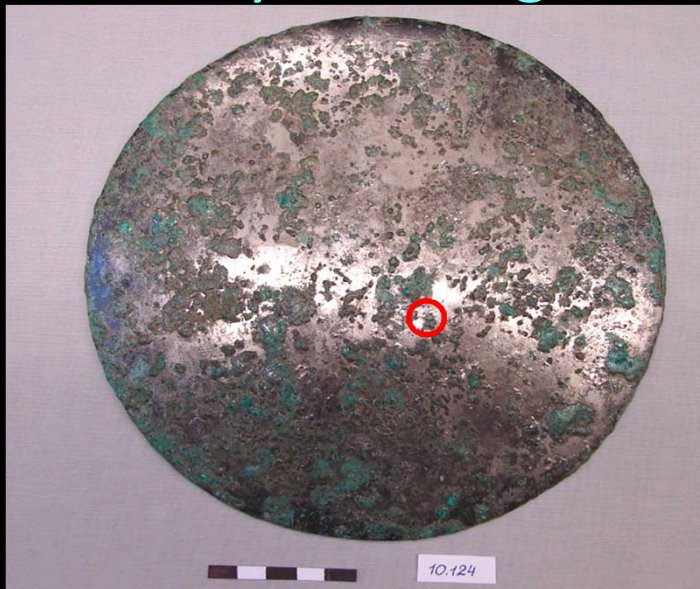
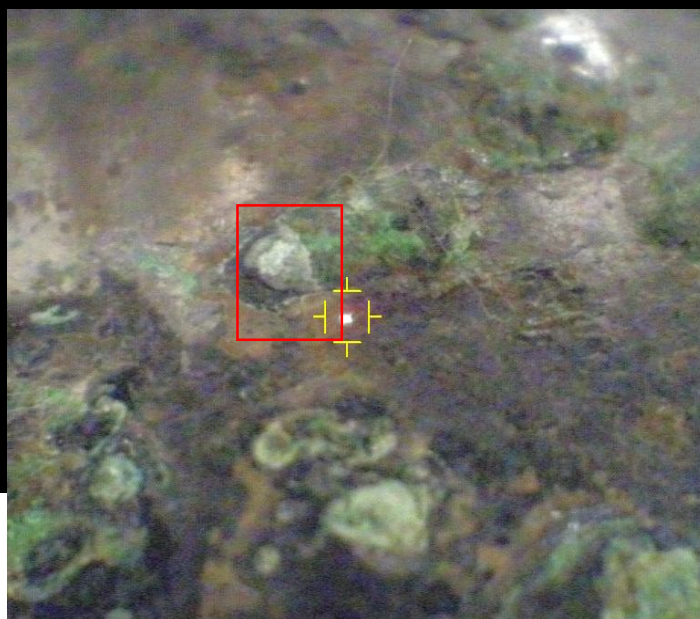
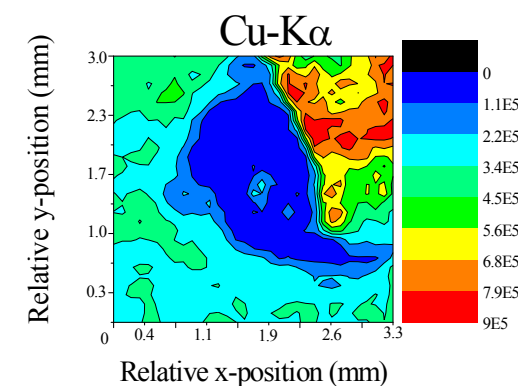
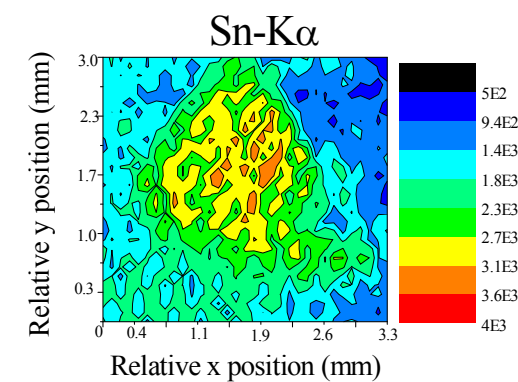
μ -XRF analysis of High Tin Bronzes

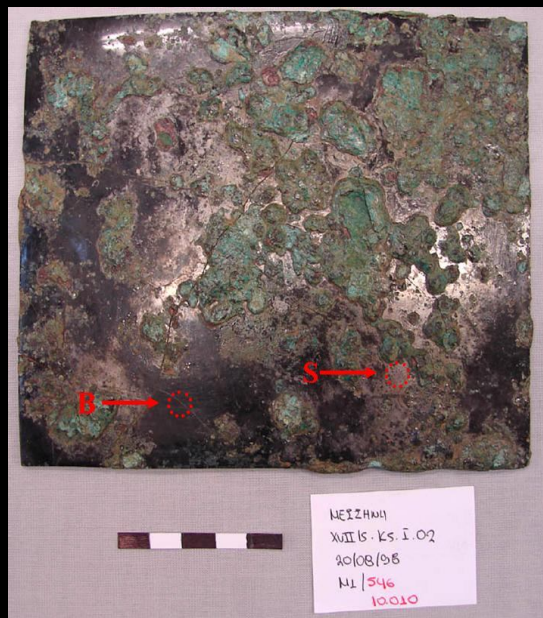
Mirror 1 (M1)

(Cu: 70.6%, Sn:26.0%, Pb:3.4 %)

Examined areas : metal, black, silverish

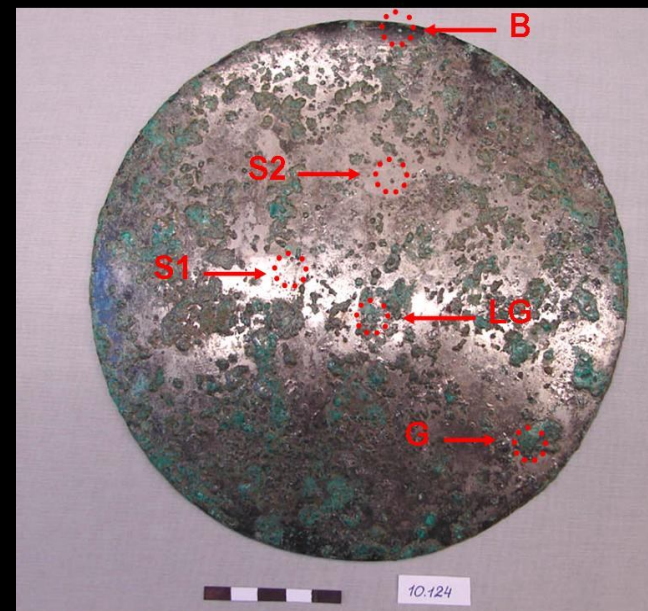
Mirror 2 (M2)

(Cu: 70.2%, Sn:22.9 %, Pb: 6.8 %)

Examined areas : metal, black, silverish,
green and light grey

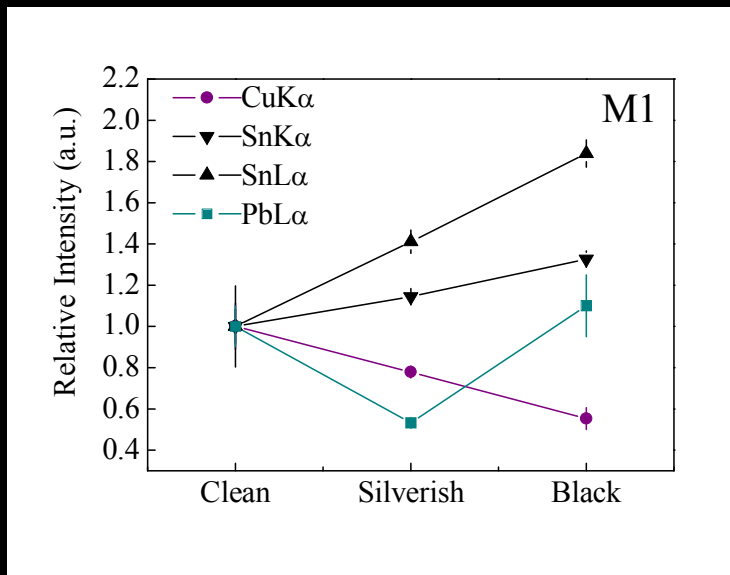
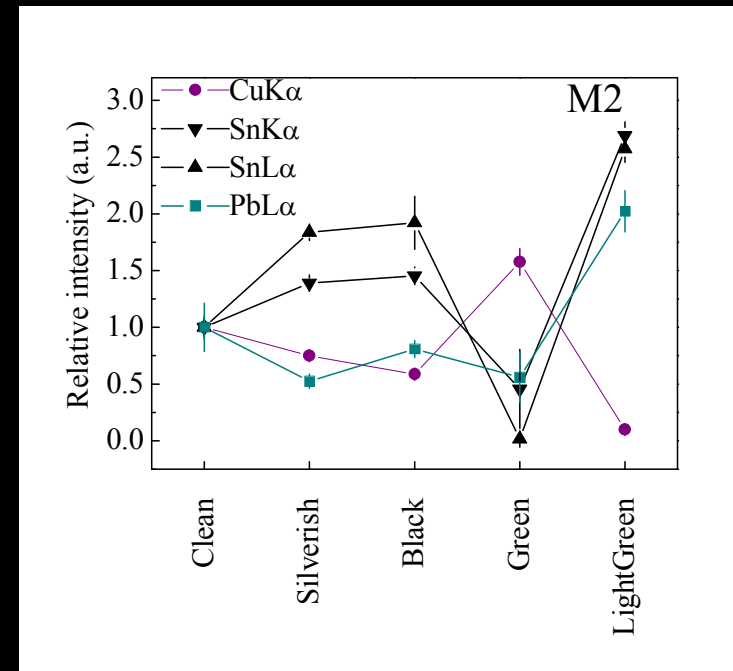
Ancient Messene, Greece: Surface examination of high tin bronze mirrors

Silverish: Increase of SnLα, decrease of CuKα and PbLα : **Sn surface enrichment**

Black : Significant increase of SnLα (**Cassiterite?**)

Green : Increase of CuKα, Cu corrosion products (**malachite?**)

Light green : Increase of PbLα, SnLα, decrease of Cu-K, (**Lead-white? Cassiterite?**)

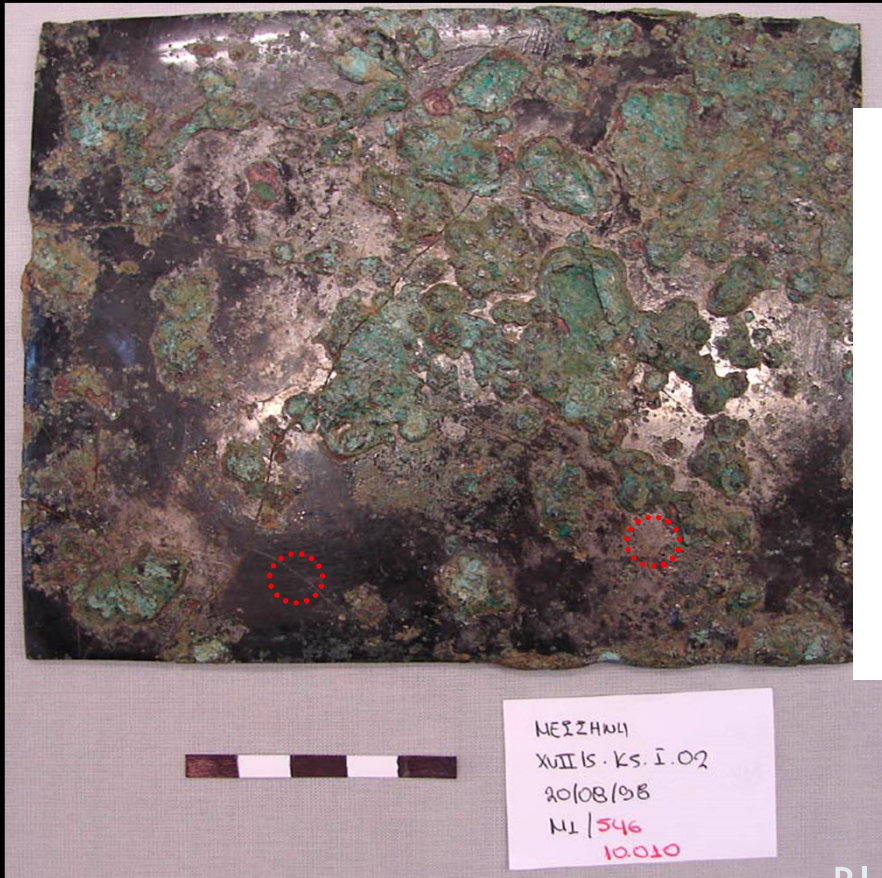
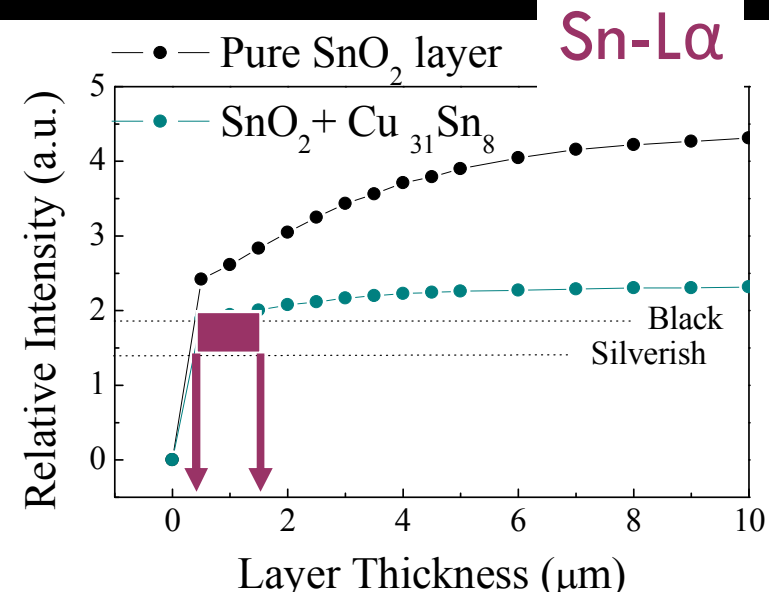
Ancient Messene, Greece: Black patina on high tin bronze mirrors

Silverish $< 1\mu\text{m}$

Black layer with a thickness of very few microns
