In-situ XRF analysis as a diagnostic analytical tool in the conservation field

A.G. Karydas, V. Kantarelou

Outline and the PROMET analytical campaigns across the Mediterranean

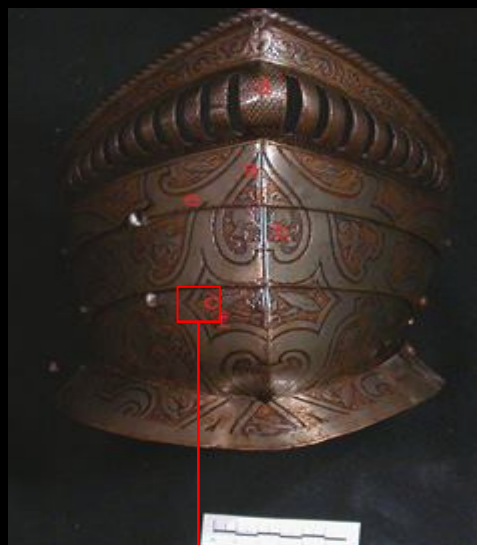
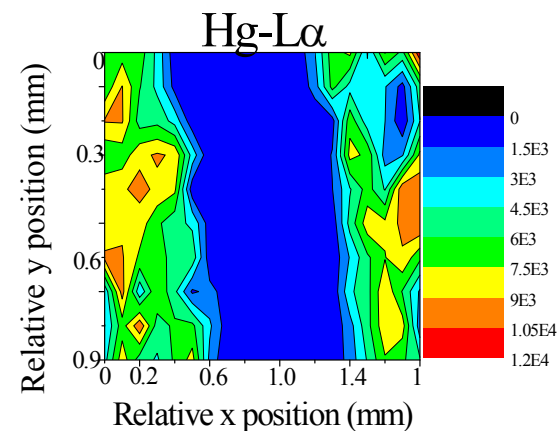
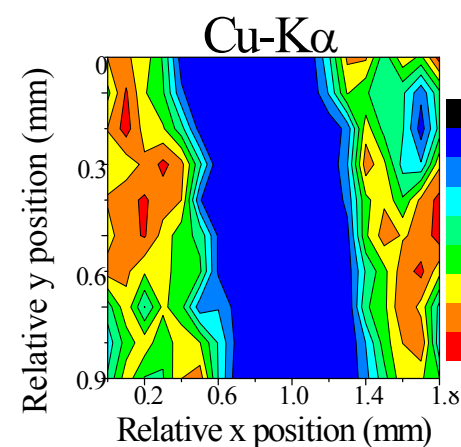
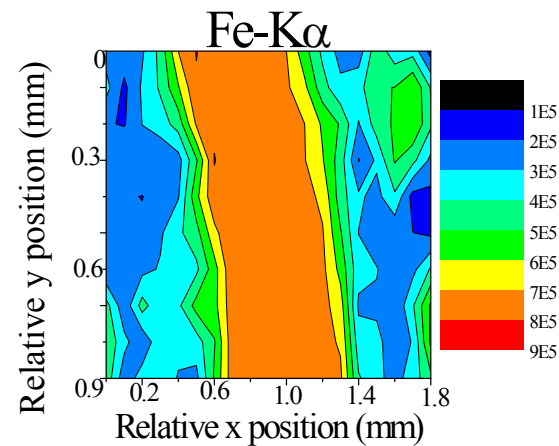
Gilded Iron Alloy Falling Buff

μ -XRF analysis of gilding areas

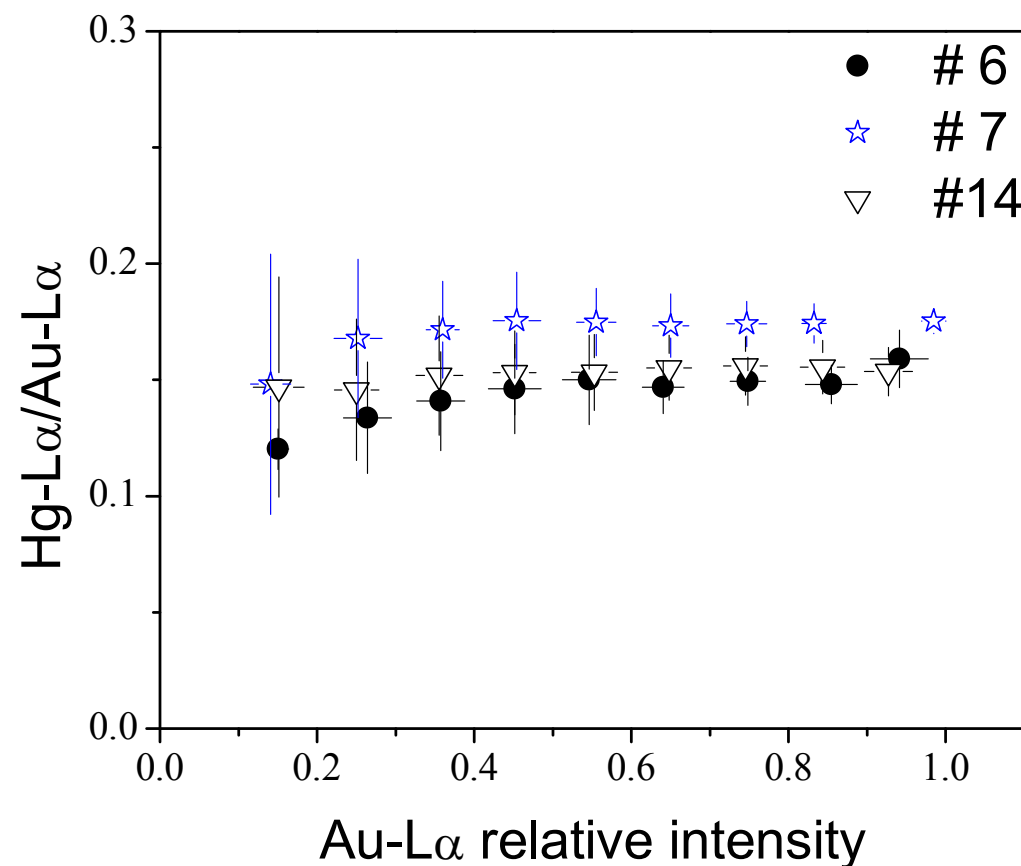
Fire-Gilding technique: Hg to Au ratio

The mean Au/Hg values were deduced among a subgroup of the area map spots, where the Au intensity varies between 0-10%, 10-20%, 30-40% etc with respect to its maximum value
