# *Neutron irradiation effects – point defect balance equations, swelling, Reactor pressure vessel*

P. Hosemann, Nuclear Engineering Department  
University of California, Berkeley

1. *Materials selection strategie*
2. *Defect balance equations*
3. *Observed microstructural defects in fcc & bcc metals*
4. *Void swelling*
5. *Reactor pressure vessel*

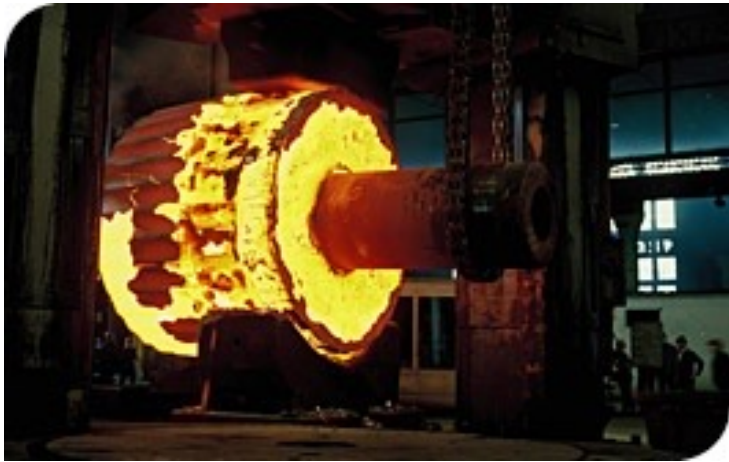
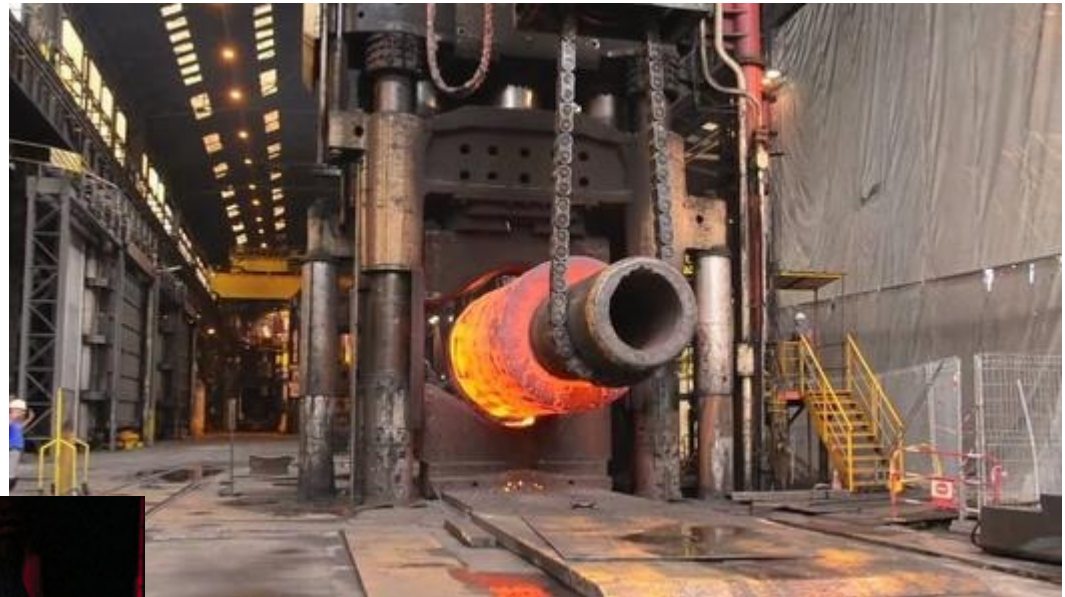
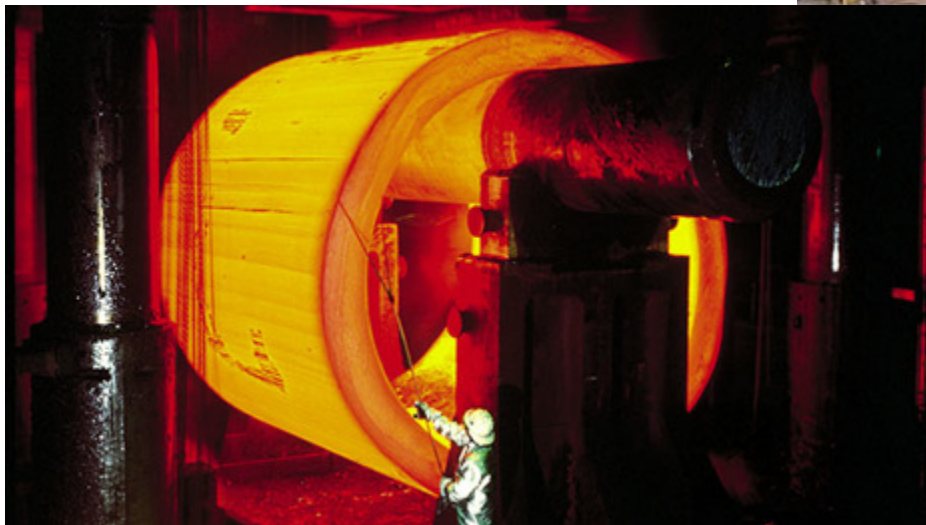
*Older RPV's have been extensively welded.*

*However, today forging is preferred.*

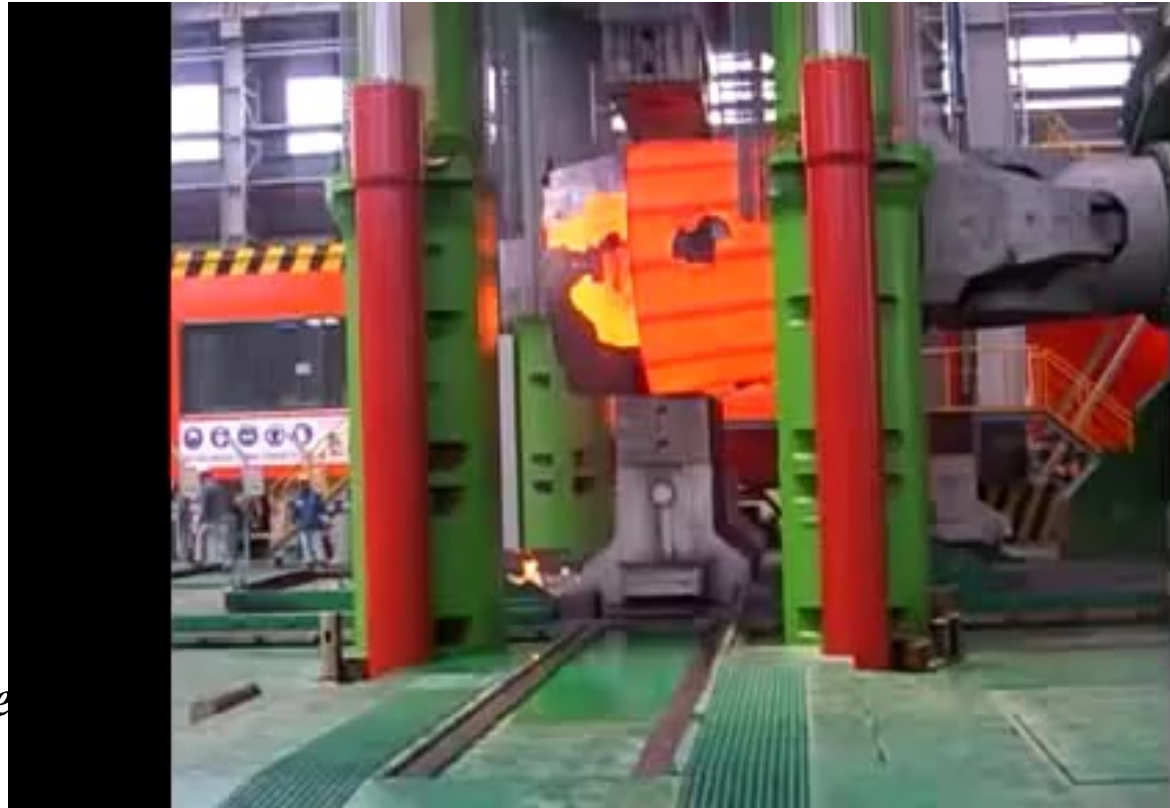
*Plants today: Japan, China, France Russia Korea*

*The largest forgings can be 650t with a 14000t press.*

*Second largest press 13.000t at Seah Besteel.*

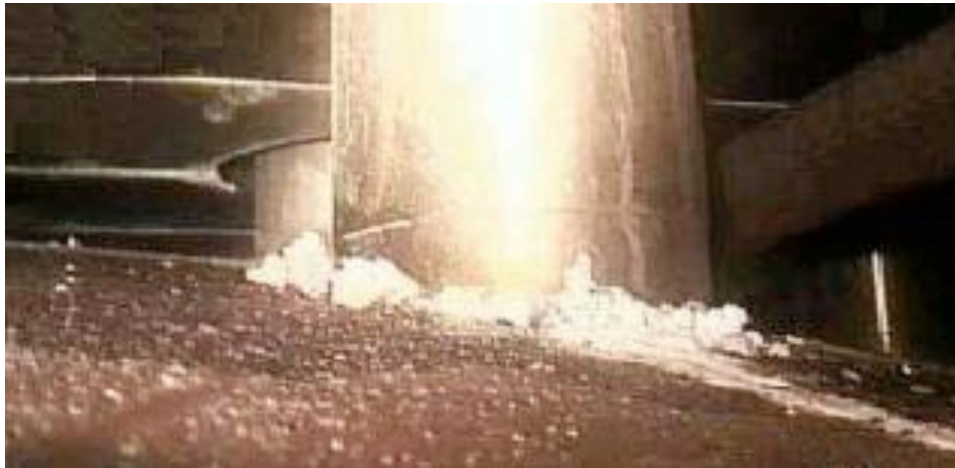
*Davis-Besse Reactor Vessel Head*

- **Leaking of primary coolant and evidence of boric acid ( $\text{H}_3\text{BO}_3$ ) outside Control Rod Drive Mechanisms (Reactor Pressure Vessel Head) at Davis-Besse indicated a cracking problem as early as fall 2001**
- **Davis-Besse management (First Energy Nuclear Corporation) continued to operate until forced by NRC order in Feb 2002 to specifically investigate the vessel head and associated penetrations.**

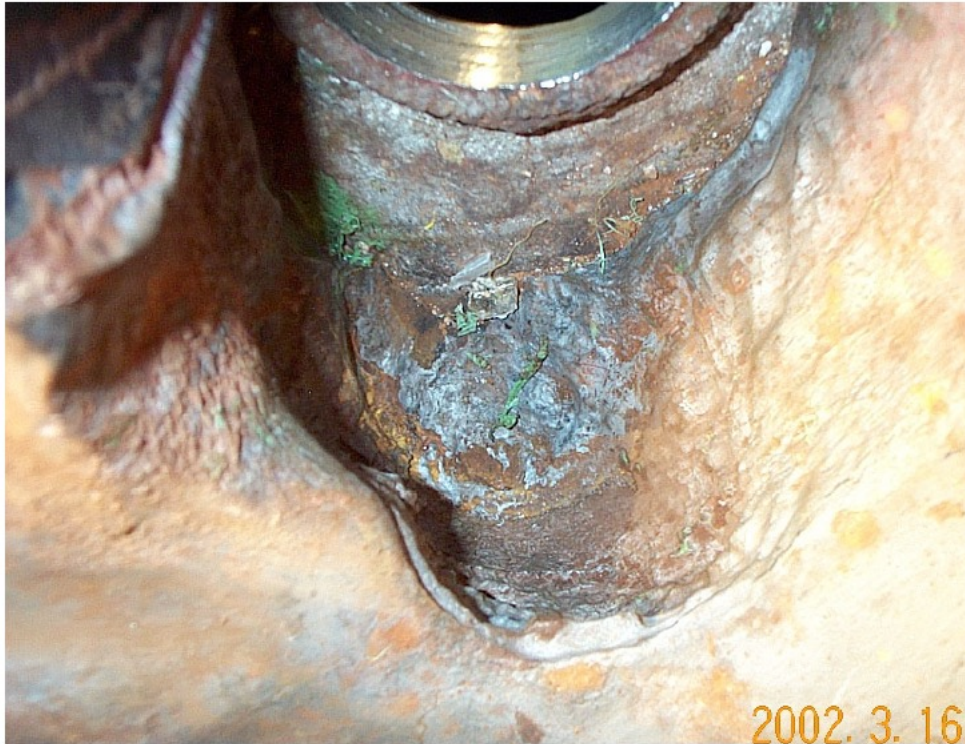
*“The wastage area was found to extend approximately 5 inches downhill on the RPV head from the penetration for CRDM nozzle 3 and was approximately 4 to 5 inches at its widest part. The minimum remaining thickness of the RPV head in the wastage area was found to be approximately 3/8 inch. This thickness was attributed to the thickness of the stainless steel cladding on the inside surface of the RPV head, which is nominally 3/8 inch thick.”*

Davis Besse Reactor Vessel Head Degradation Head Cutaway View

The above figure shows the Davis Besse reactor vessel head degradation between nozzle #3 and nozzle #11. This sketch was provided to the NRC by the Licensee.

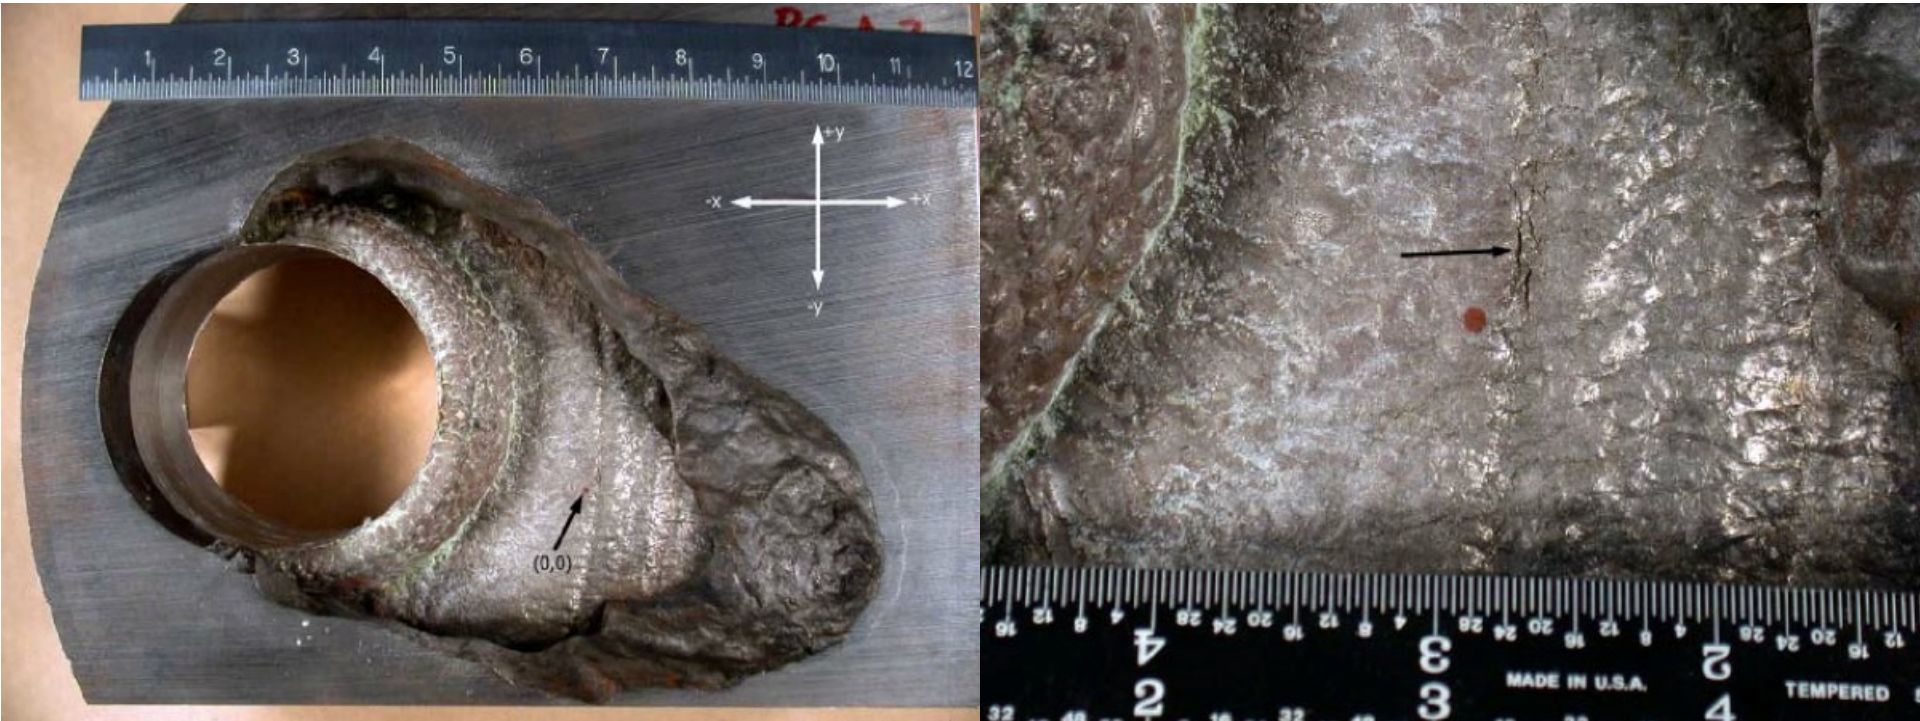
*Further, the stainless steel cladding had significantly bowed upward and cracked, indicating substantial plastic deformation - **the cladding, not designed as a pressure containment structure is all that prevented a severe loss of coolant accident***

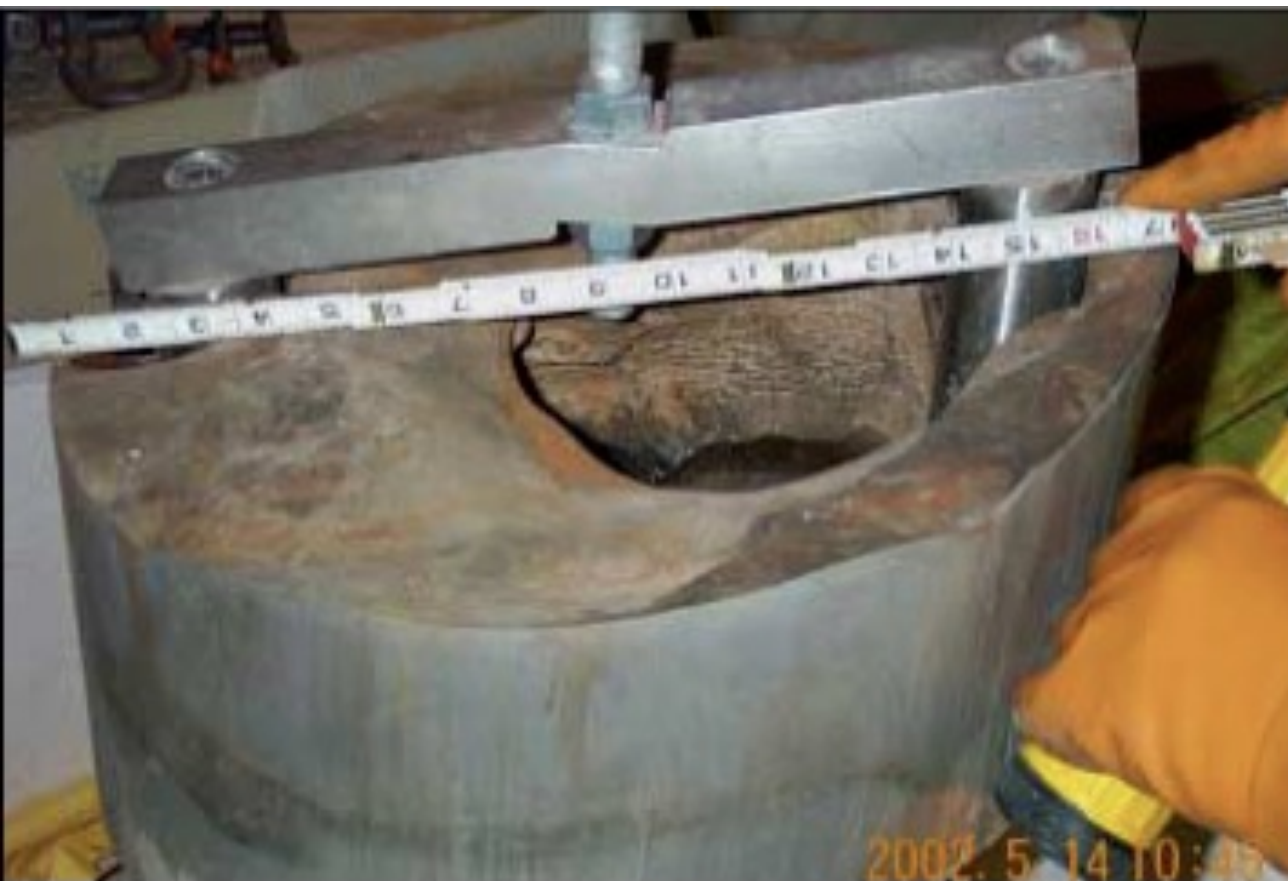
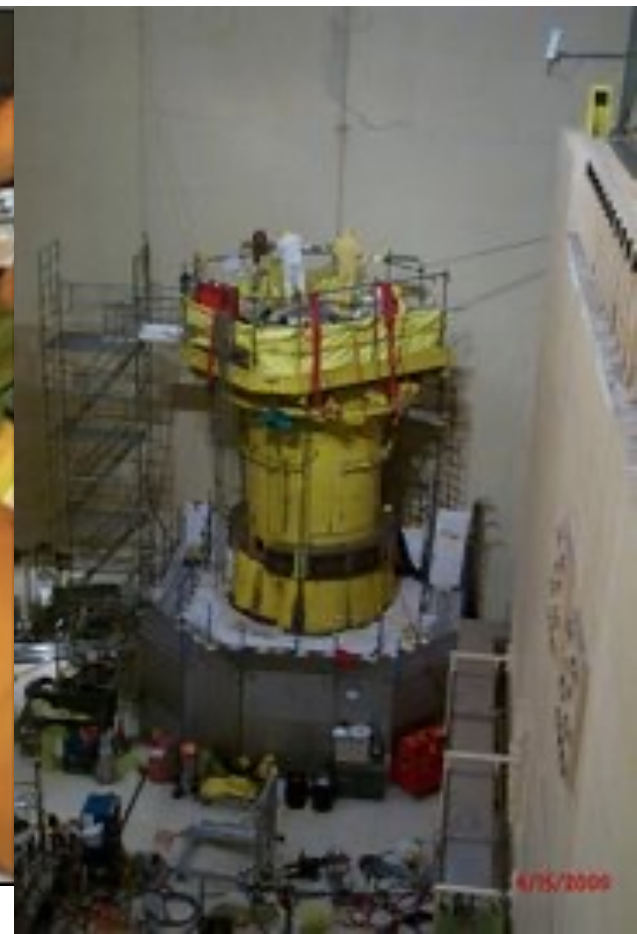
*“The investigation of the causative conditions surrounding the degradation of the RPV head at Davis-Besse is continuing. Boric acid or other contaminants could be contributing factors. Other factors contributing to the degradation might include the environment of the RPV head during both operating and shutdown conditions (e.g., wet/dry), the duration for which the RPV head is exposed to boric acid, and the source of the boric acid (e.g., leakage from the CRDM nozzle or from sources above the RPV head such as CRDM flanges).”*

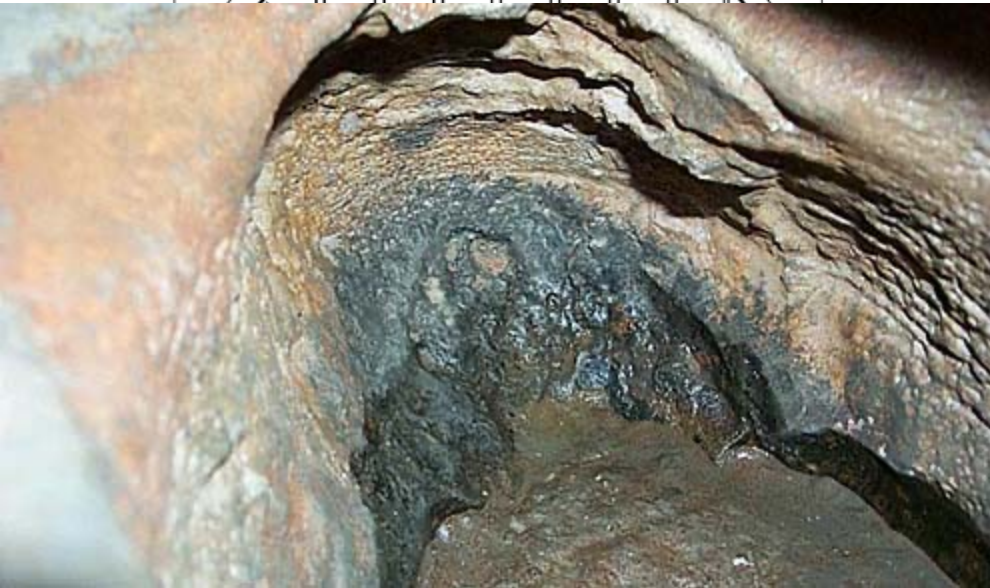
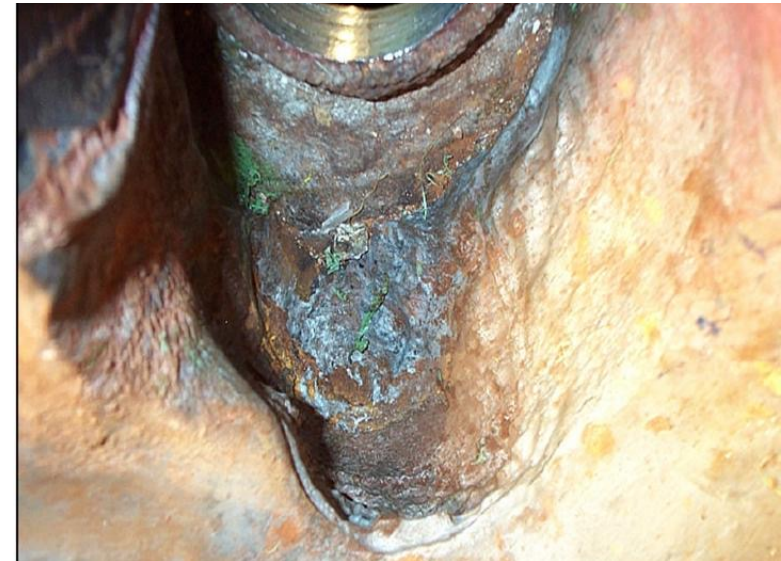
### Reactor Vessel Head Degradation Location

## Typical Pressurized Water Reactor

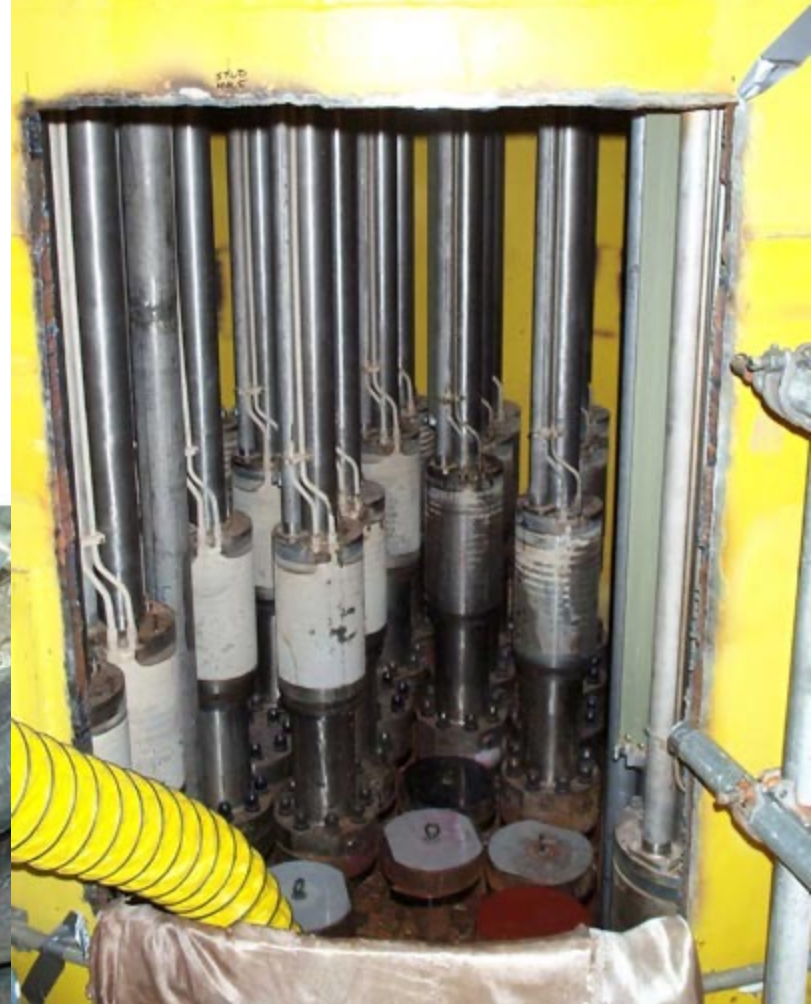
Nozzle #3  
Removed

Reactor  
Vessel  
Head  
Nozzle  
to CRDM  
Flange
