# Status of the Fukushima Dai-ichi NPP and our contribution to its decommissioning

**Neil Hyatt\***

**ICTP Summer School on Radiation Effects on Nuclear Wasteforms**  
11-16 September 2016

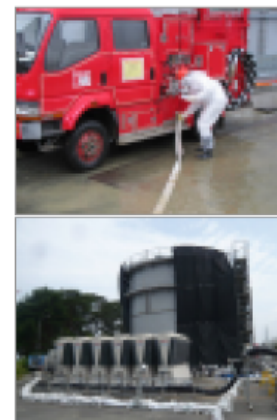
**<Cooling multiplexed>**

Various auxiliary means have been readied to inject cooling water into the core to maintain Units 1~3 in cold shutdown

Even if power sources fail, cooling water injection can be restarted using fire engines within three hours.

Also, multiplexing is achieved with multiple tanks ready to serve as sources for cooling water injection pumps.

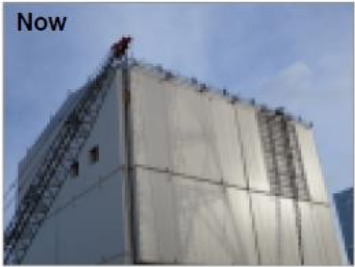
Unit 1	<div>Current status</div> <div>Tasks</div>	<p><b>Building cover installed</b> October 2011  <b>Removal of building cover to allow removal of fuel from spent fuel pool</b></p> <p>Identification of debris on operating floor and inside spent fuel pool  Countermeasures for dispersion of radioactive materials during removal of building cover</p>	<p>Immediately after the earthquake</p>

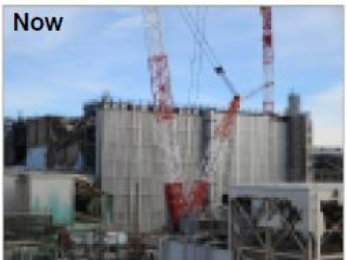
Unit 3	<div>Current status</div> <div>Tasks</div>	<p><b>Debris removal from top of the reactor building competed</b> October 2013  <b>Installation of fuel removal cover and fuel handling facility planned</b></p> <p>Radiation dose reduction measures  Installation of remote controlled heavy machinery</p>	<p>Immediately after the earthquake</p>

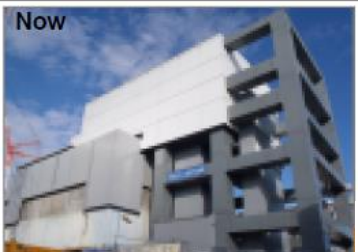
Unit 4	<div>Current status</div>	<p><b>Fuel removal from spent fuel pond completed</b>  Start: 18 Nov. 2013, finish 22 Dec. 2014</p>	<p>Immediately after the earthquake</p>

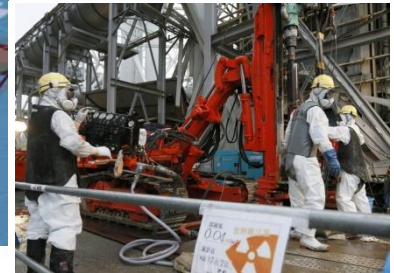
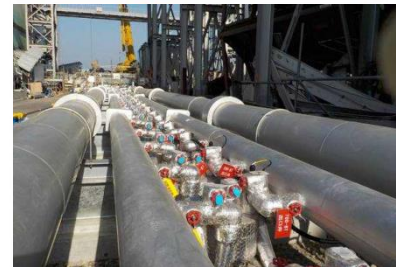
## Fundamental Measure② Install land-side (frozen soil) impermeable wall

- Buildings will be enclosed by ice wall to curb inflow of groundwater into buildings
- Full-scale construction began in June 2014
- Construction of the mountain side was completed in September, 2015. As for the sea side, freeze pipe etc. setting construction was completed in January, 2016

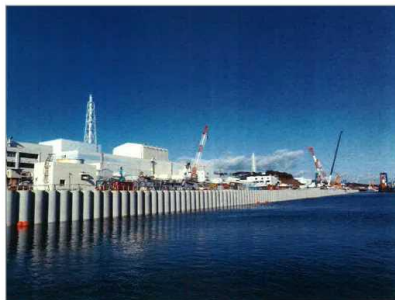
## Fundamental Measure ① Construct sea-side impermeable wall

- Impermeable wall will be constructed along the sea side of Units 1~4 to prevent outflow of contaminated groundwater into sea
- Construction of steel sheet-piles comprising impermeable wall was completed in October 2015. The radioactive material concentration inside the harbor has become lower

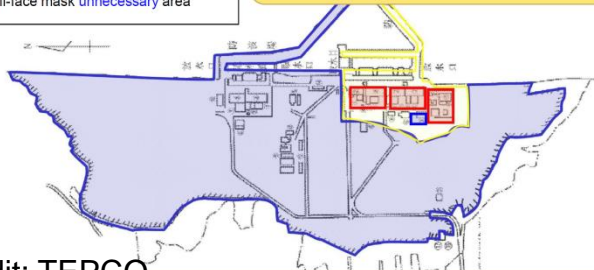
- Full-face mask **necessary** area
- Full-face mask or Half-covered face mask **necessary** area
- Full-face mask **unnecessary** area

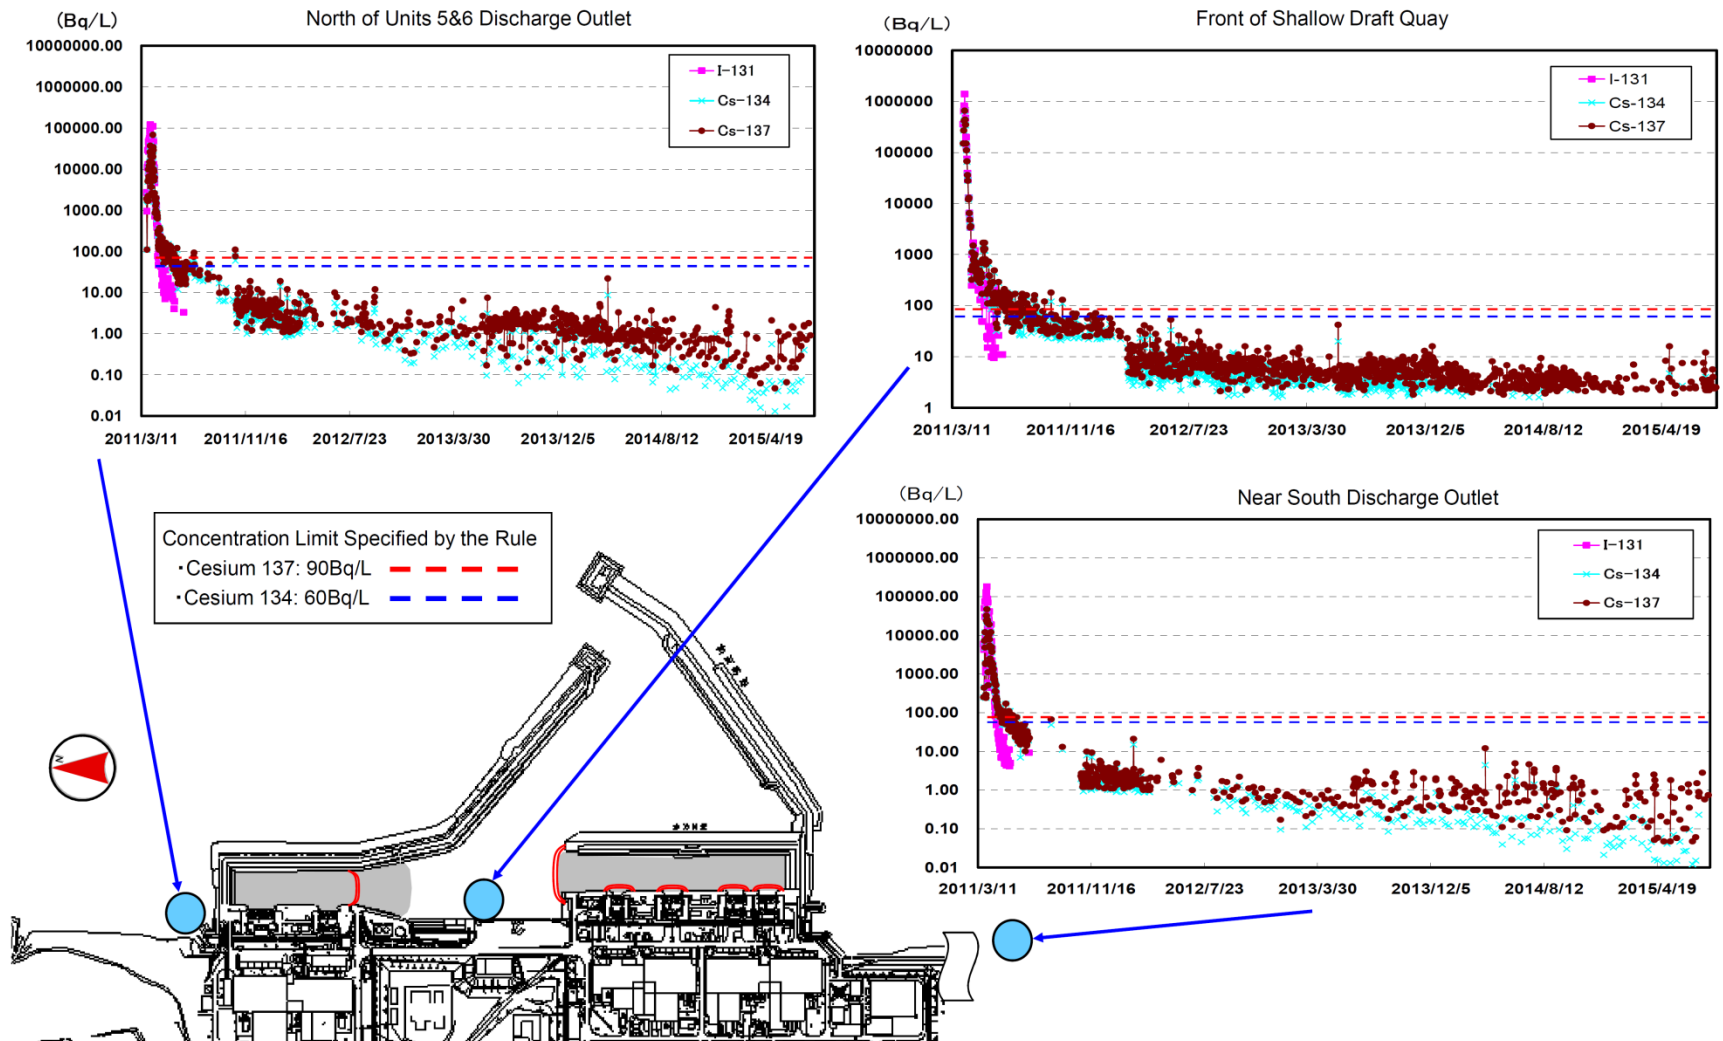
- The radioactive material concentration in the sea area decreased by one- 100,000th ~ 1,000,000th after the accident
