IAEA Meeting on Achieving the Site End State: Characterisation  
Strategies and Instrumentation for Land Contamination (Thurso-Dounreay-Wick, 2019)

Radiological Characterization of site Palomares:  
Historic evolution and current situation

J.C. Sáez Vergara  
jc.saez@ciemat.es

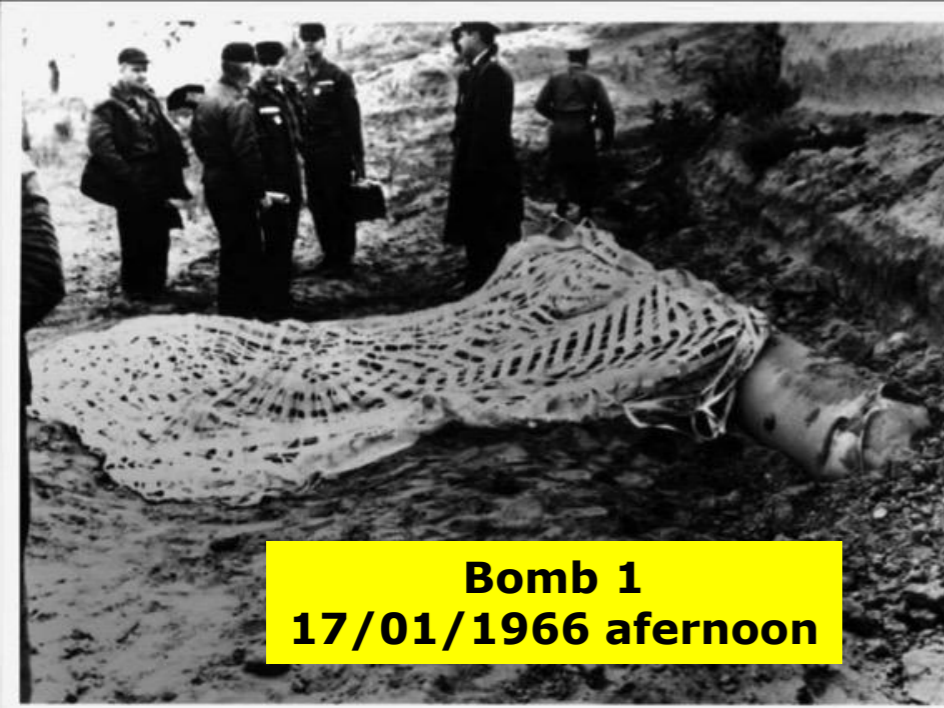
**Bomb 1**  
**17/01/1966 afternoon**

Bombs 1 & 4 were found slightly damaged with the nuclear material undisturbed. Radiation checks were negatives.

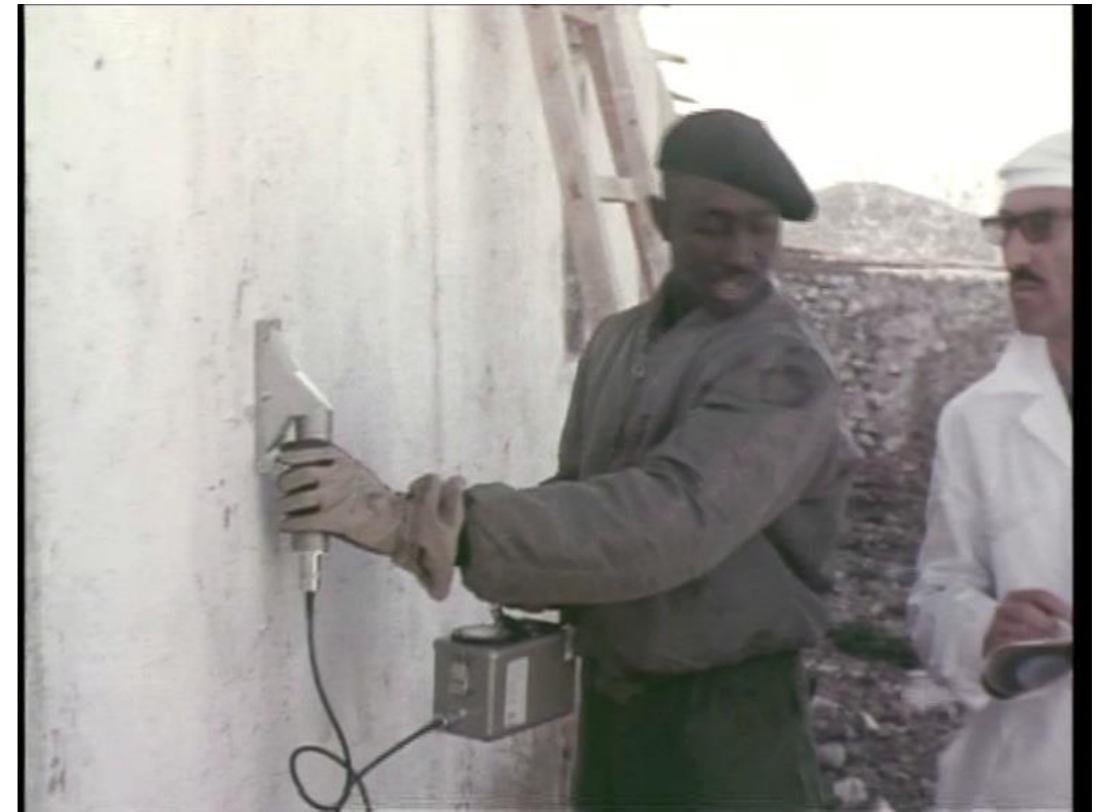
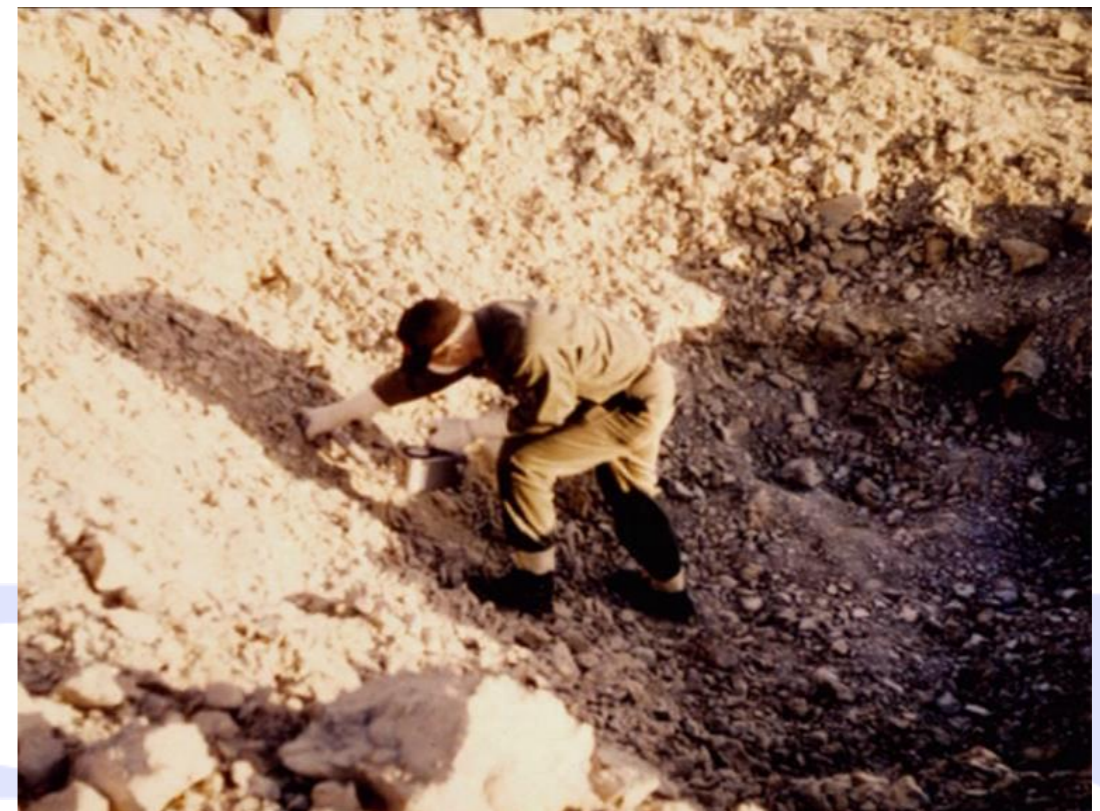
'Zero Line' as stated by US-Air Force on 11 February 1966 in terms of  $^{239}\text{Pu}$  surface contamination units  $\mu\text{g}/\text{m}^2$  ( $130 \text{ cpm} \rightarrow 1 \mu\text{g}/\text{m}^2$ )

**About 6 kg  $^{239}\text{Pu}$  (13 TBq) were spread over 226 ha**

> 1200 kBq·m <sup>-2</sup> (2.2 ha, 12 TBq)
120 - 1200 kBq·m <sup>-2</sup> (17 ha, 0.9 TBq)
12 - 120 kBq·m <sup>-2</sup> (87 ha, 0.02 TBq)
< 12 kBq·m <sup>-2</sup> (120 ha, < 0.01 TBq)

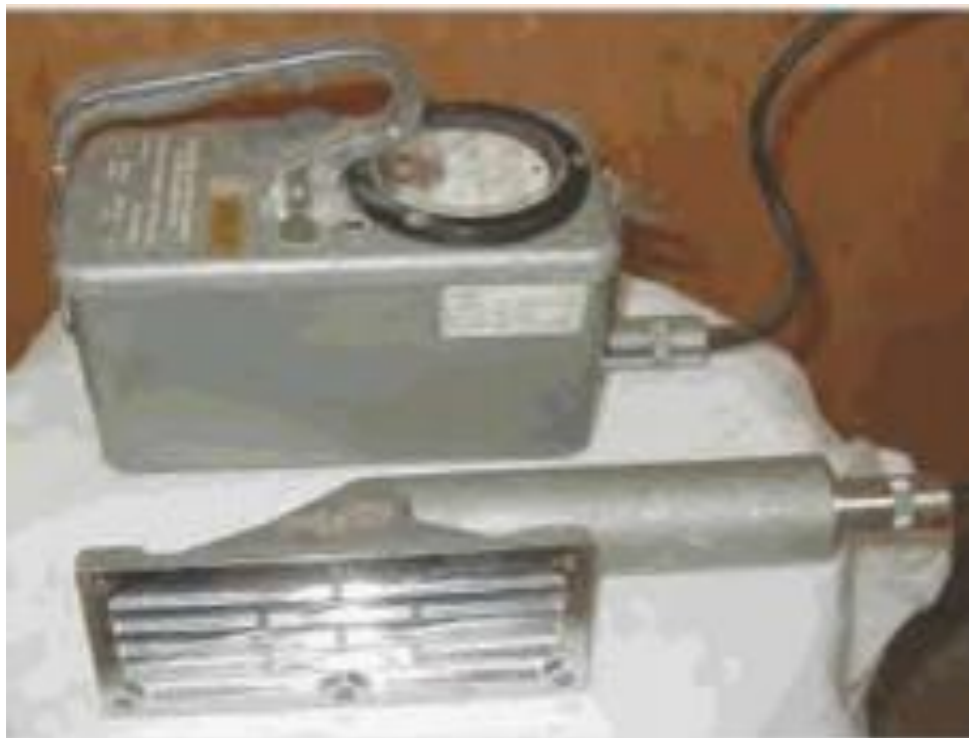
***PAC-1S Alpha Scintillator detector***

- 1) "Acceptable radiation levels had to be established according to the texture of the terrain
- 2) A more reliable field instrument should be developed to detect Pu-239
- 3) Due to the training and difficulties of alpha detection, experienced personnel is required
- 4) Extensive previous training is necessary to conduct a first-class monitoring
- 5) PAC-1S should only be deployed on the field under pertinent directives and repair capabilities

Immediate radioactive contamination surveys were conducted during six weeks by 200 military people using up to 20 Eberline PAC-1S  $\alpha$  scintillator (cpm).

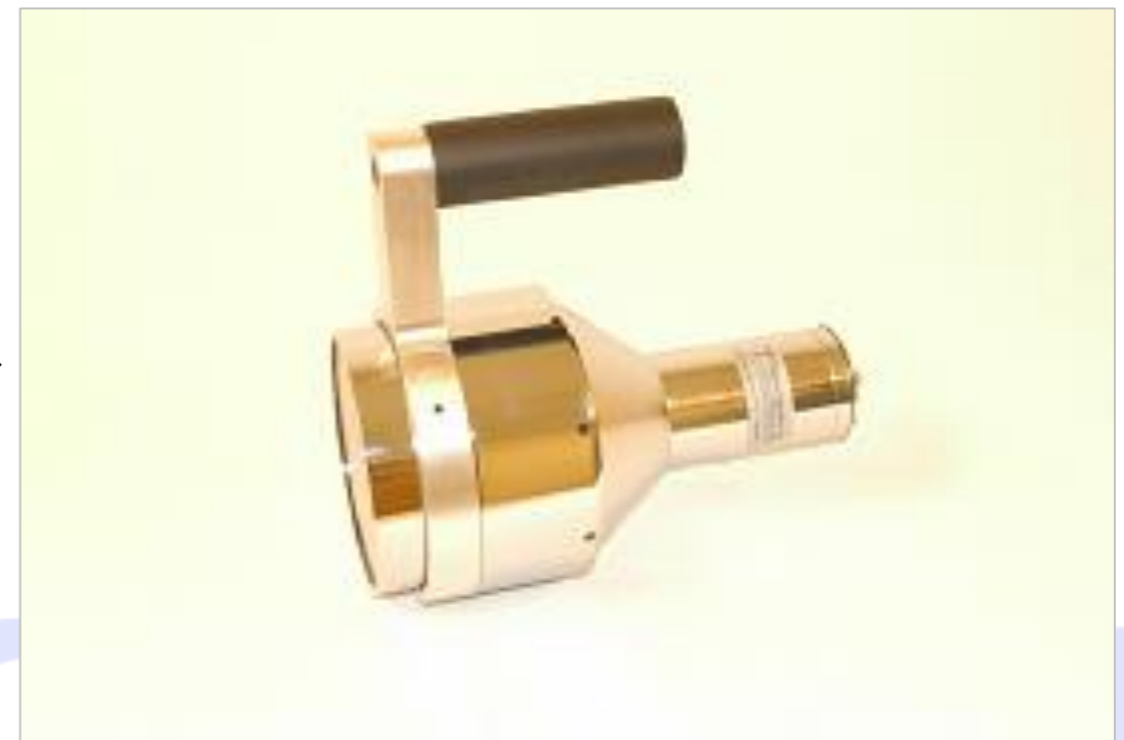
***FIDLER: Field Instrument for Detection of Low Energy Radiation (photons)***

A new instrument was designed to detect the low energy but more penetrating X-rays and gammas present in weapon Pu."

- Developed by USAF after the Palomares accident
- NaI:TI 12.7 cm diameter ( $S=117 \text{ cm}^2$ ) and 0.16 cm thickness
- Mini-FIDLER: NaI:TI 2.5 cm diameter ( $S=5 \text{ cm}^2$ ) and 0.25 cm thickness

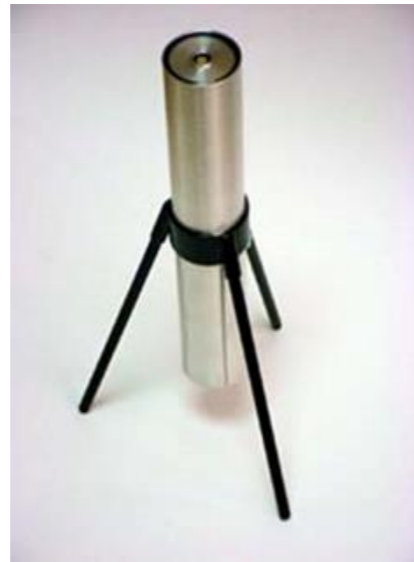
# FIDLER, Field Instrument for the Detection of Low Energy Radiation

Detector	Efficiency 60 keV (point source)	Background 60 keV cps	MDA, Bq		
			t=2 s	t=300 s	t=3 600 s
NaI:TI 3x3	7.16E-02	1.05E+02	509	39	11
FIDLER	1.04E-01	4.90E+01	248	18	5
HP-Ge	5.39E-03	2.53E+00	1472	83	23

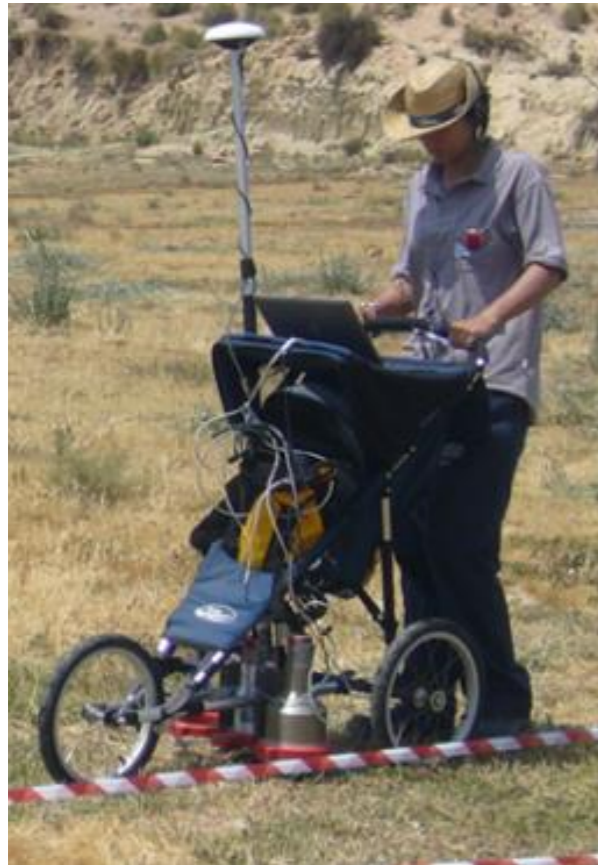
# Radiological Characterization: Top soil (0 – 15 cm)

Measurement	Instrument (Acquisition time)
Dynamic In Situ Gamma Spectrometry	FIDLER (2 – 5 s)
Static In Situ Gamma Spectrometry	FIDLER, HP Ge (5 – 30 min)
Dose rate	Plastic scintillator Atomtex (1 min)
Unaltered soil samples	FIDLER x 2, HP Ge (1 – 10 min)
Granulometry	HP Ge (1 -10 min)

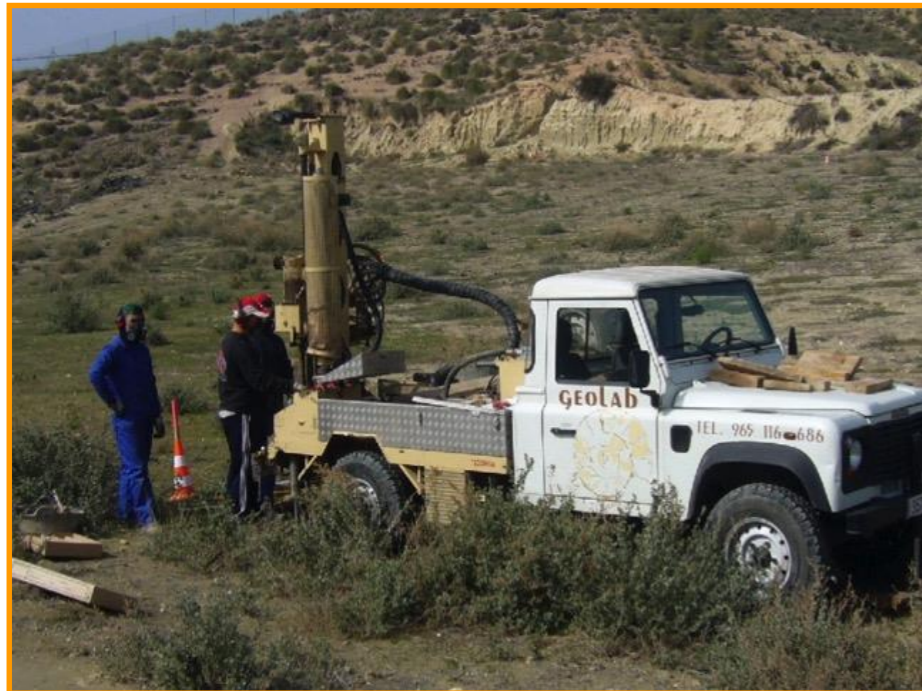
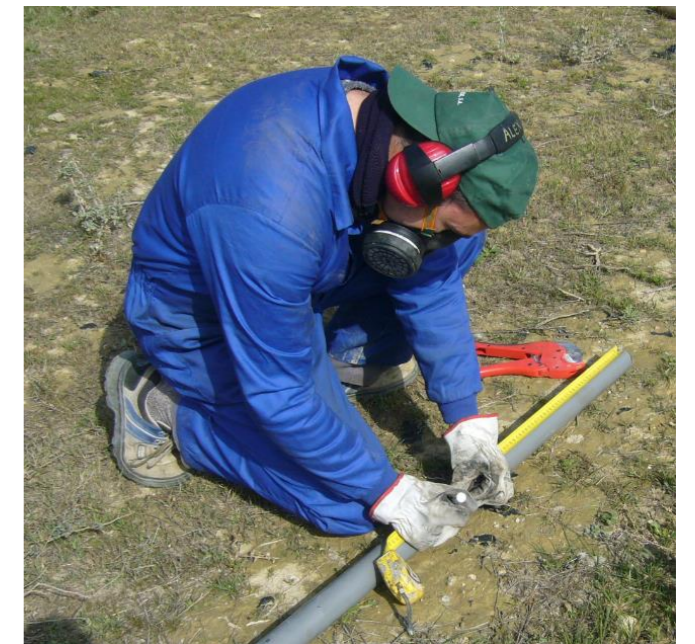
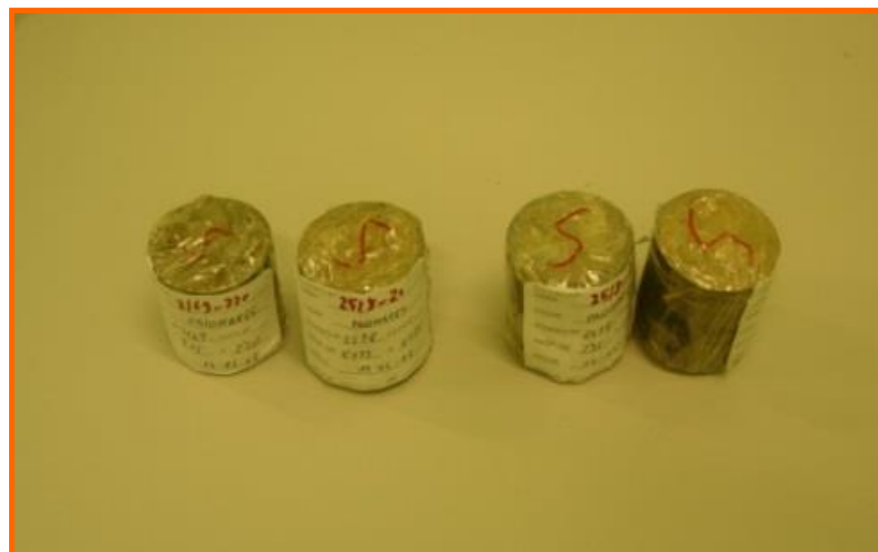
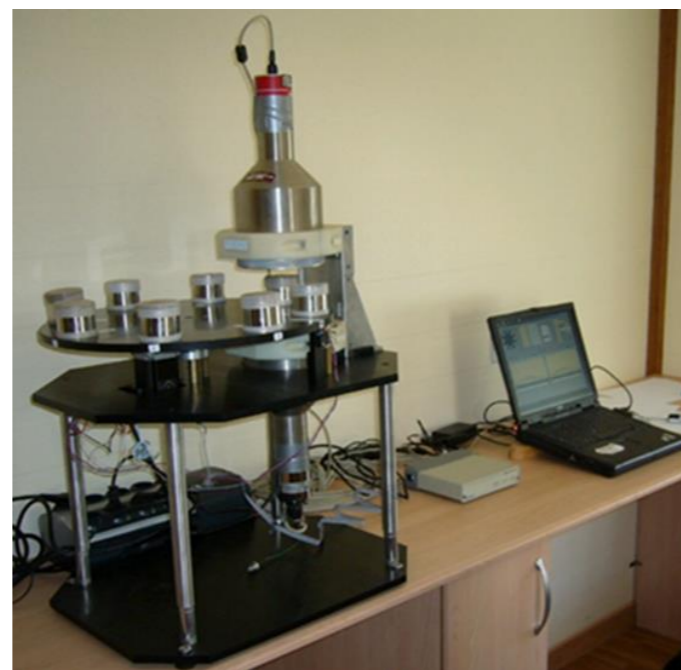
# Radiological Characterization: Subsoil (0 – 5 m)

Measurement	Instrument (Acquisition time)
Radiological profile of borehole samples	Mini-FIDLER (2 s)
Unaltered soil samples	FIDLER x 2, HP Ge (5 - 10 min)

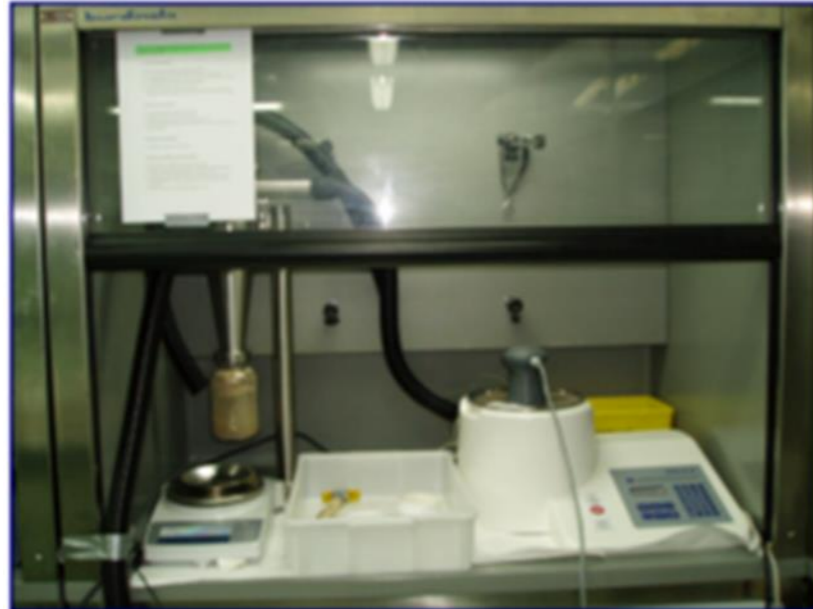
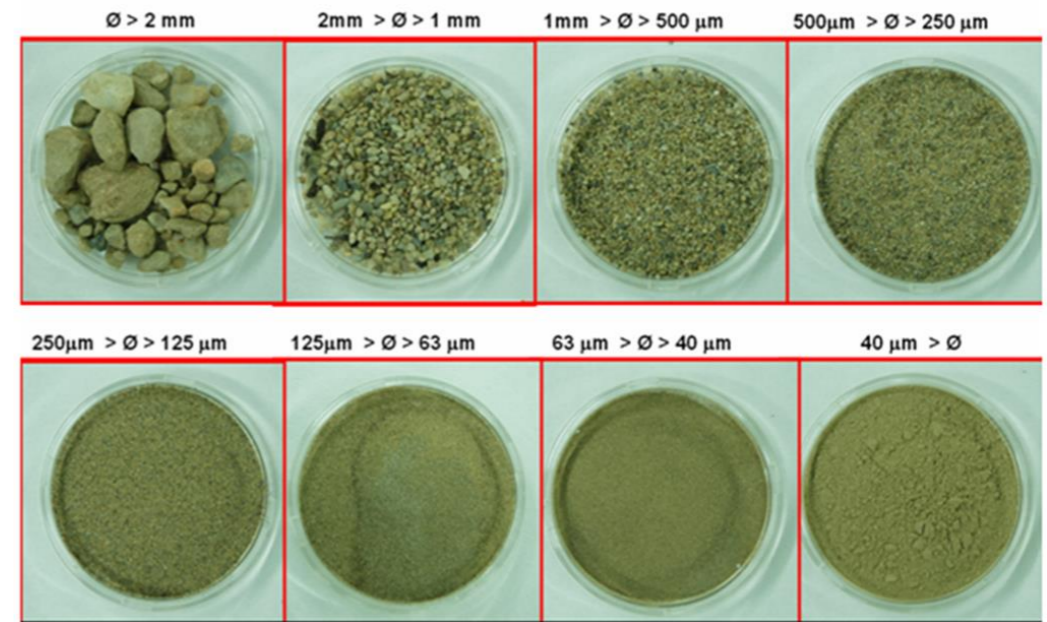
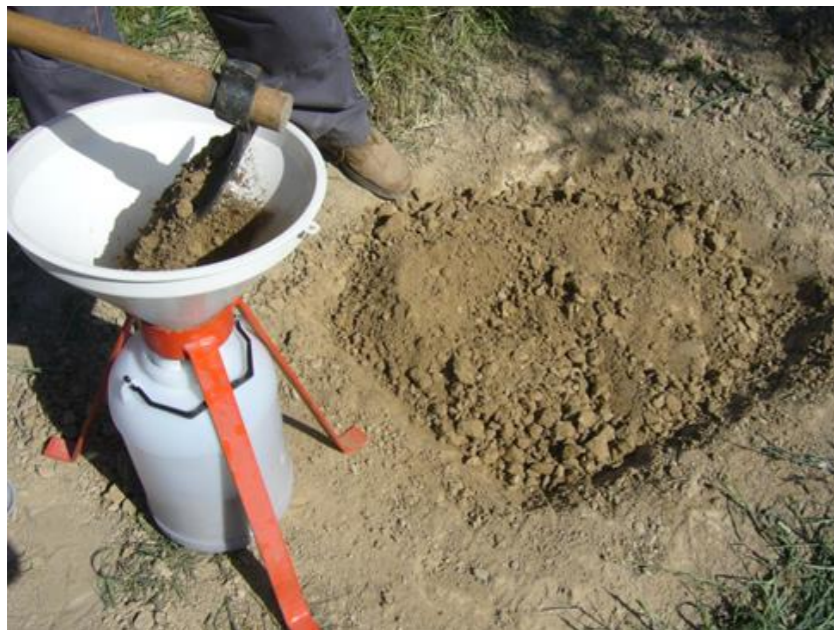
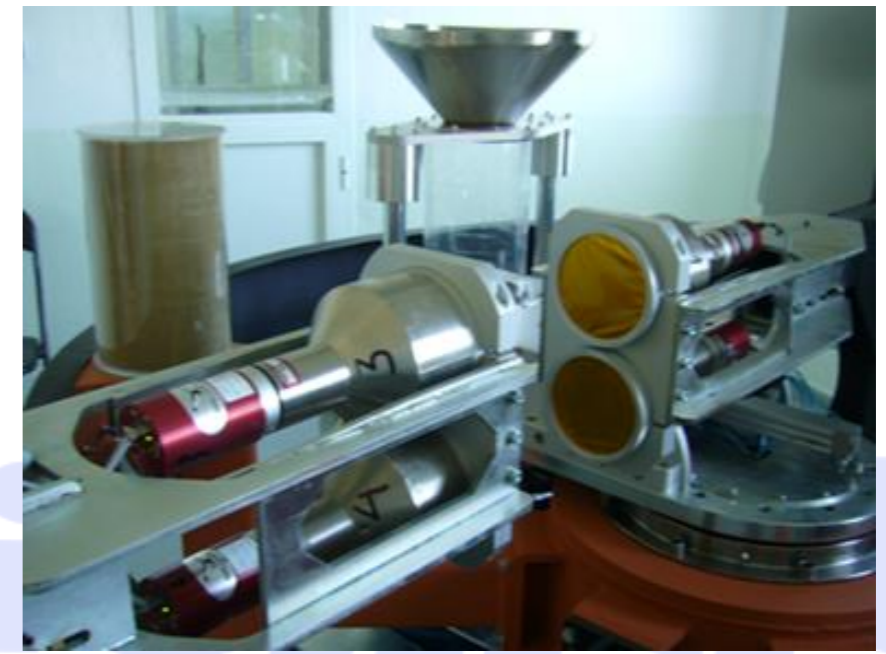
# Radiological Characterization: Particle size studies (Granulometry)

Laboratory (0.1 dm<sup>3</sup>)

Dry cyclon separator, HP Ge (5 min)

Pilot Plant (10 dm<sup>3</sup>)

Prototype, FIDLER x 4 (1 – 5 min)

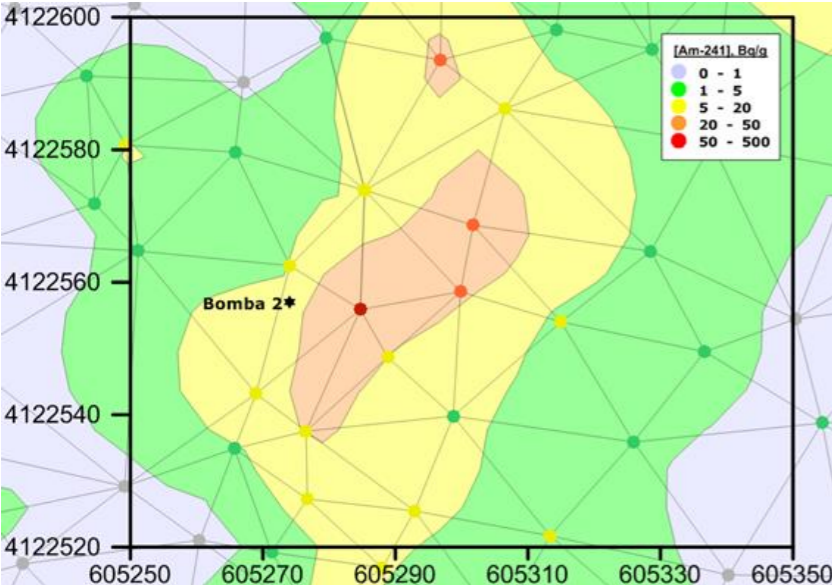
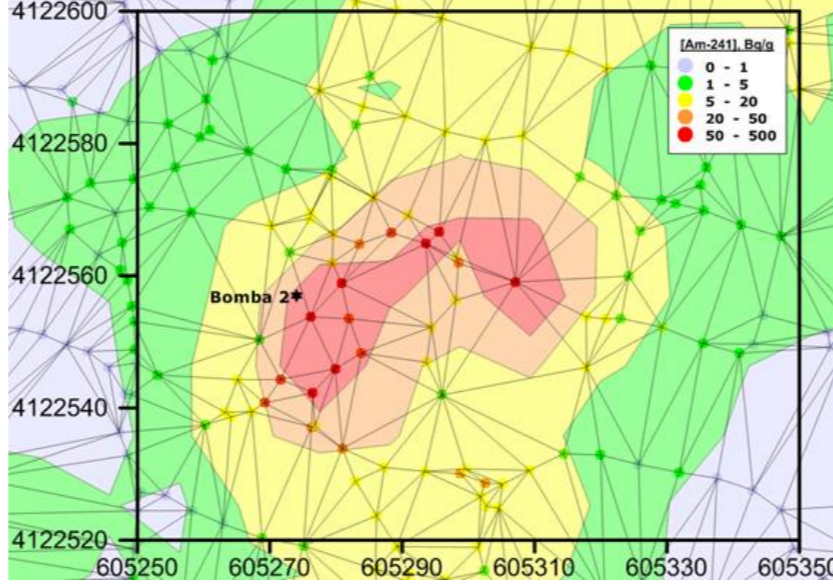
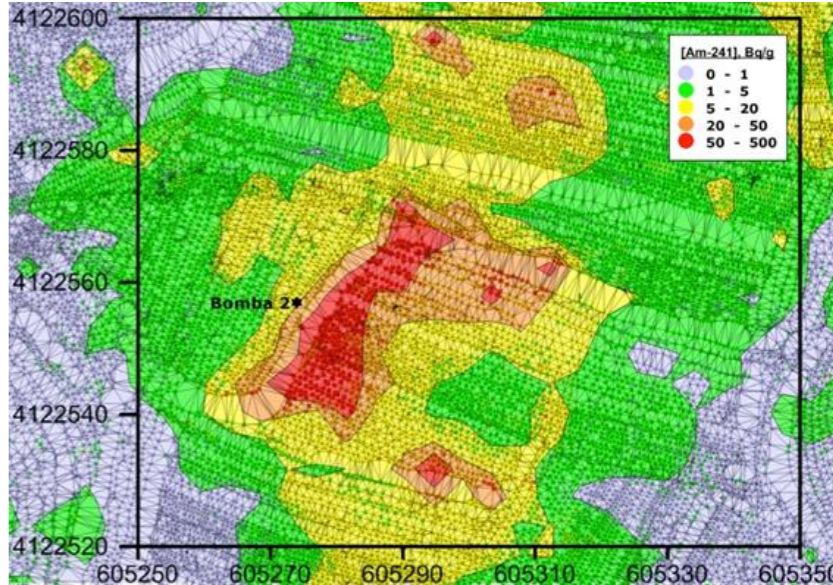
# Geostatistics approach: poligonal interpolation, natutral neighbor

Dynamics Extensive	Statics	Dynamics Intensive
30 points	100 points	8 000 points
14 x 14 m <sup>2</sup>	5 x 5 m <sup>2</sup>	0.4 x 0.4 m <sup>2</sup>
105 m <sup>2</sup> /measurement	20 m <sup>2</sup> /measurement	0.5 m <sup>2</sup> /measurement

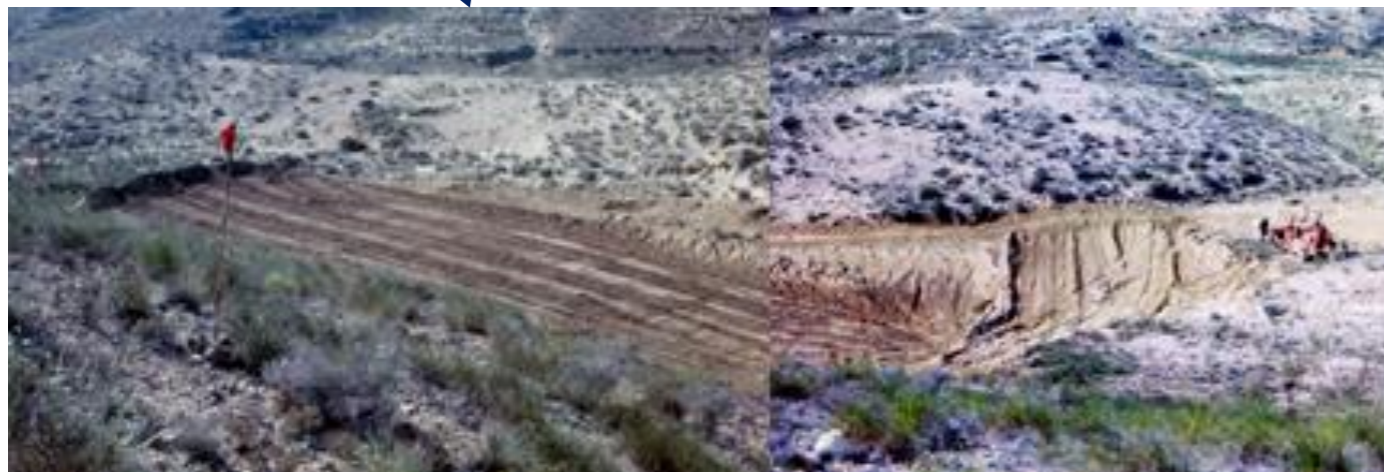
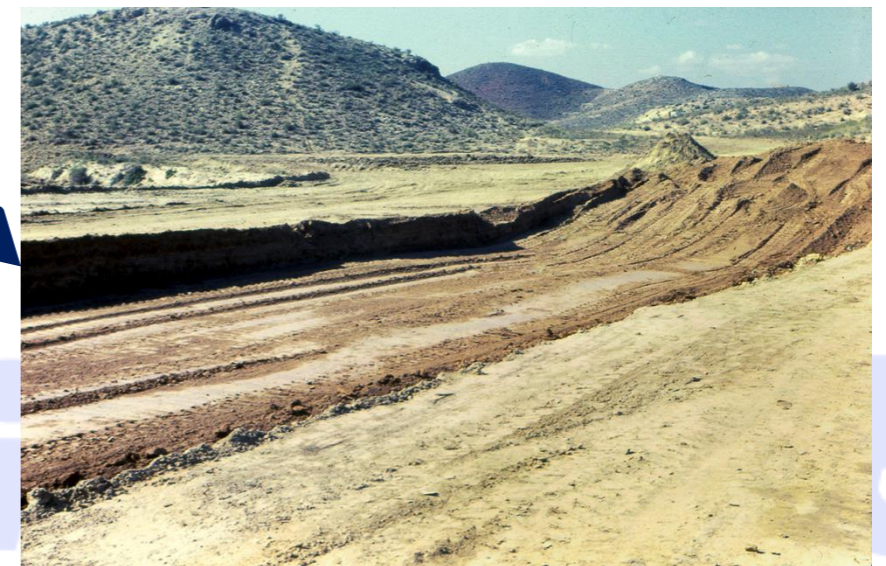
# Top-soil radiological intensive characterization (Zone 2):

200 km over a net 1 x 1 m<sup>2</sup> (203 000 data)

Location of burial pits

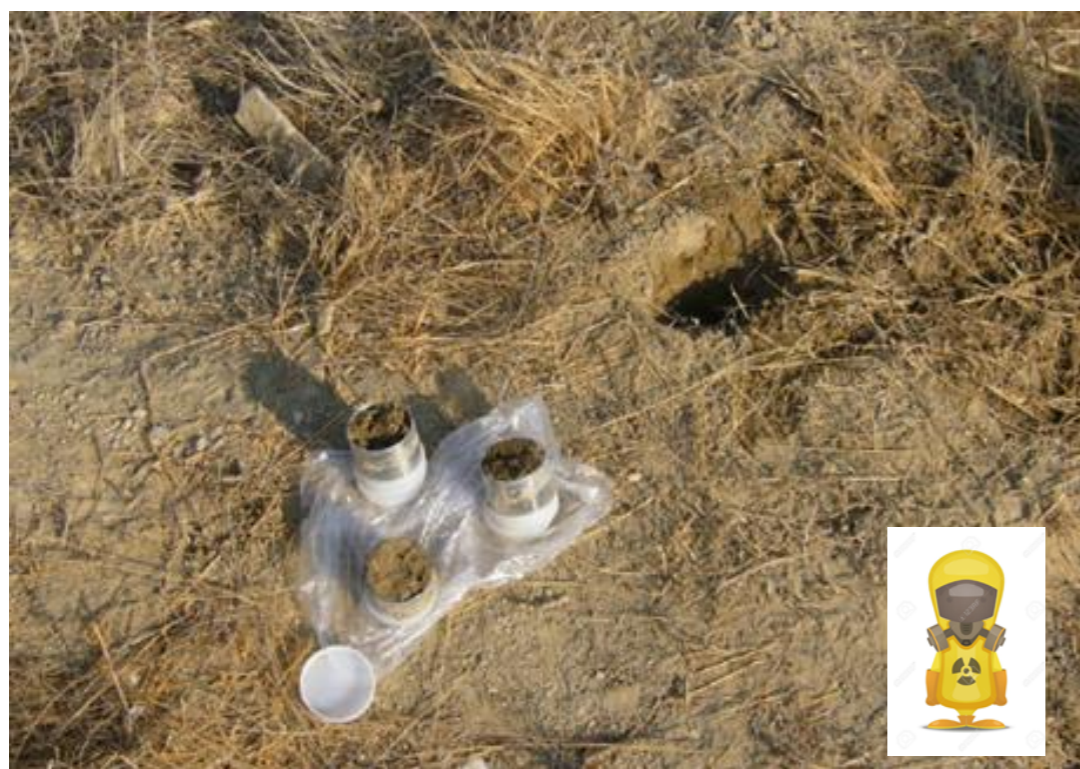
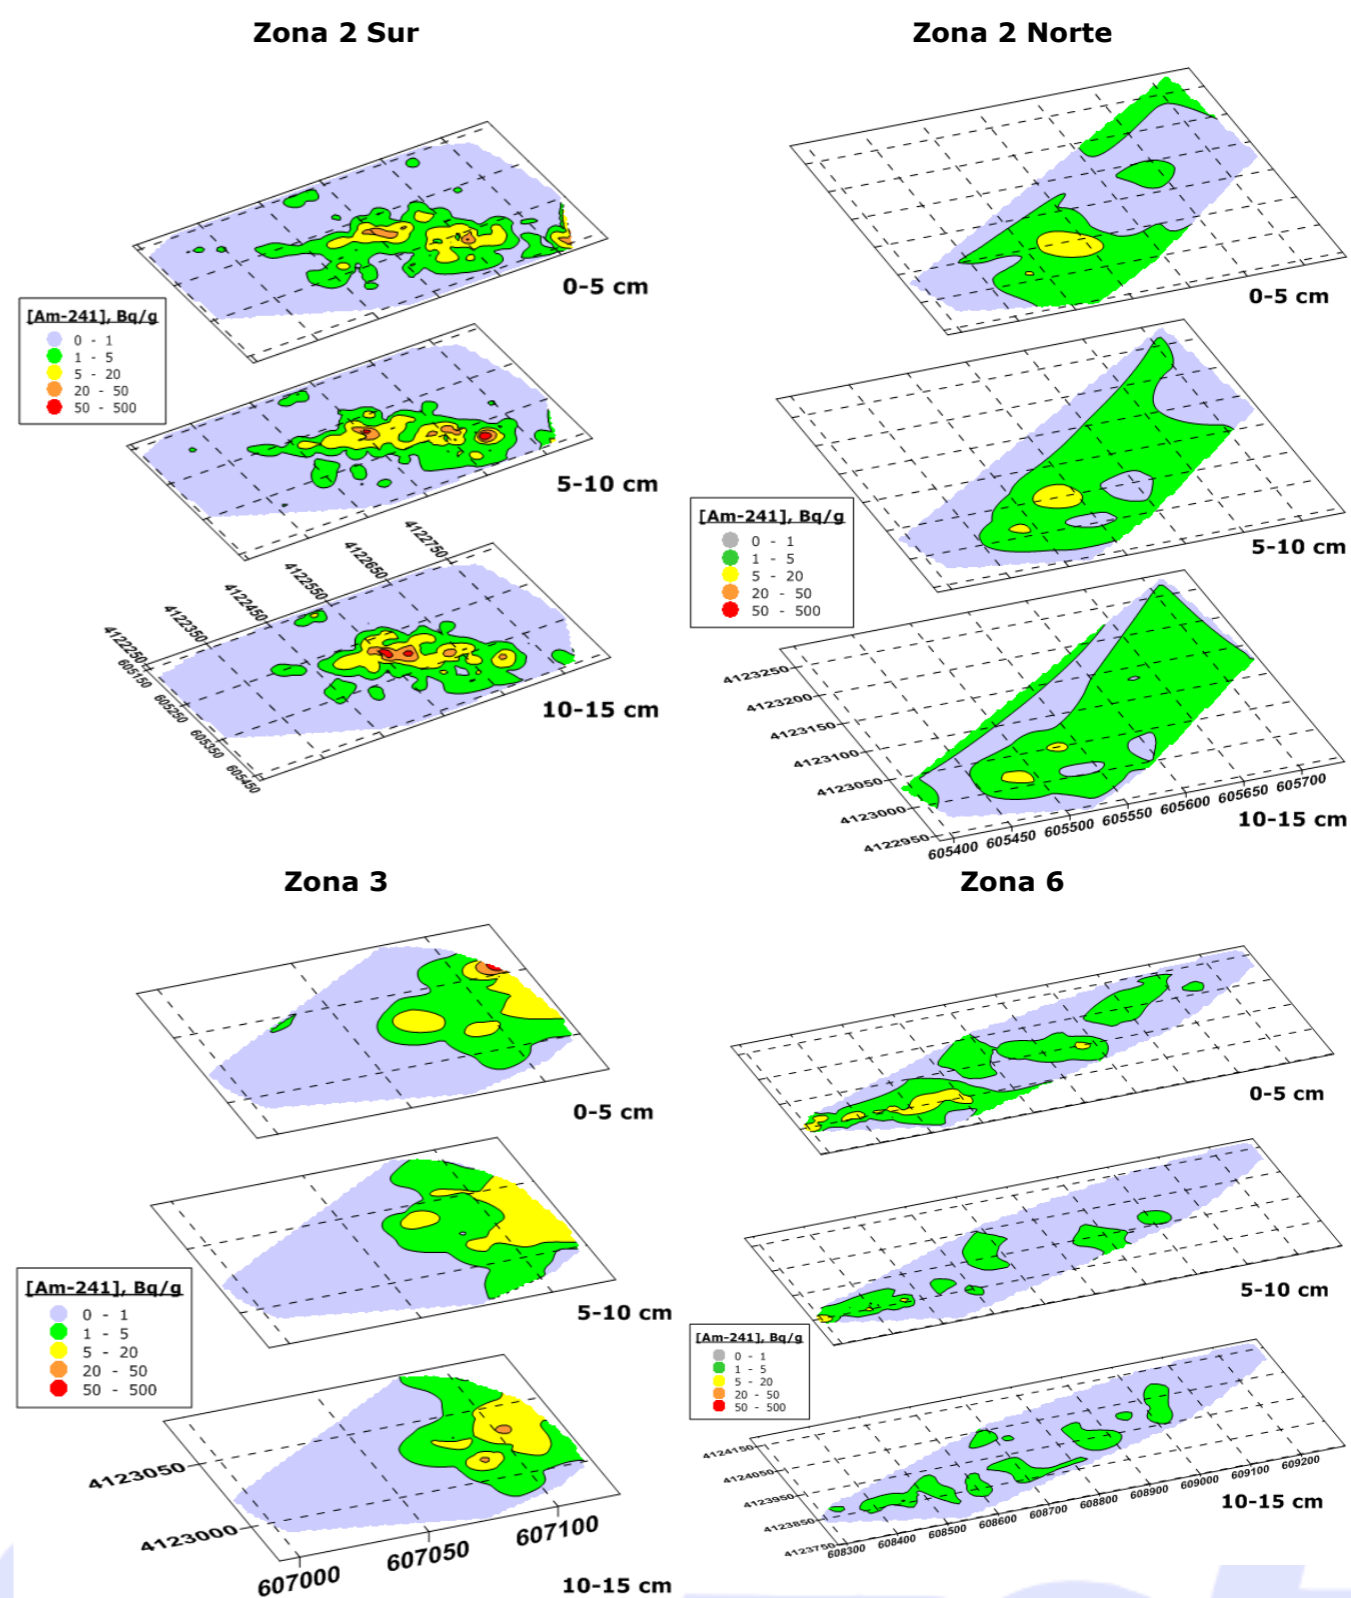
# Activity distribution in the top-soil (0 – 15 cm):

1 854 unaltered samples from 618 points

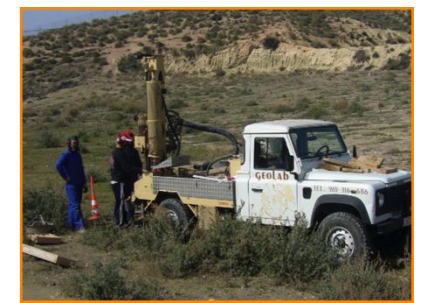
# Sub-soil radiological (0 – 5 m):

321 borehole, 734 samples, 7700 scanning data

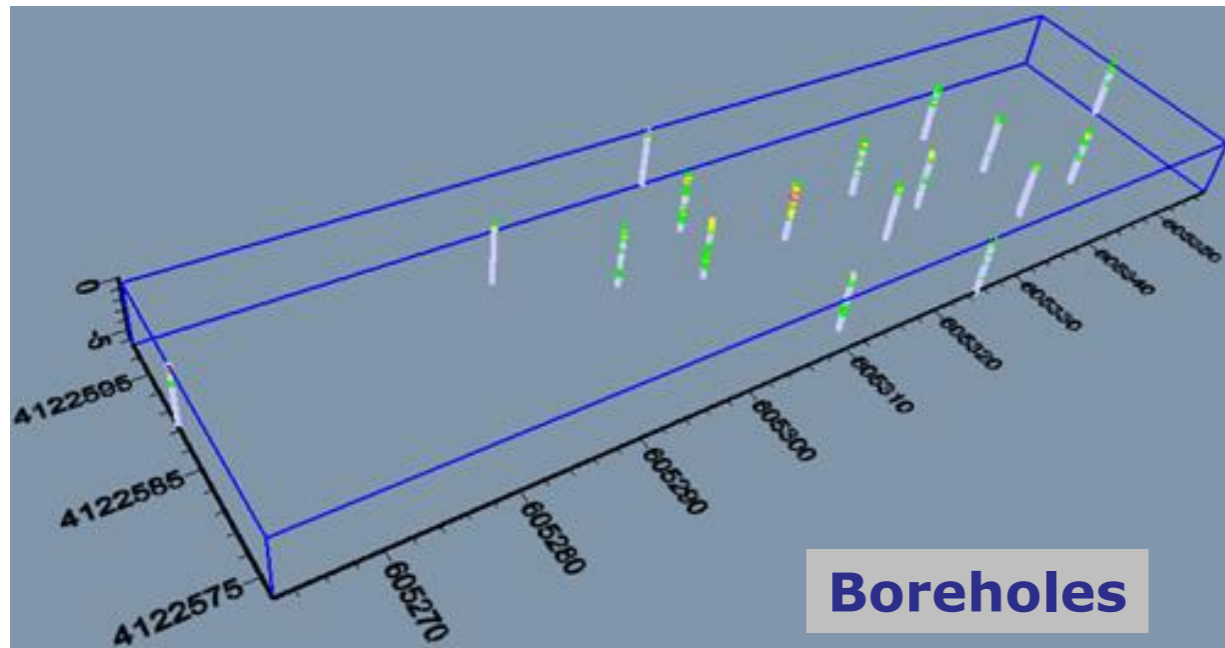
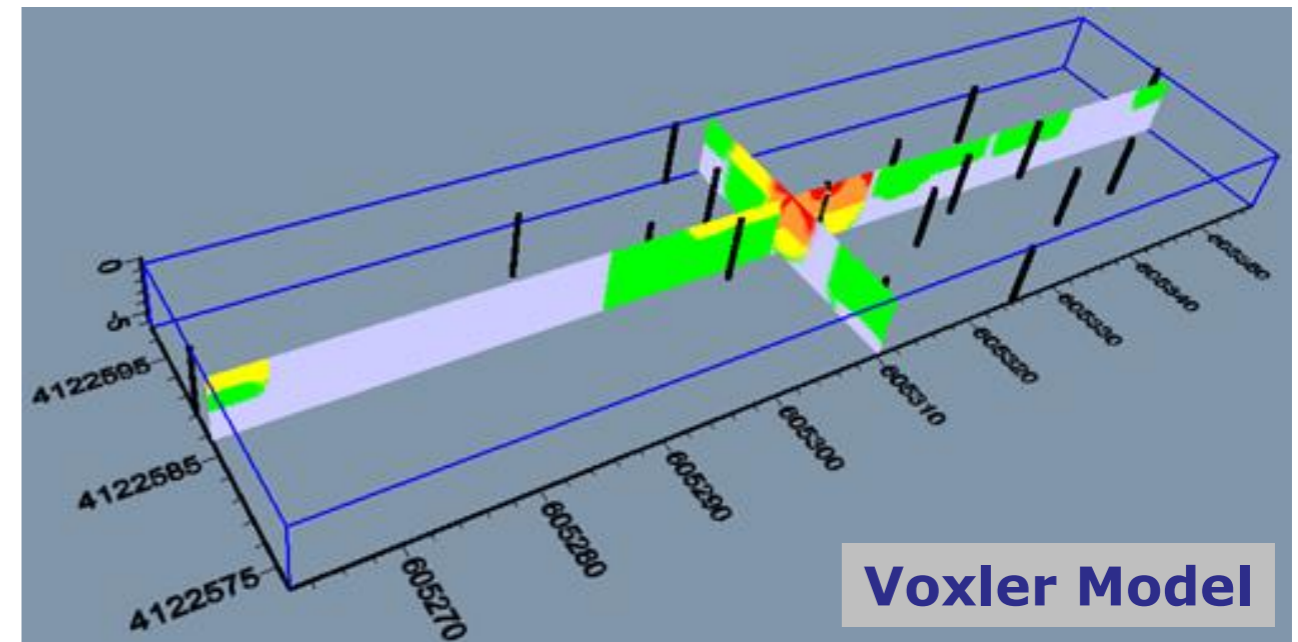
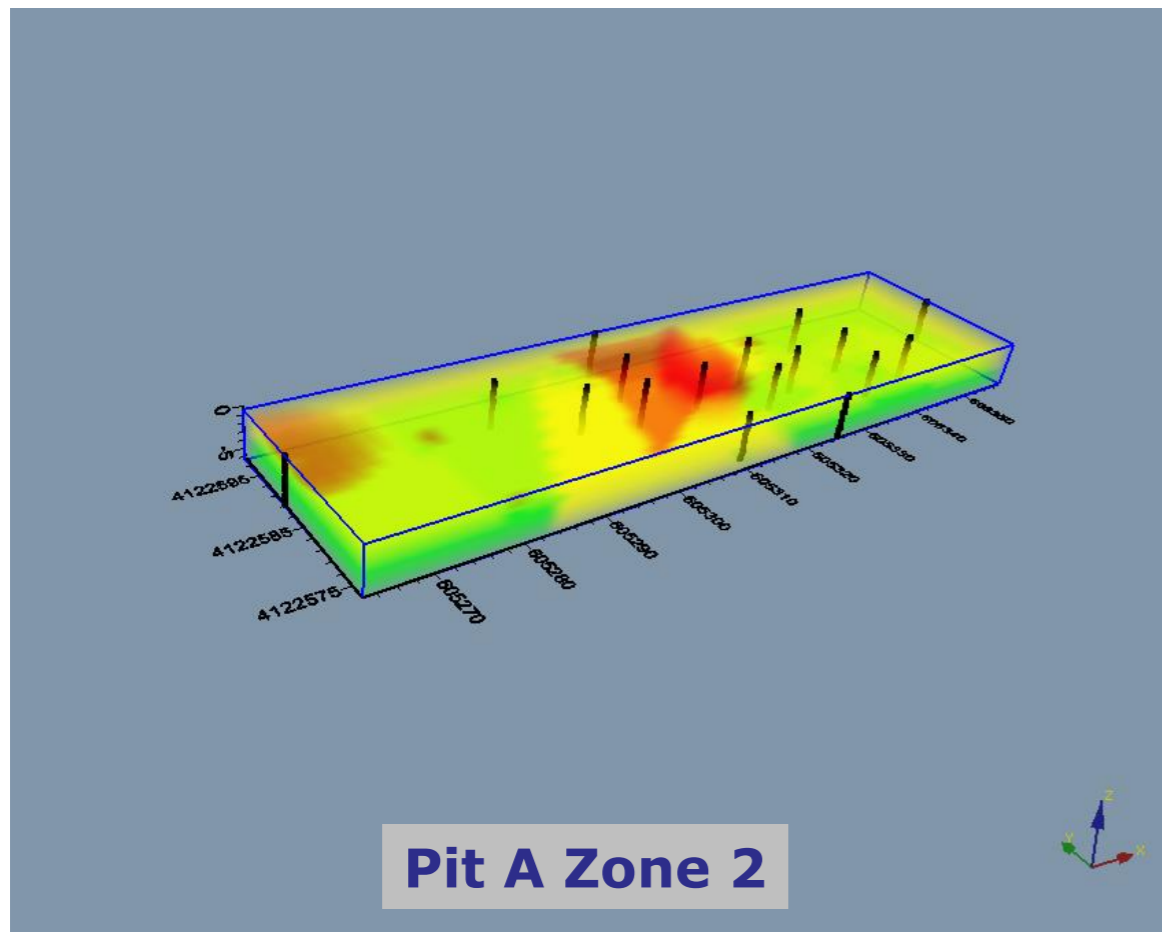
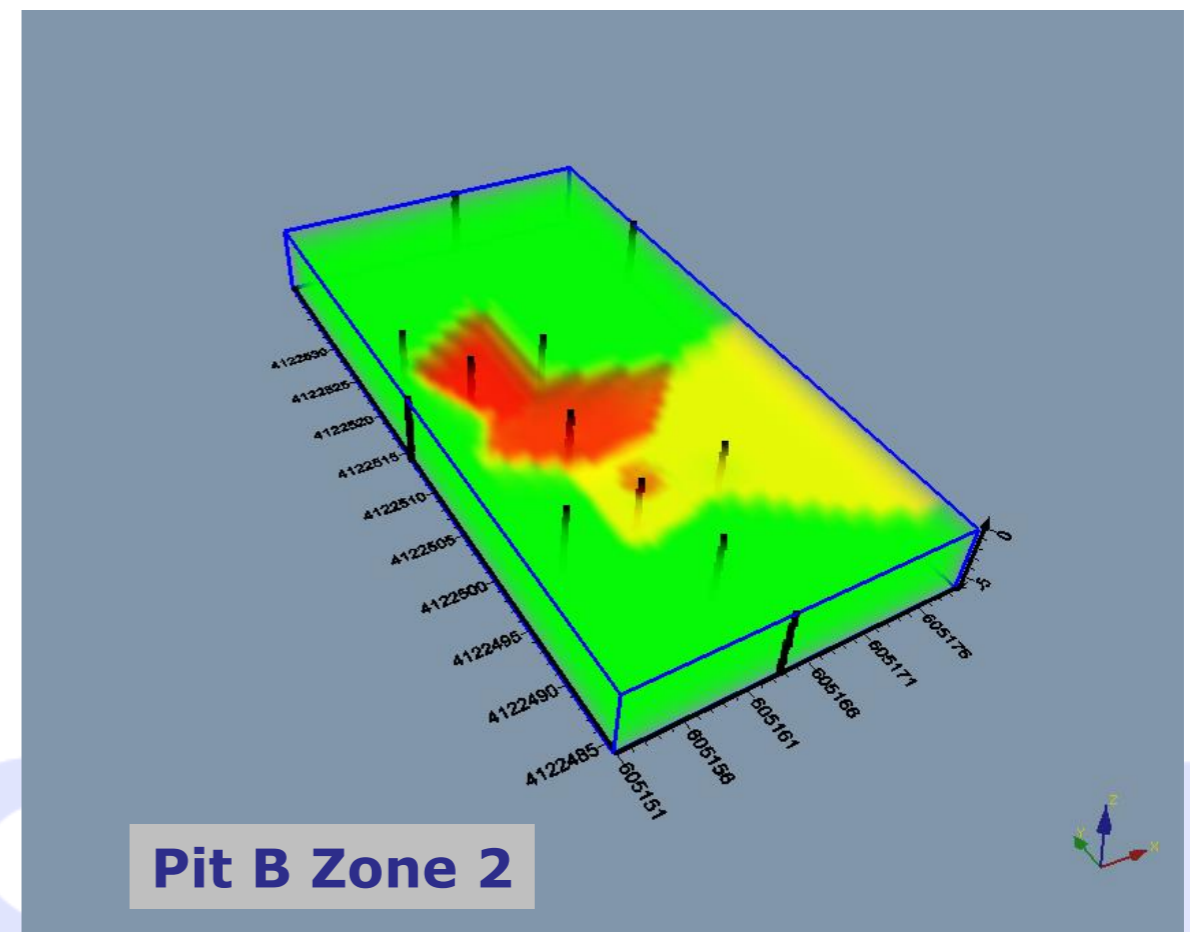
# Computation of contaminated volumes: 1 m<sup>3</sup> cell, Isotropic geometry and inverse squared distance approach

Zone 2	Zone 2-Bis	Zone 3	Zone 6	Total
Surface of affected topsoil (0-15 cm), m <sup>2</sup>	59,000	32,200	6,035	100,000	197,235
Volume of affected topsoil (0-15 cm), m <sup>3</sup>	8,850	4,830	905	20,000	34,585
Volume of affected subsoil (0.15cm-5 m), m <sup>3</sup>	12,670	271	2,245	0	15,186
Total affected soil, m <sup>3</sup>	21,520*	5,101	3,150	20,000	49,771

(\*) Pit A = 2,270 m<sup>3</sup> Pit B = 669 m<sup>3</sup>
