Meeting on Seismic Hazard in Asia

**Seismicity and Seismic Hazard
Assessment in Bangladesh:
Reference to Code Provisions**

Dr. Tahmeed Malik Al-Hussaini

Bangladesh University of Engineering & Technology

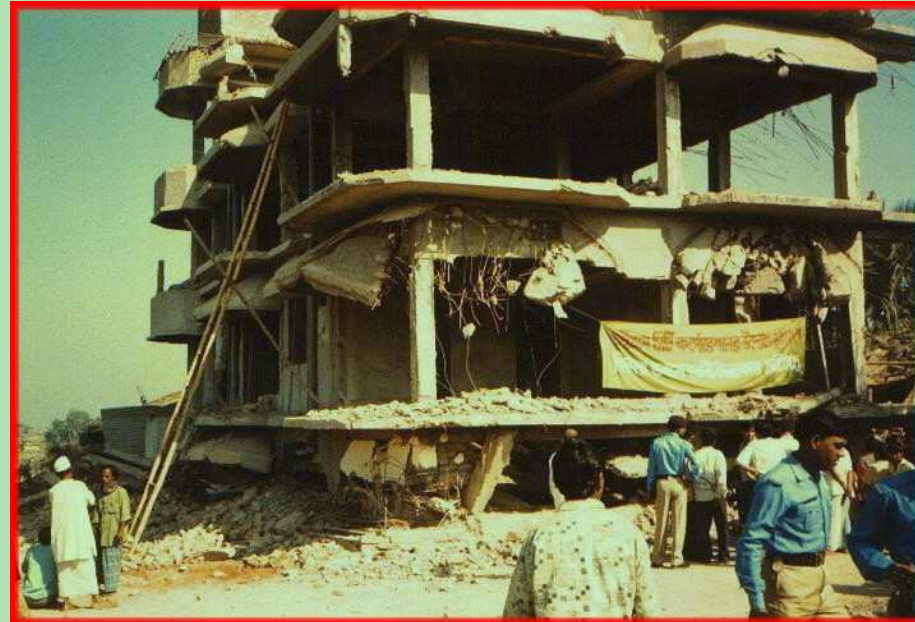
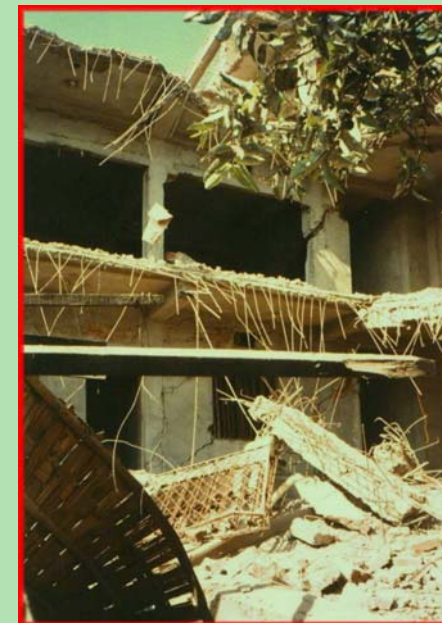
**1997 collapse of this
reinforced concrete
frame building in
Chittagong city was
triggerred by $M=6.0$
earthquake more than
100 km away.**

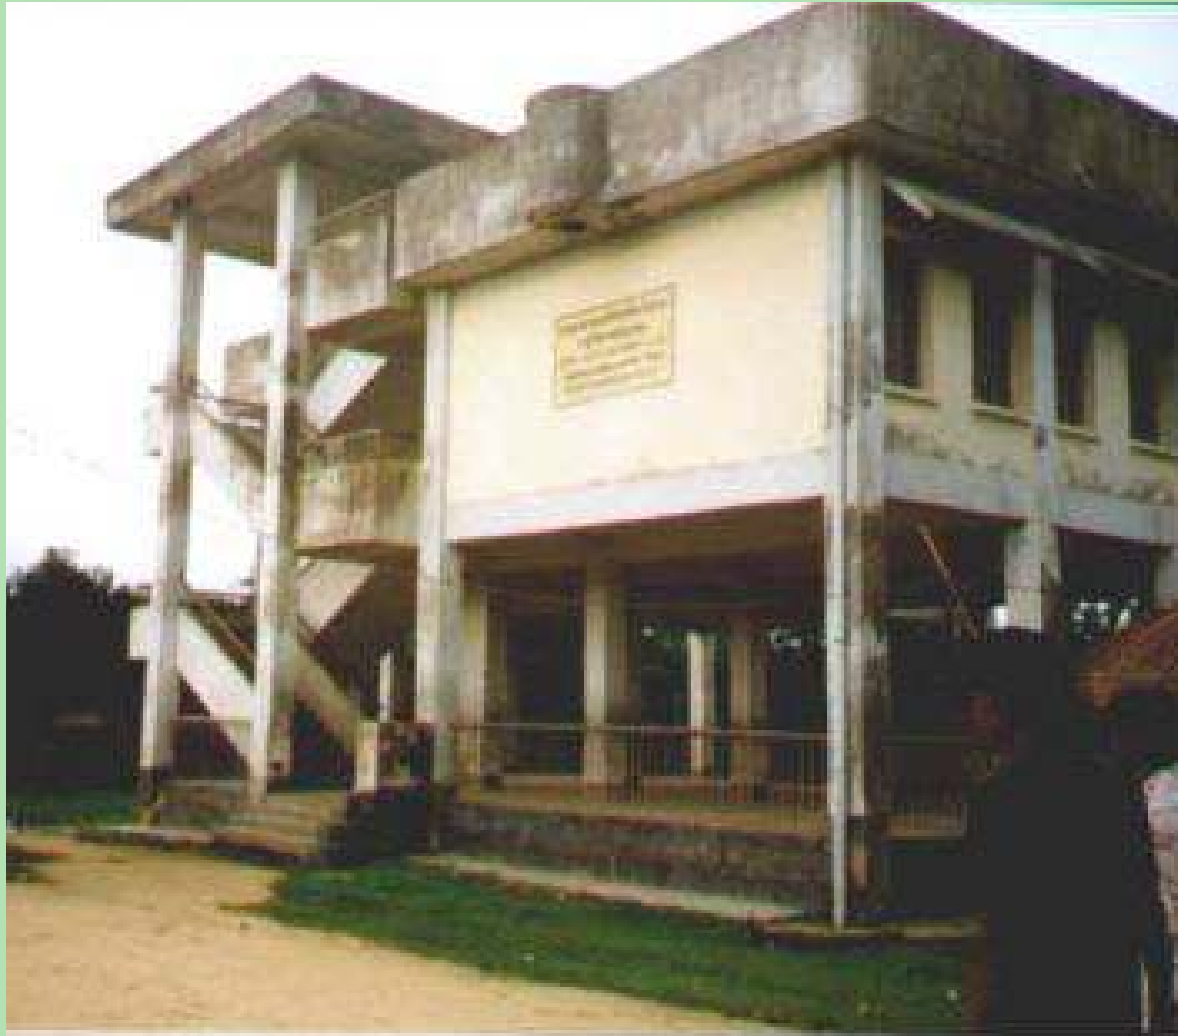
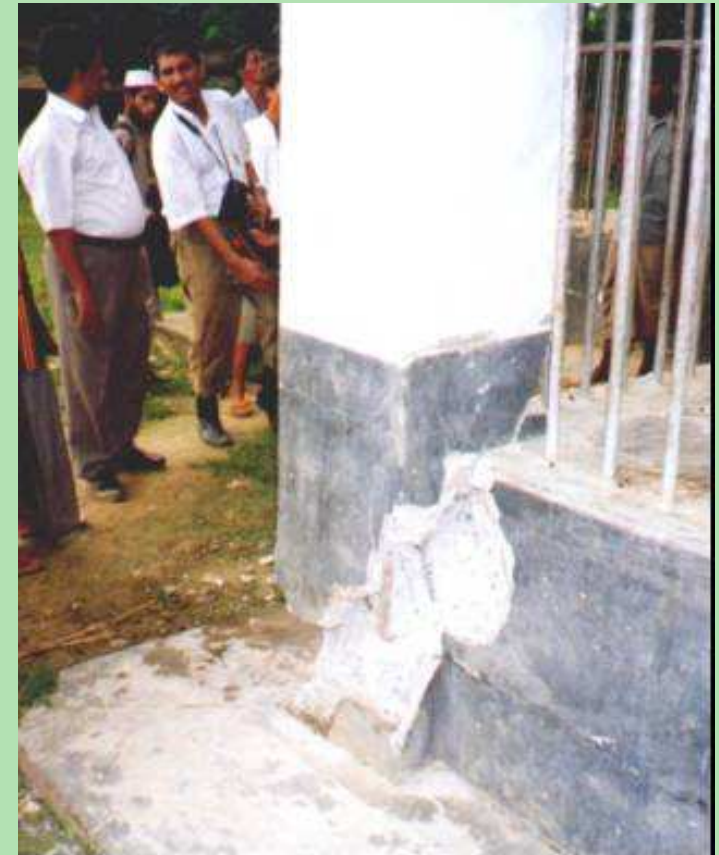
Cyclone Shelter

Column damage during 1999 Moheshkhali earthquake (M=5.1)

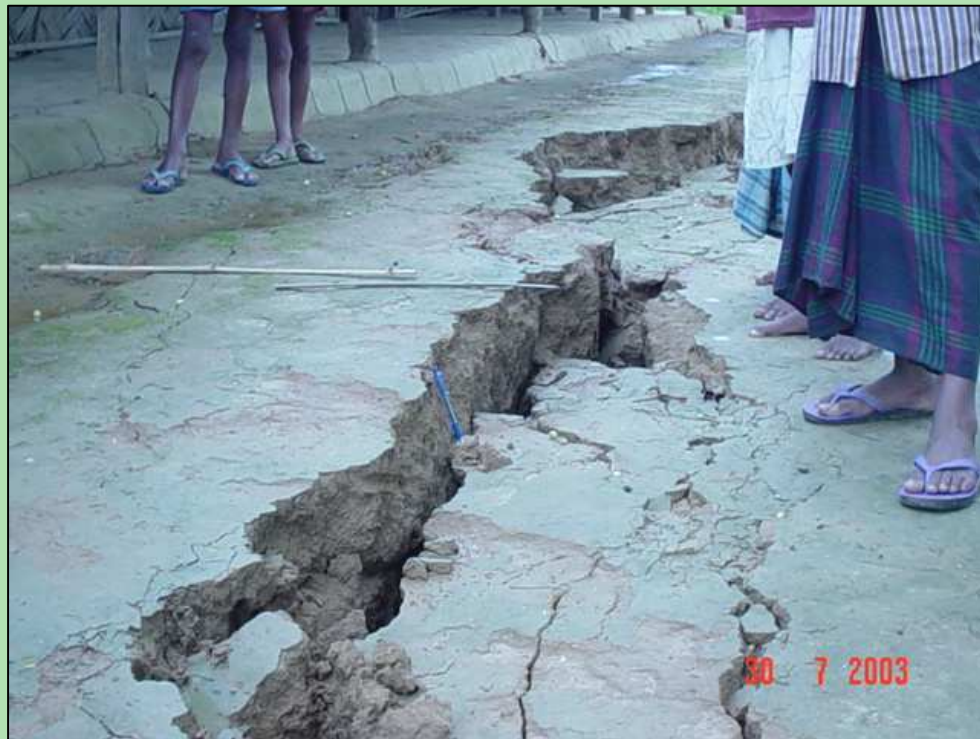
**Long soil crack
along the river**

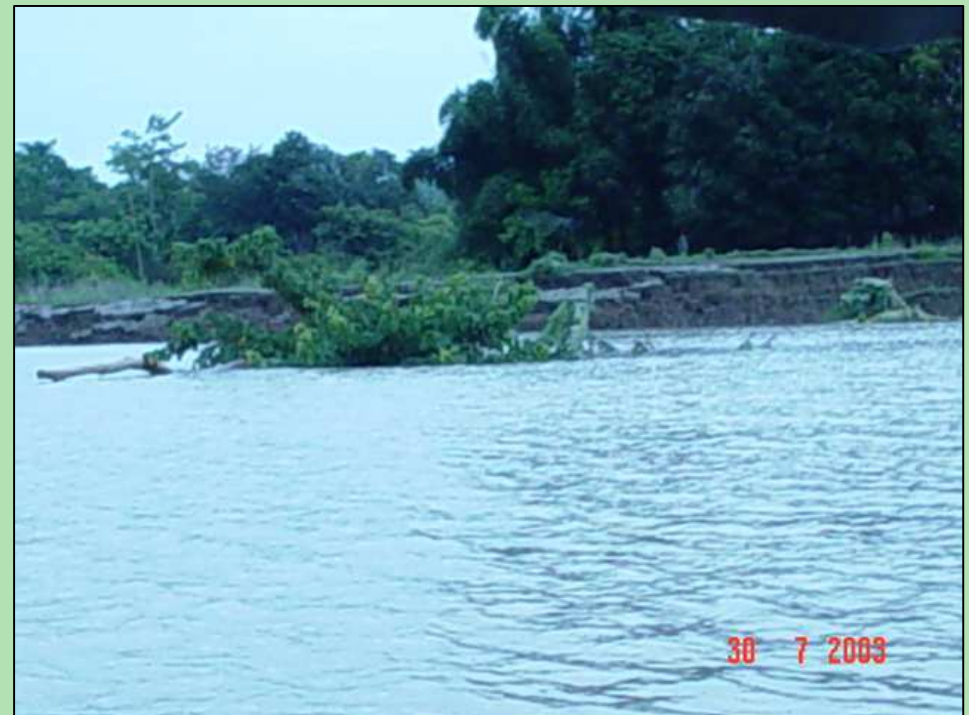
**Slumping of soil at
river bank**

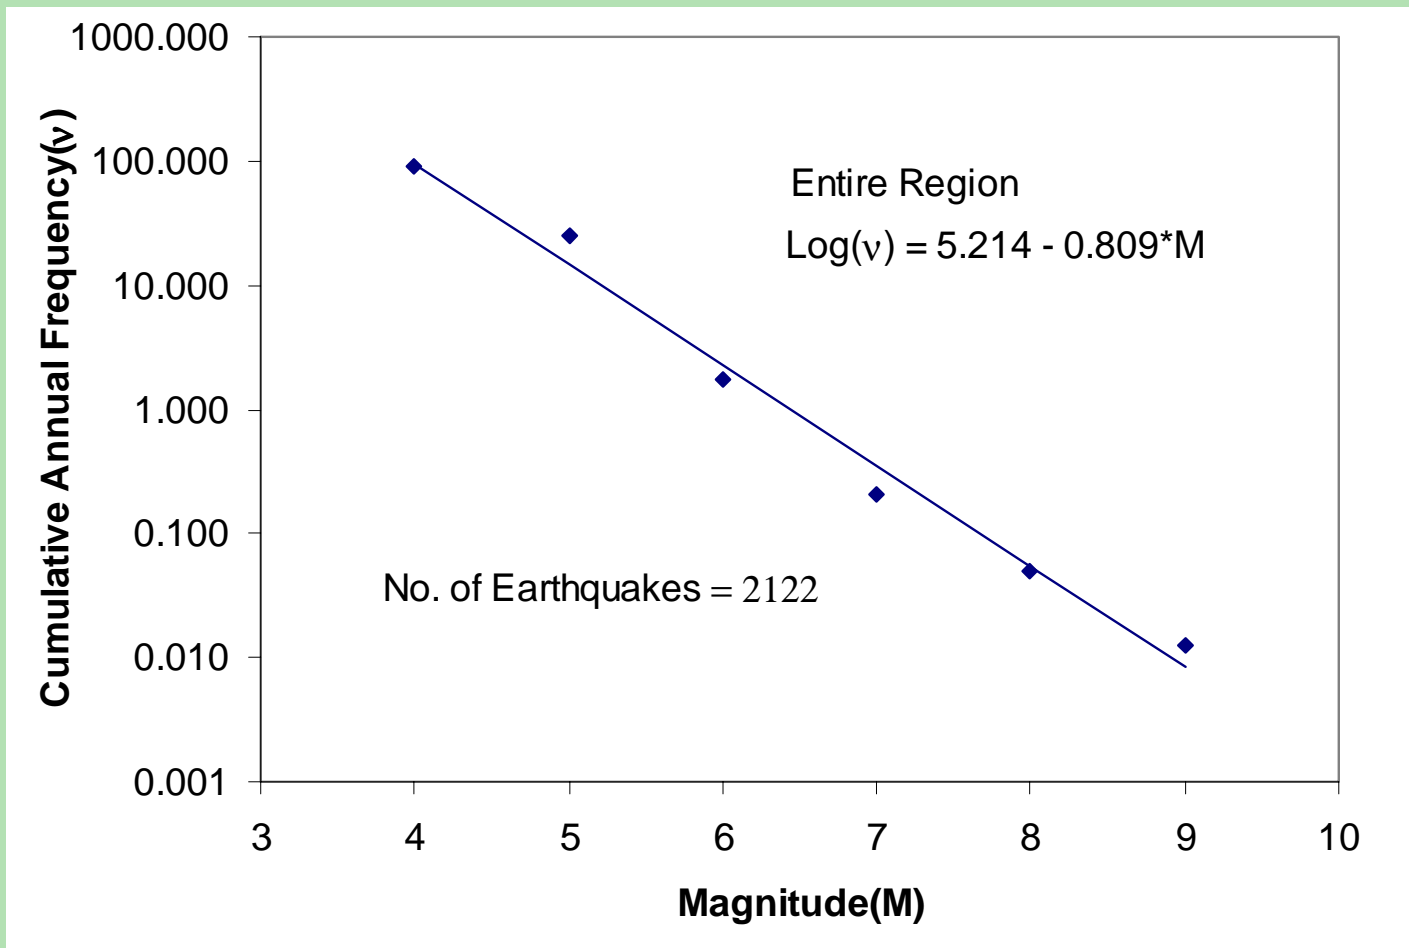
Magnitude-Frequency relationship for Entire Region

$$a = 5.21$$
$$b = 0.81$$

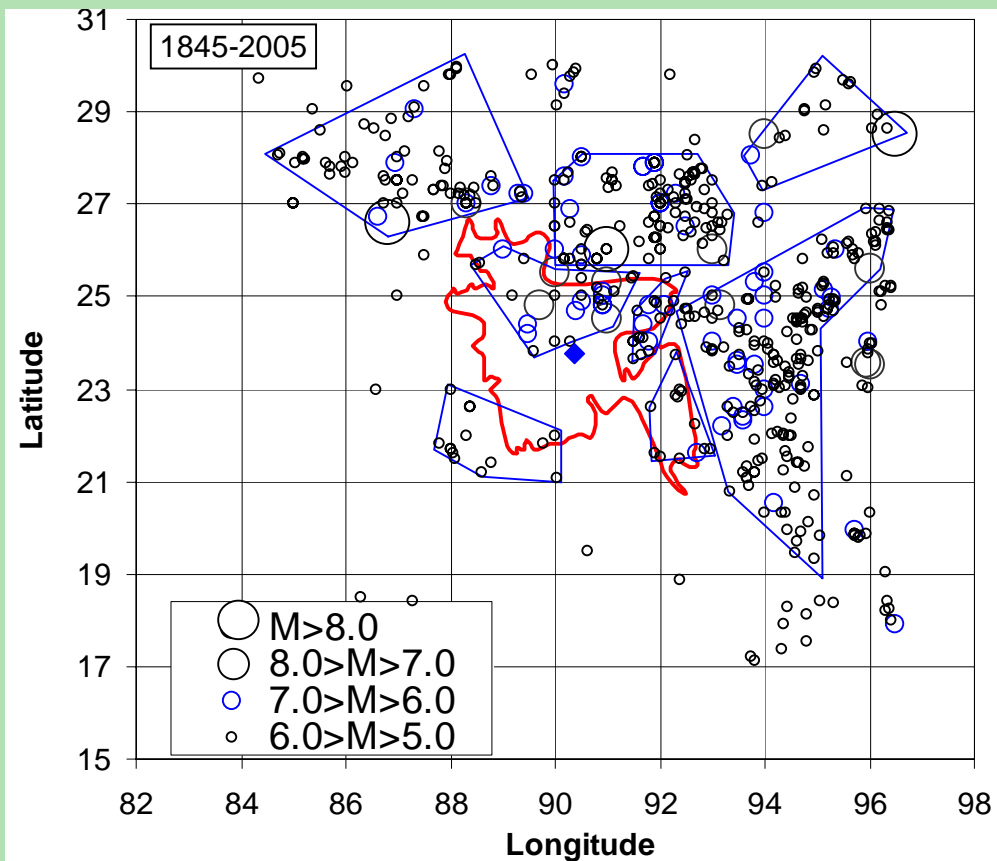
Eight Seismic Source Zones

Zone	Location	Number of earthquakes	M_{max}	a	b
1	Nepal, Darjeeling	315	8.3	4.872	0.929
2	Meghalaya, Assam, Bhutan	270	8.7	3.789	0.705
3	NE Assam, Arunachal	86	8.6	2.616	0.571
4	Rangpur, Bogra, Dinajpur, Mymensingh, Dhaka, Sylhet	47	7.6	2.556	0.592
5	West Sylhet, Tripura	38	6.5	3.116	0.73
6	Southwestern Coastal Region	8	5.7	2.9	0.809
7	Chittagong	41	6.5	3.59	0.828
8	Mizoram, Manipur, NW Myanmar	1092	7.6	5.467	0.933

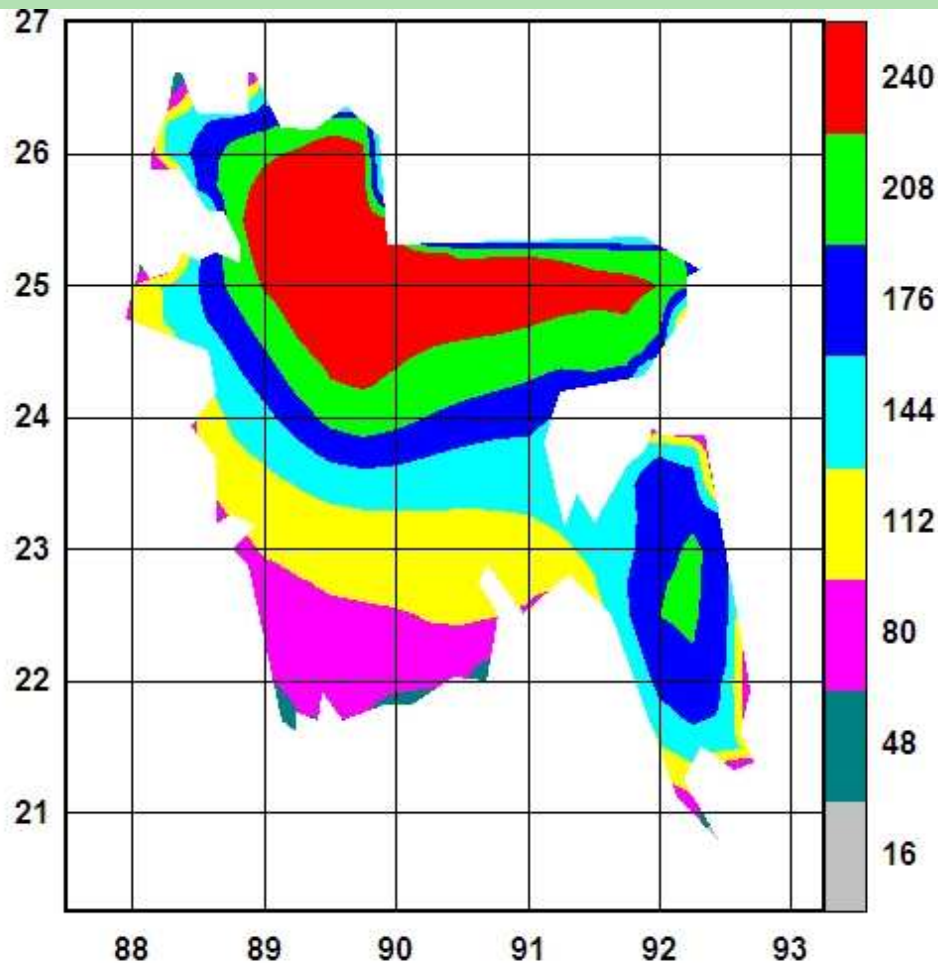
Estimation of Probabilistic seismic hazard (PGA in cm/sec²) for Bangladesh

(8 seismic source zones, return period 500 years)

This is not the final hazard map!

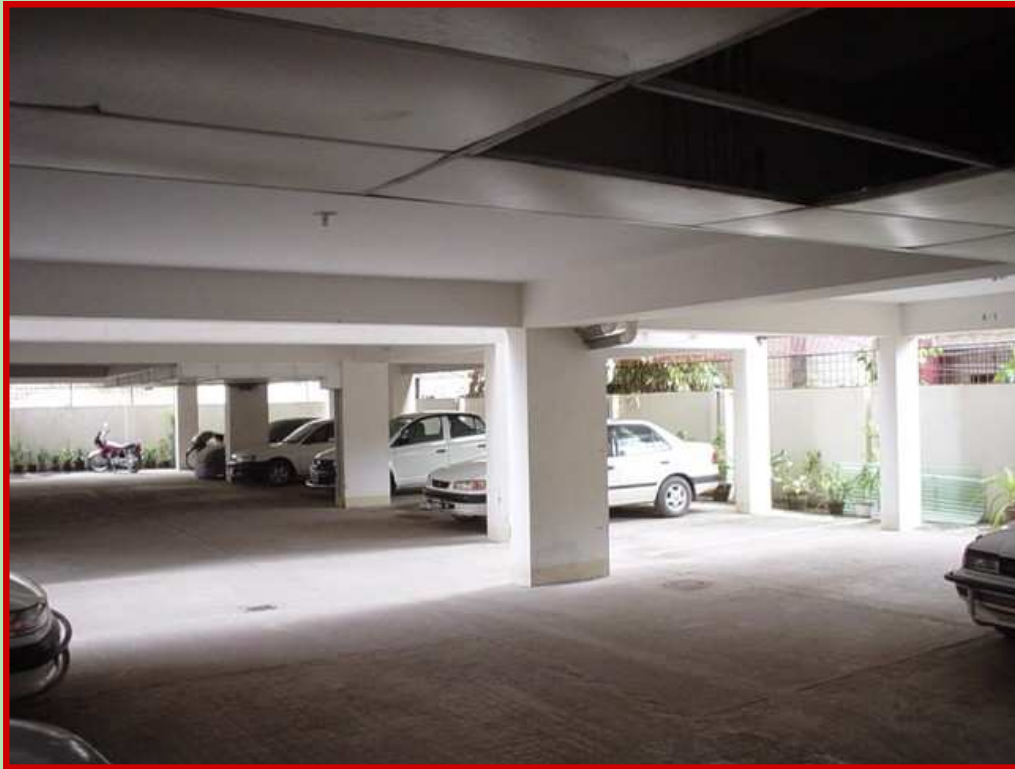
**Open Ground Story
(Car parking)
6-Storied Apartment Building**

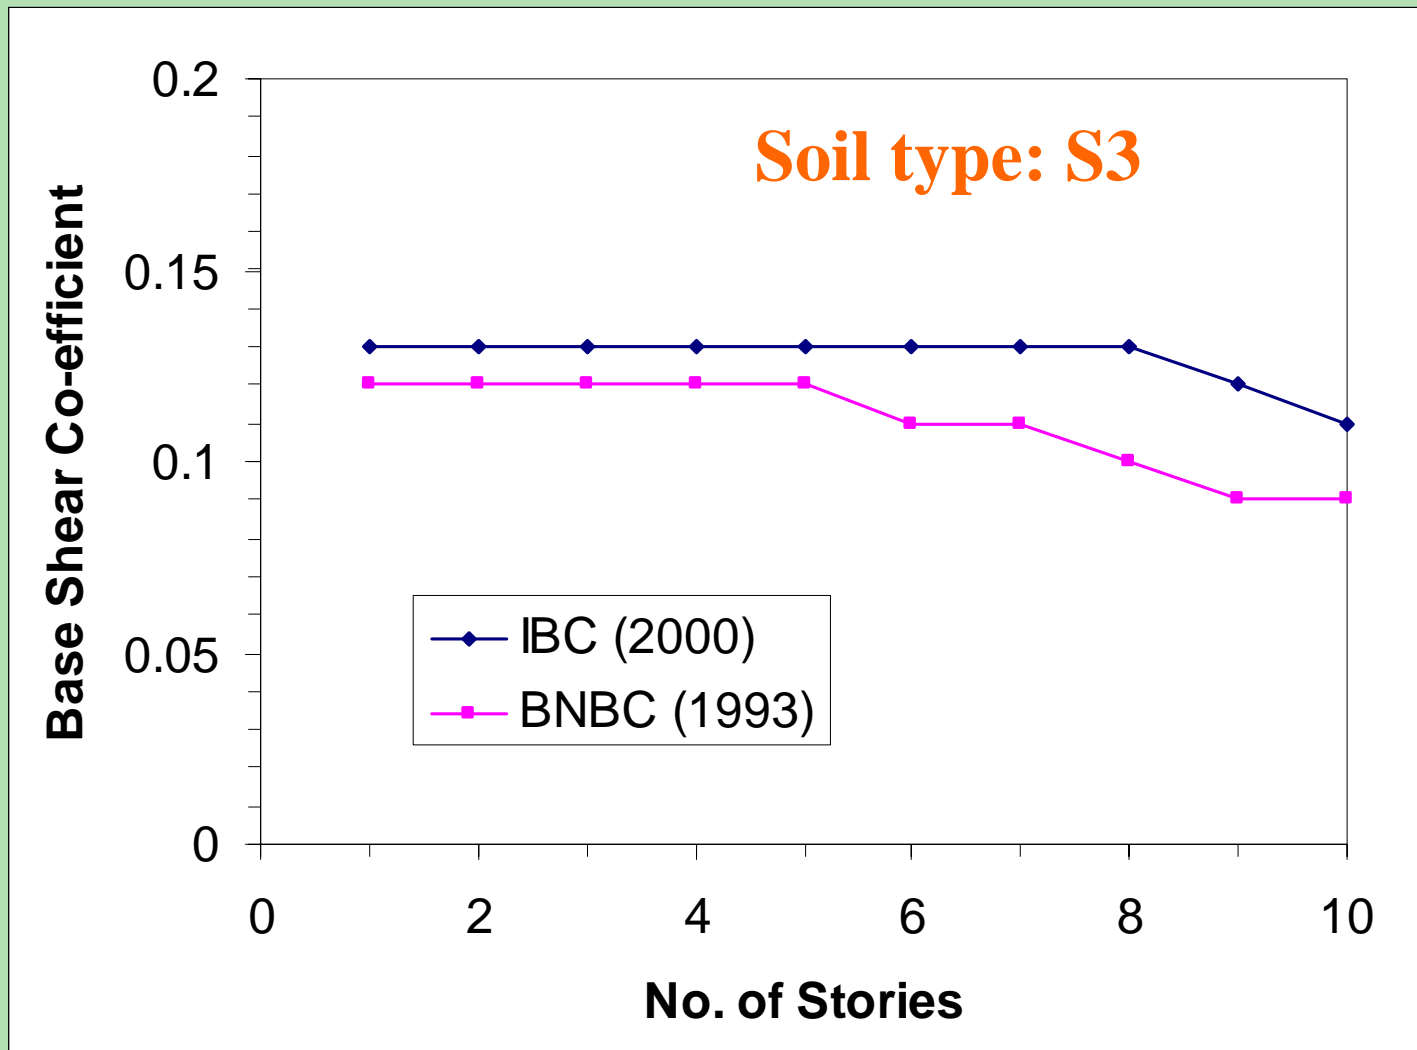
**BNBC
(1993)**

vs.

**IBC
(2000)**

Taller buildings (6 stories or more) are subjected to larger base shear than what BNBC suggests

BNBC appears to be unsafe for buildings 6 stories and taller when compared with recent IBC code.

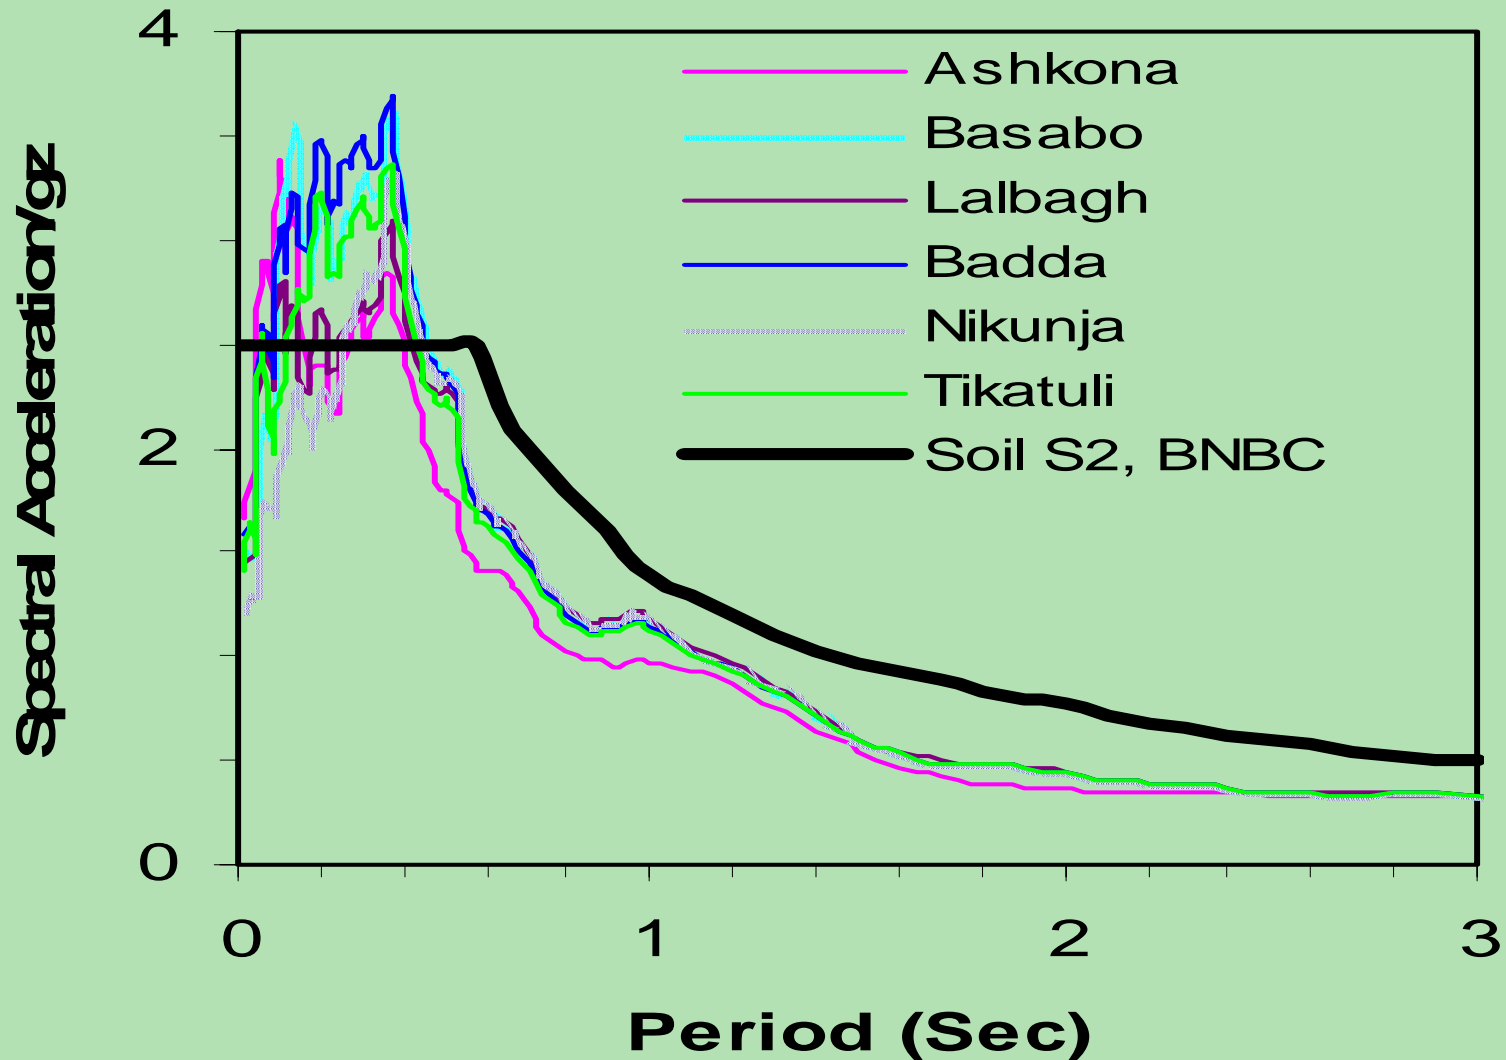
Response Spectrum (wave propagation analysis) obtained for Various S2 Sites in Dhaka City

BNBC design response spectra appear to underestimate peak spectral acceleration as shown by wave propagation analysis results.

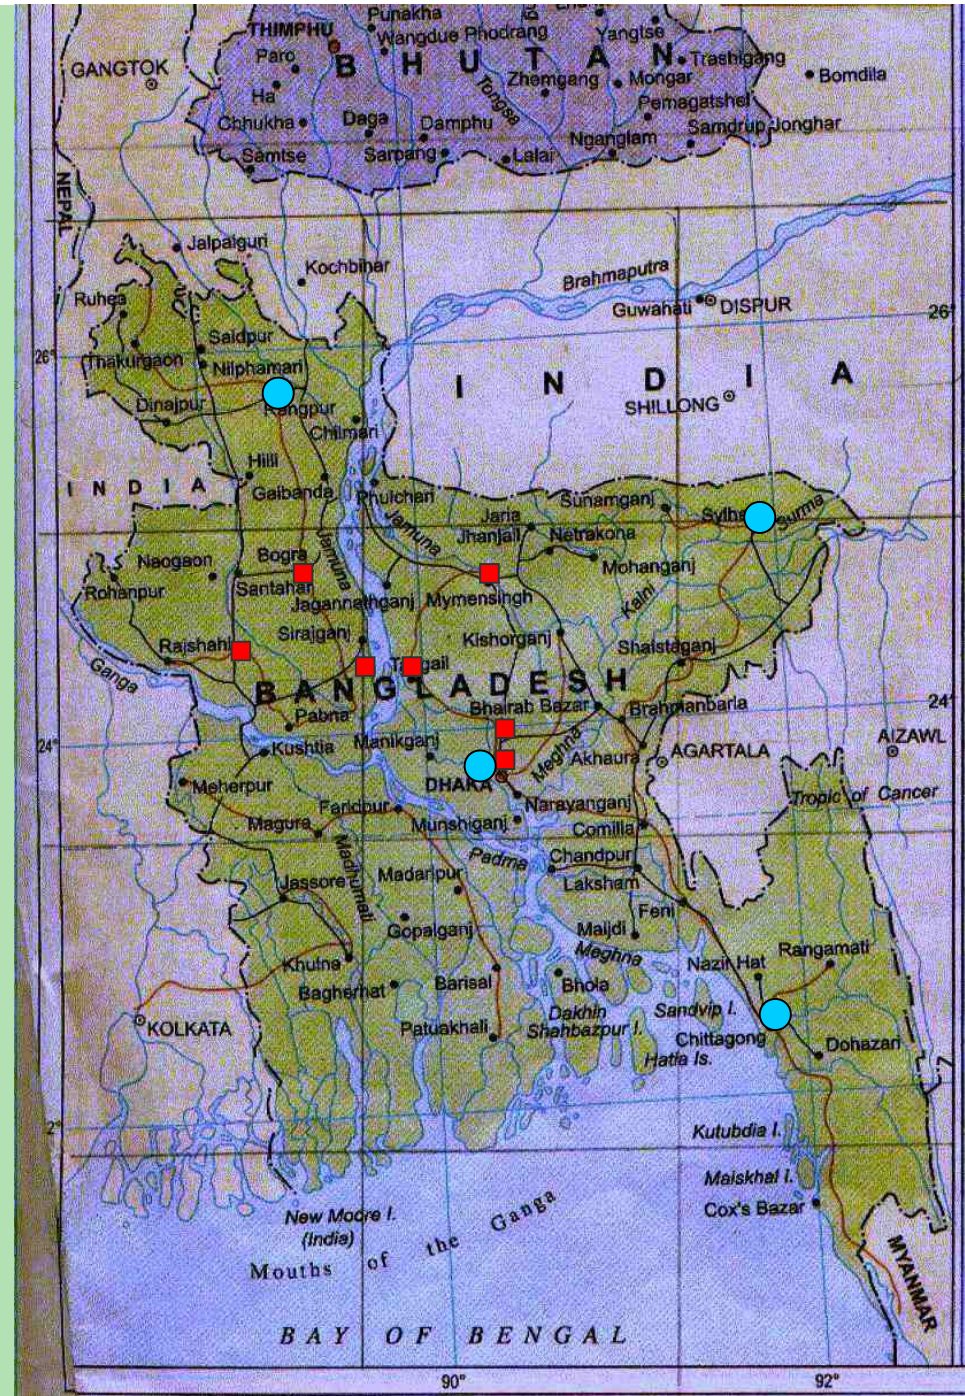
Digital Seismic Stations

- **7 Accelerometer** ■
(JMBA-BUET) since 2003
- **4 Broad Band Seismometer + Accelerometer** ●
(BMD) to be installed shortly
- **6 Short Period Seismometer**
(BMD) planned for other locations.

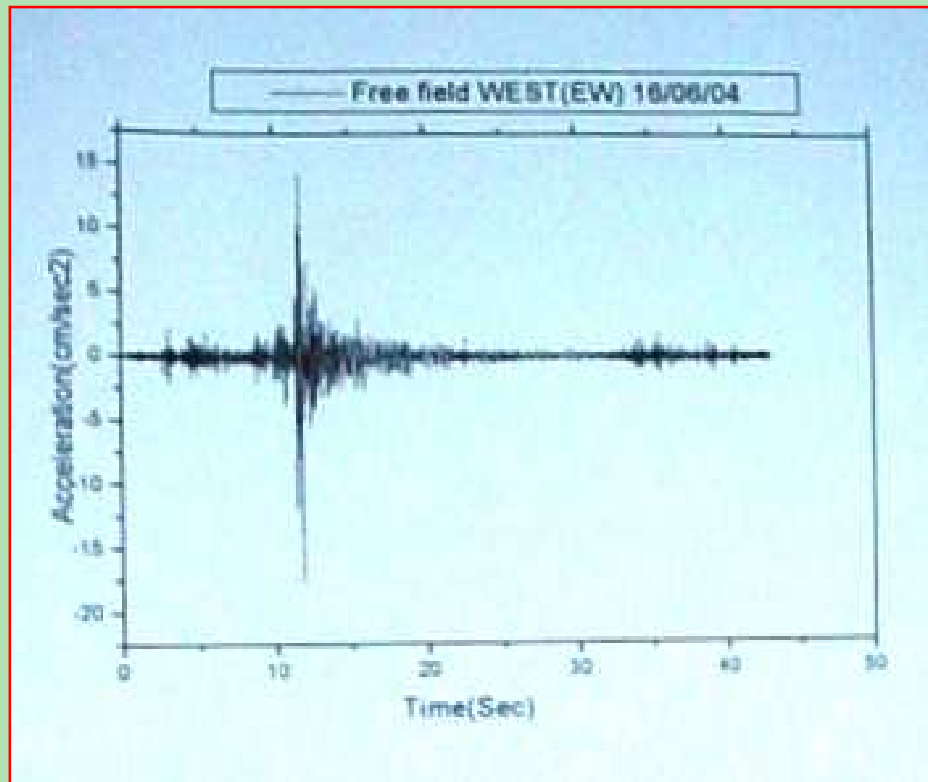
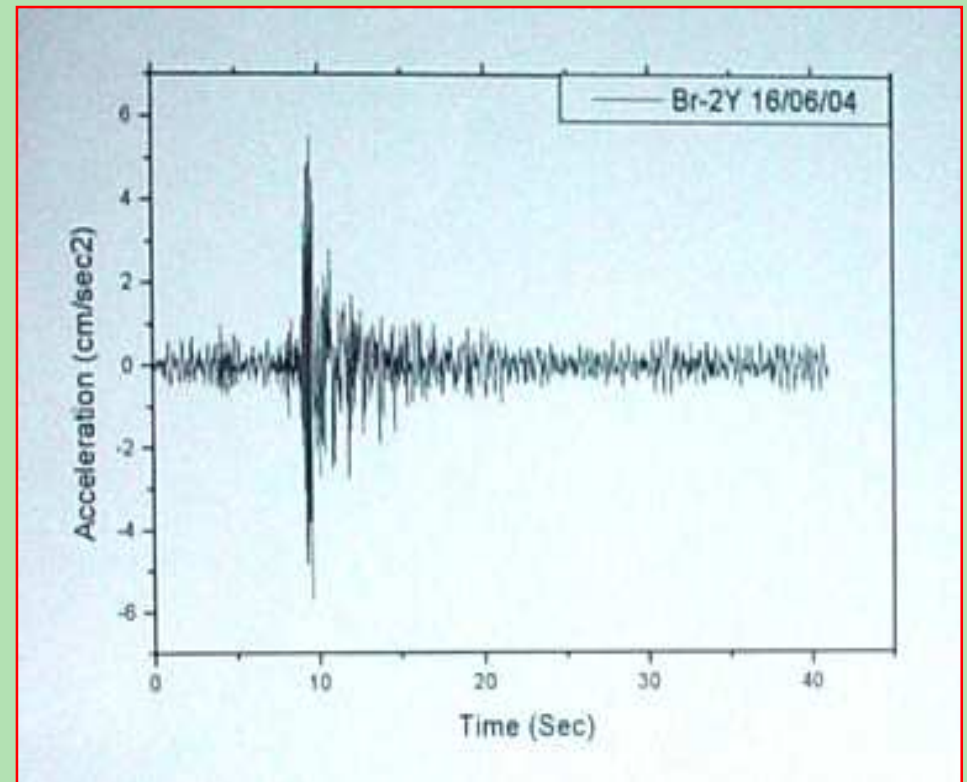
Seismic Data

(recorded July 16, 2004)

Free Field (West End)

Bridge: Pile Cap
