**Joint ICTP/IAEA Advanced Workshop on Earthquake Engineering
for Nuclear Facilities**

**Kashiwazaki-Kariwa Nuclear Power Station's
Case of Evaluation on Plant Integrity and
Seismic Reinforcement**

Yamamiya T.
*Tokyo Electric Power Company
Japan*

Dec 4, 2009

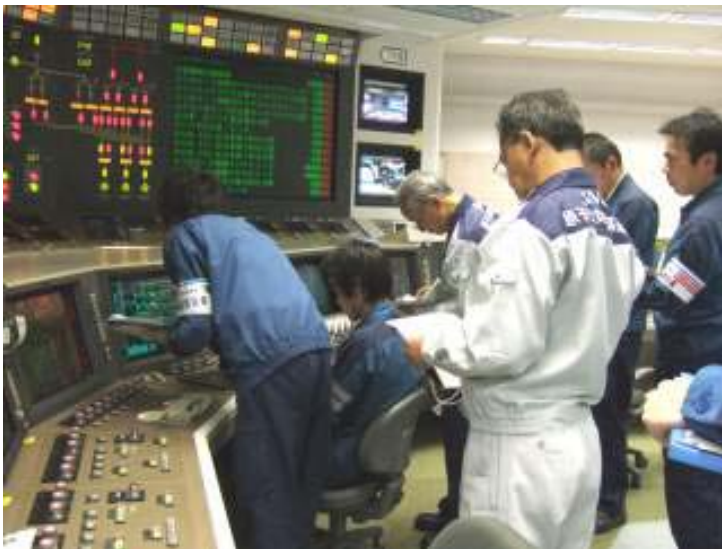
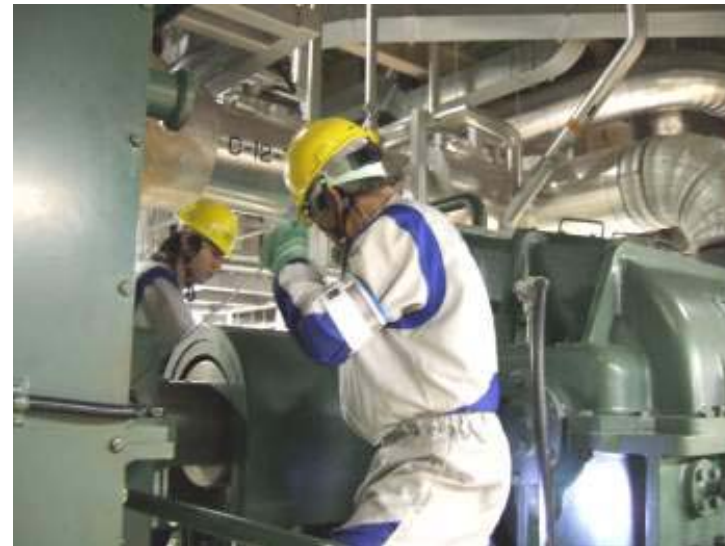
Case of System Function test (Reactor Feed Water System)

- The number of System function test : 23
- In all test, confirmed the system fulfill a function
- Abnormality by earth-quake was not founded in all test.

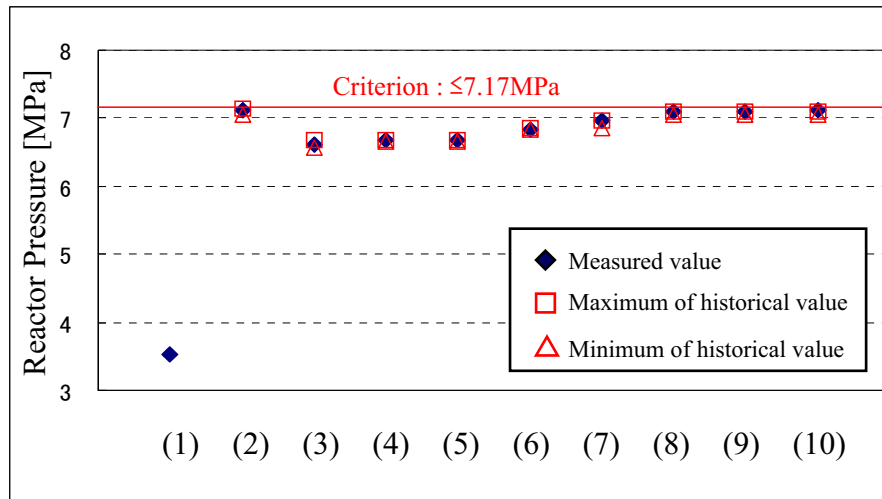
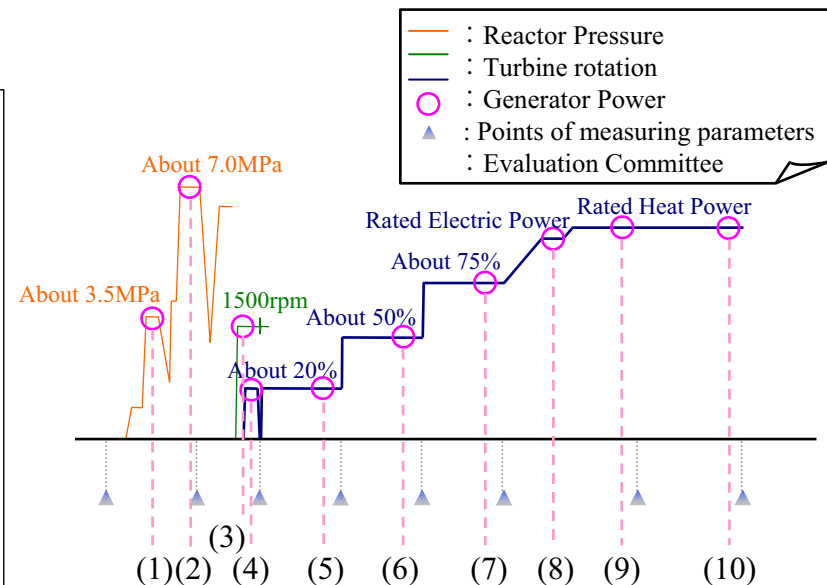
Example of Reactor Pressure

- Results of Comprehensive evaluation for Plant Operating condition
 - ◆ None of parameter affected adversely by the earthquake have been found.

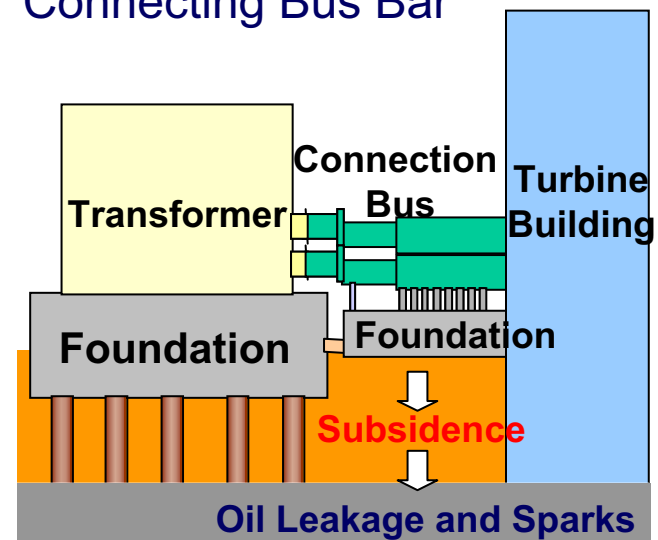
Connecting Bus Bar

■Transformer Damages
