**Some remarks on the earthquakes in L'Aquila,  
Haiti and Chile. Seismology and damages**

Luis D. Decanini  
*Sapienza, Universita di Roma  
Dipartimento di Ingegneria Strutturale e Geotecnica  
Roma  
ITALY*

**Trieste, May 13 2010**

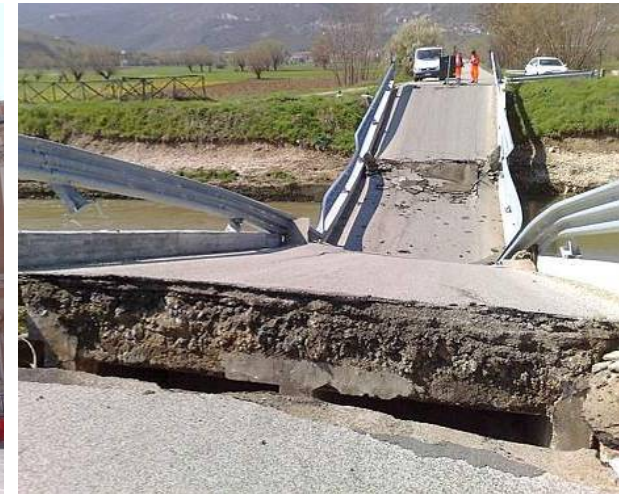
Failure of a bridge

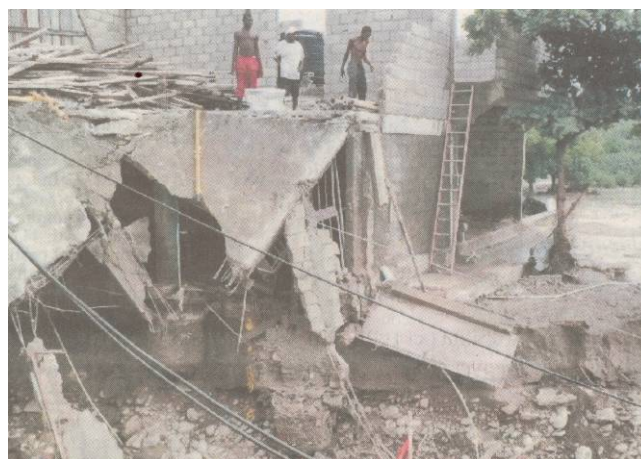
Reinforced concrete floor

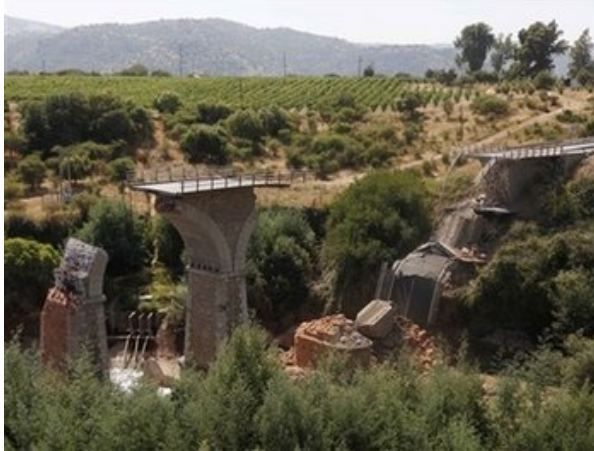
Historic masonry bridge

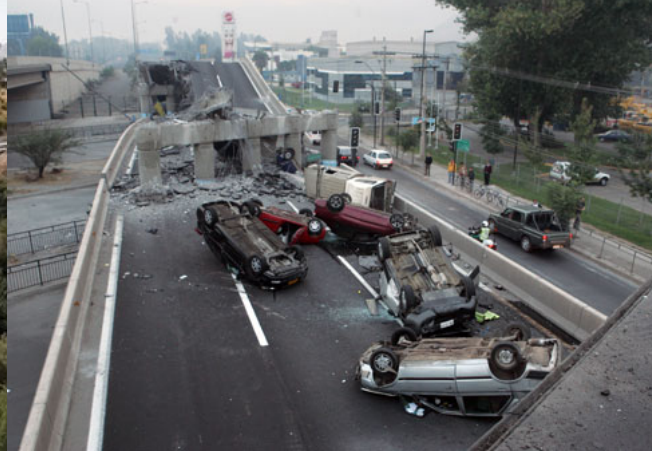
Reinforced concrete bridge

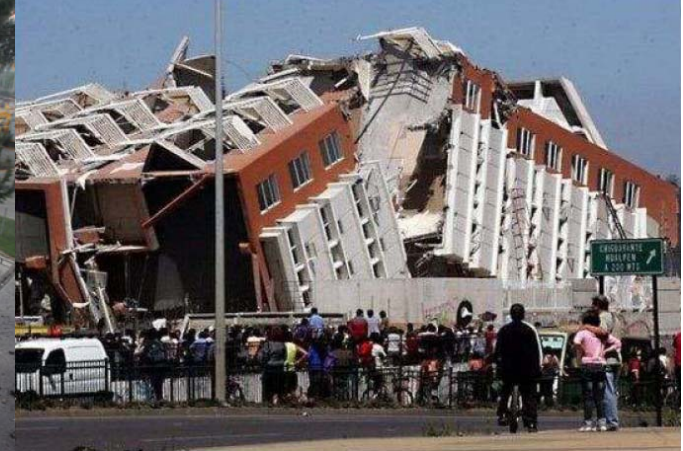
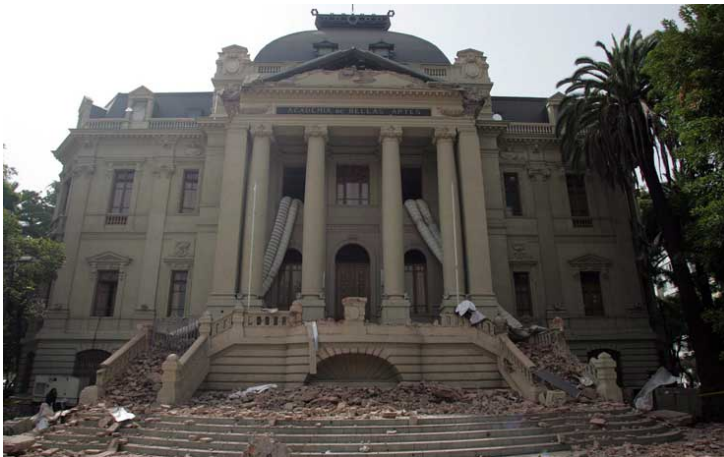
RC Building collapse

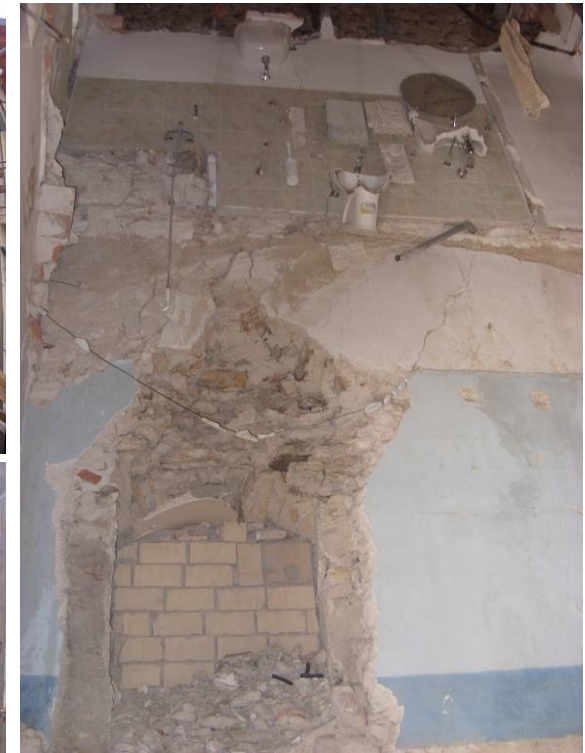
Testata d'angolo su via del Pizzicagnolo

Interni. Collasso degli orizzontamenti

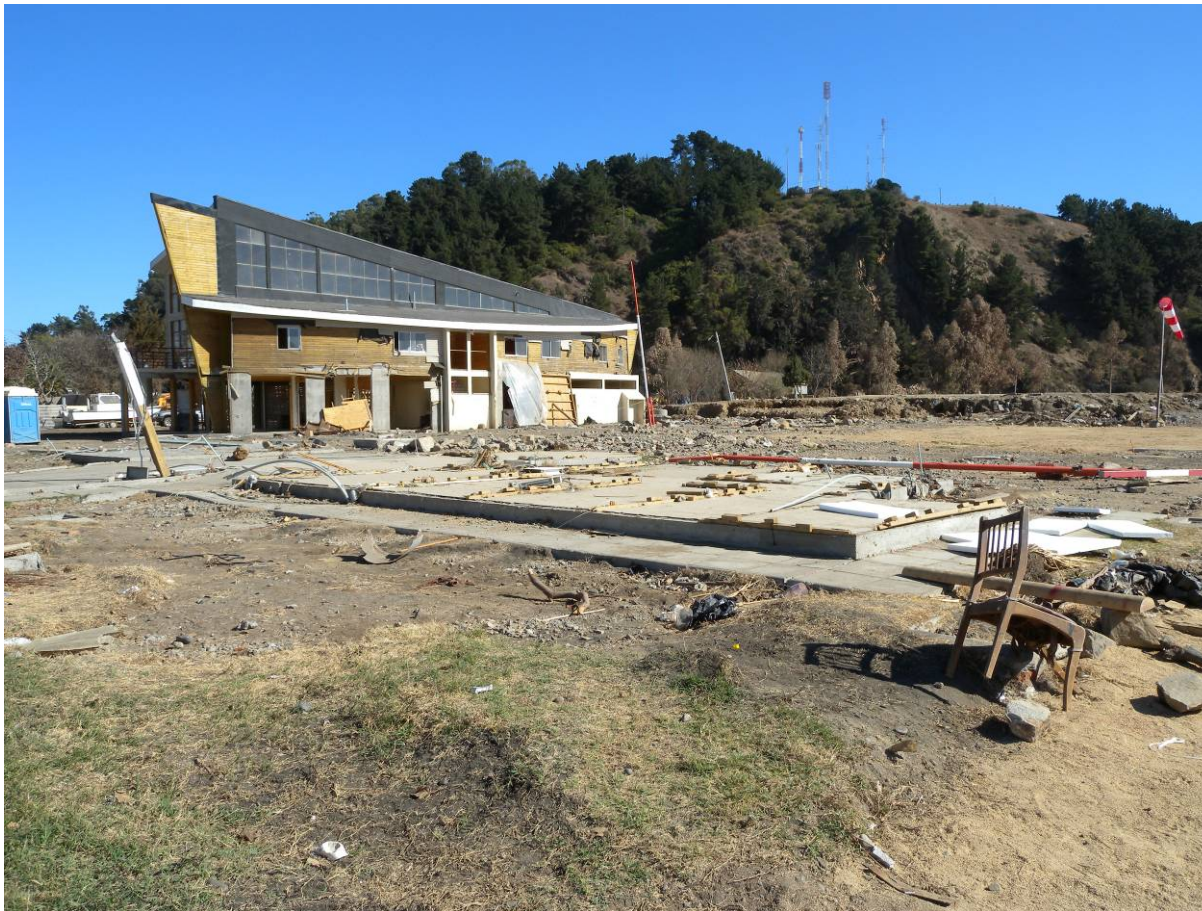
Constitucion. Reinforced concrete building survived the tsunami

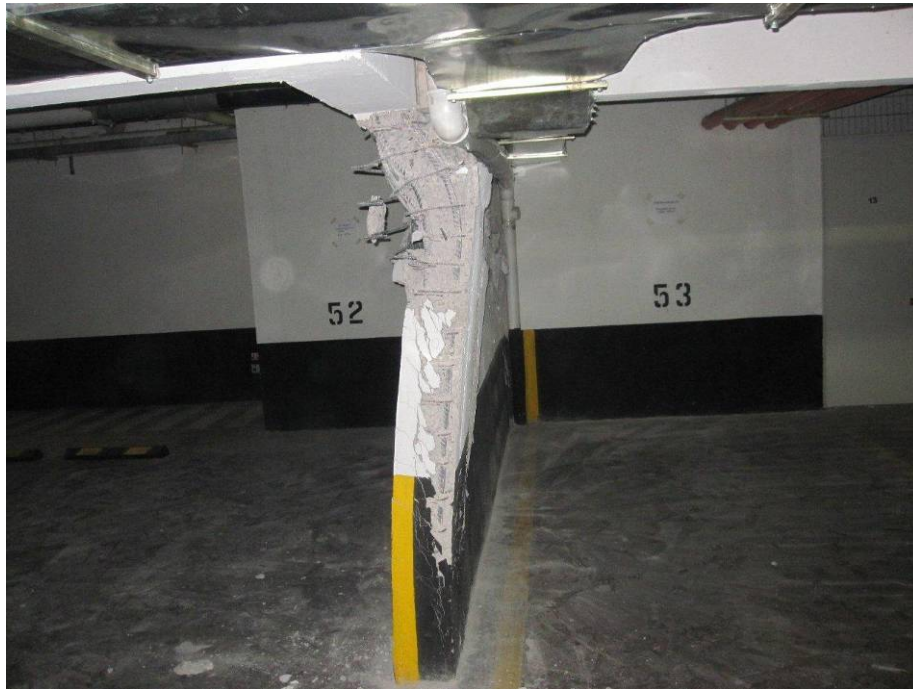
Santiago, Edificio Emerald.  
Severe damage in the  
basement's shear walls.
