# Case histories of radiotherapy accidents & clinical consequences

Ben Mijnheer

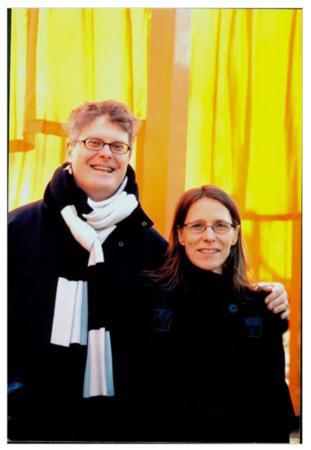
Mr. Jerome-Parks with his wife, Carmen, on the day he received his diagnosis of tongue cancer. For his treatment, he chose St. Vincent's Hospital in Manhattan, which was promoting a new linear accelerator and a treatment called Intensity Modulated Radiation Therapy, which could more precisely shape and modulate the radiation beam. Treatment started March 8, 2005

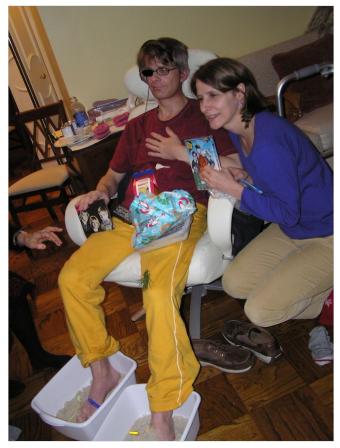
Sensing that death was near, Mr. Jerome-Parks and his wife summoned his family for a final Christmas together. Friends sent buckets of sand from the beach in Gulfport, Miss., where they had played together, so that he could sink his feet in it and remember happy times. Two month later in Febr. 2007 he died from his injuries.
