# Radiation Safety in IGRT

## Cases, Causes and Culture of Safety

**Joint ICTP-IAEA International Workshop on the  
Implementation of Image Guided Radiotherapy (IGRT)**  
8-12 May 2017

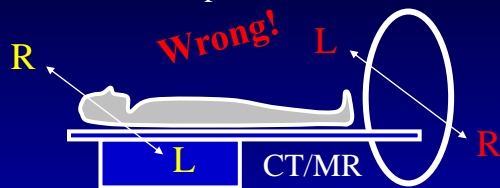
"Due to a left - right reversal of the treatment planning MRI images, the patient's left side was targeted and treated rather than the right side. The error resulted in an **18 mm shift of isocenter across midline** of the brain. The collimator diameter selected for the treatment was 18 mm, thus resulting in some overlap of the delivered 50% isodose volume with the correct intended target lesion volume. The event resulted in approximately 7% of the lesion volume receiving the prescribed dose of 18 Gy to the 50% isodose, rather than the preferred 95% of the lesion volume.

Patient: Supine, Head First  
Scan Label: Supine, **Feet First**

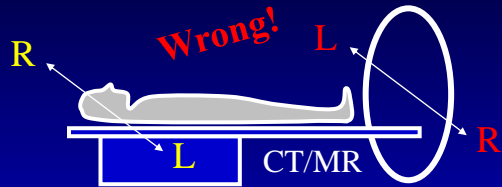
Patient + Scan Label:  
Supine, Head First

Patient: Supine, Head First  
Scan Label: Supine, **Feet First**
