Techniques of Post-Irradiation Examination (PIE) for Water Reactor Fuel and IAEA PIE Facilities/Techniques Database

For Workshop on "Modelling and Quality Control
for Advanced and Innovative Fuel Technologies"

ICTP, Trieste, November 2005

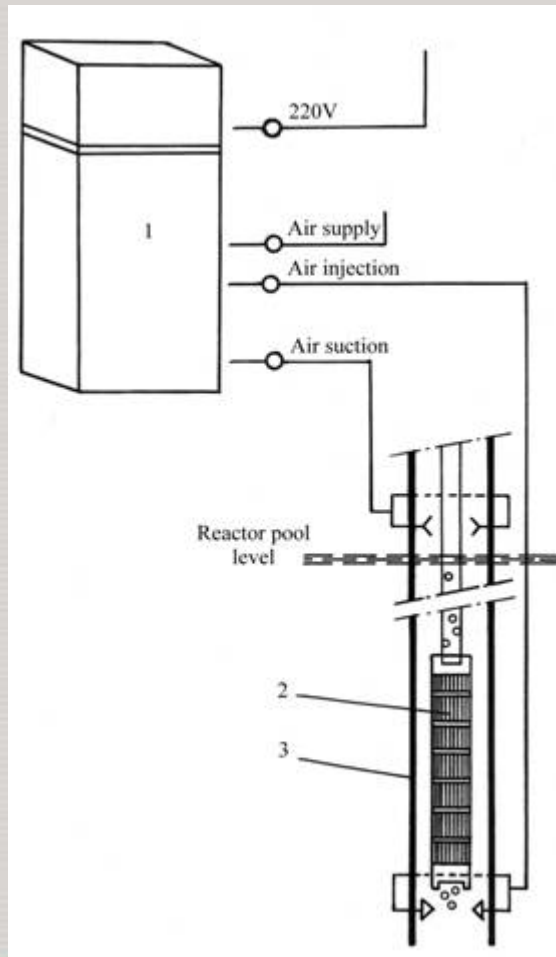
FA Sipping test (2) – In-mast On-line

1-Control cabinet

2-FA

3-Manipulator crane mast

FA is lifted into the mast. Due to hydrostatic pressure change, fission products are released from leaky rod into water. FPs soluble in water are captured by injected air and transferred for Xe-133 gamma analyzer and compared with value averaged for 10 FAs.

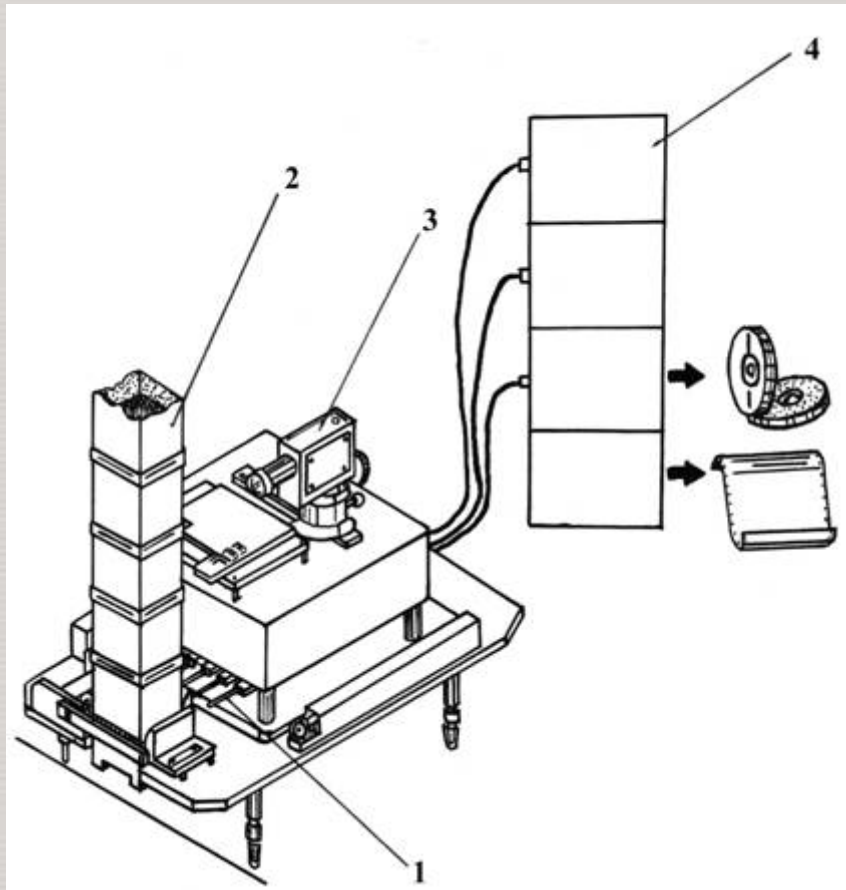
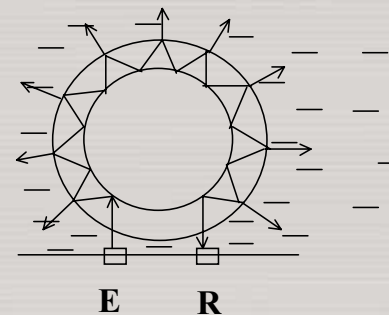
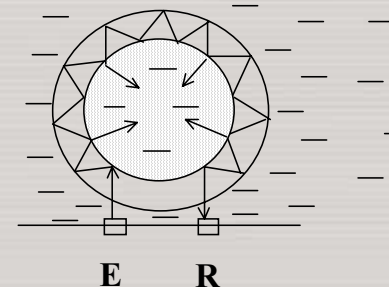
Single FR Leak Detection in a FA (1)

UT, circular wave propagation (BBR-B & W)

1-set of ultrasonic probes; 2-FA; 3-video camera; 4-cabinet

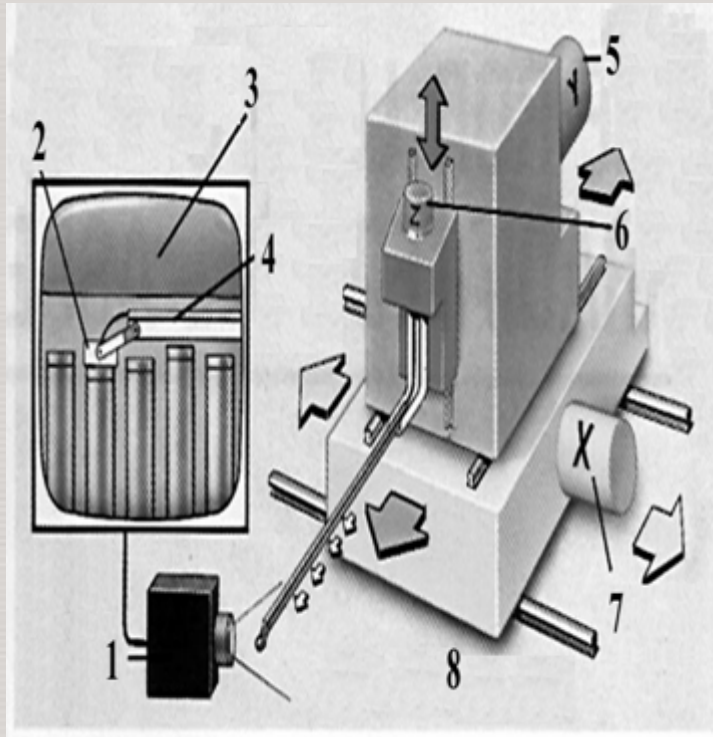
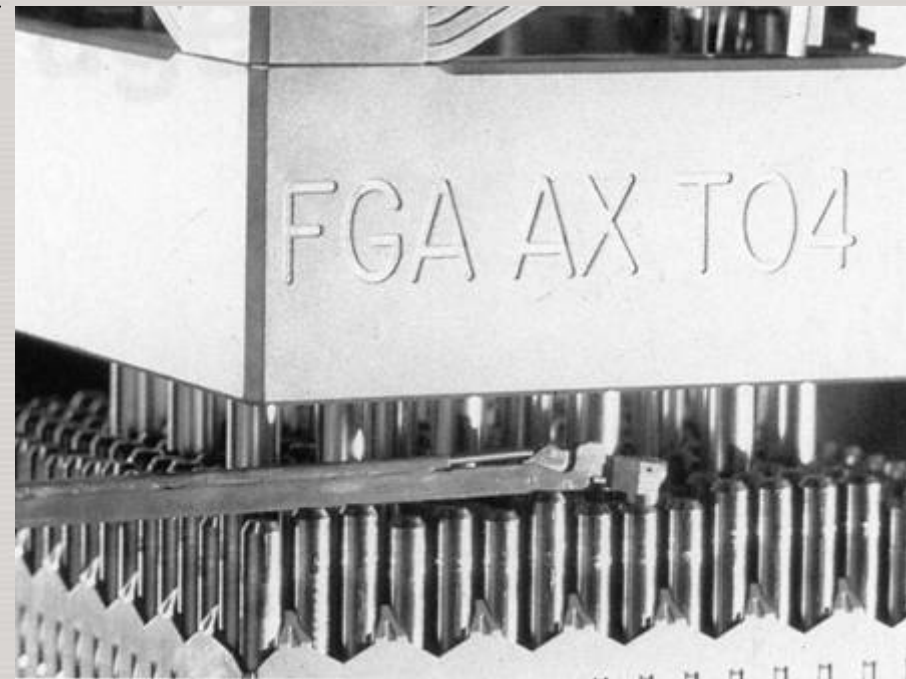
Single FR Leak Detection in a FA (2)

UT, vertical wave propagation (FRAGEMA)
1-video camera; 2-UT probe; 3- top nozzle; 4- manipulator; 5-7-motors; 8 X & Y-motion table

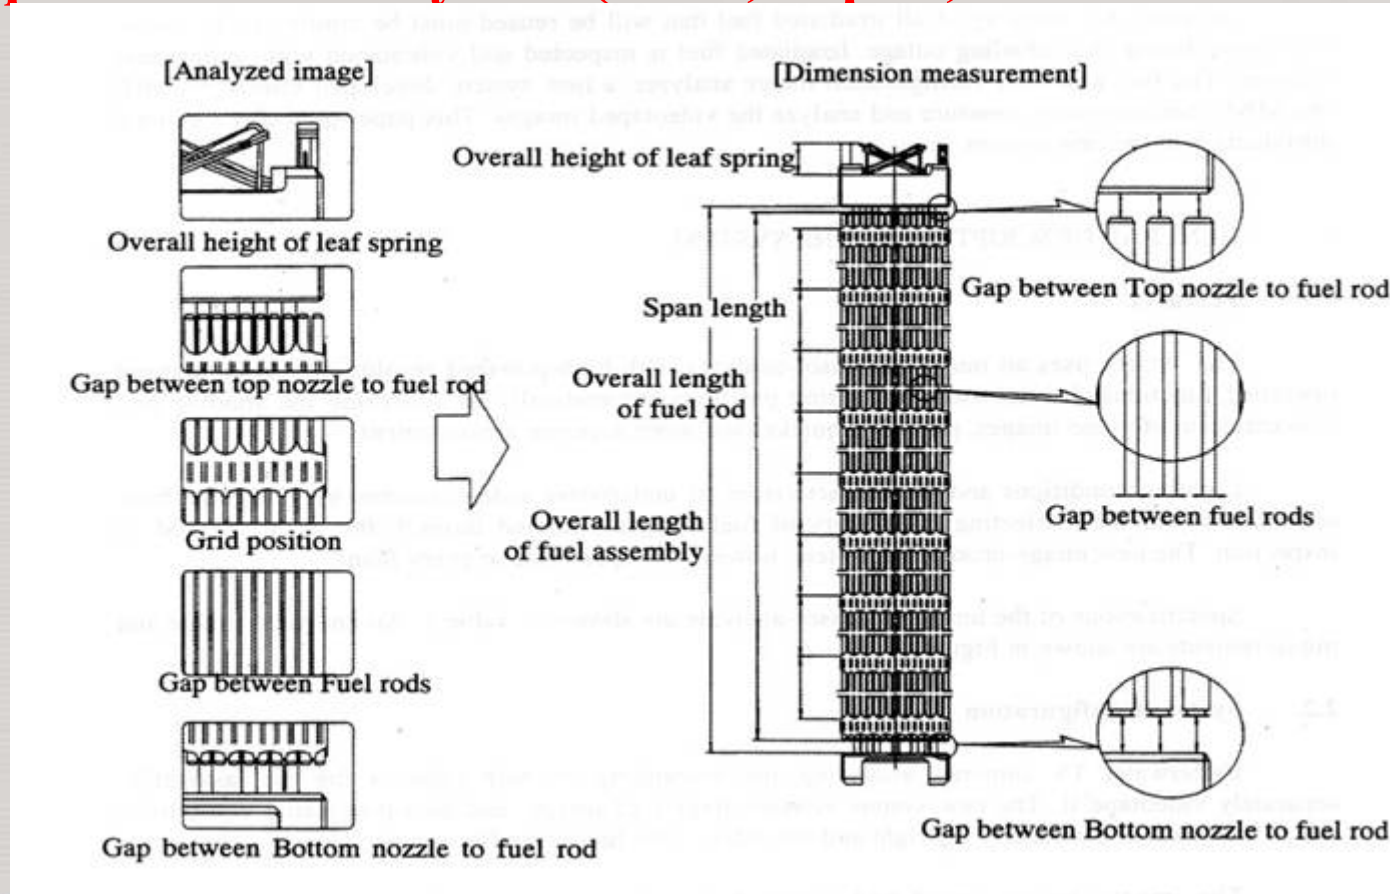
Fuel Assembly Dimensional Measurements (2) – What might be measured using TV cameras and image processors-analyzers (MHI, Japan, TECDOC-1050)

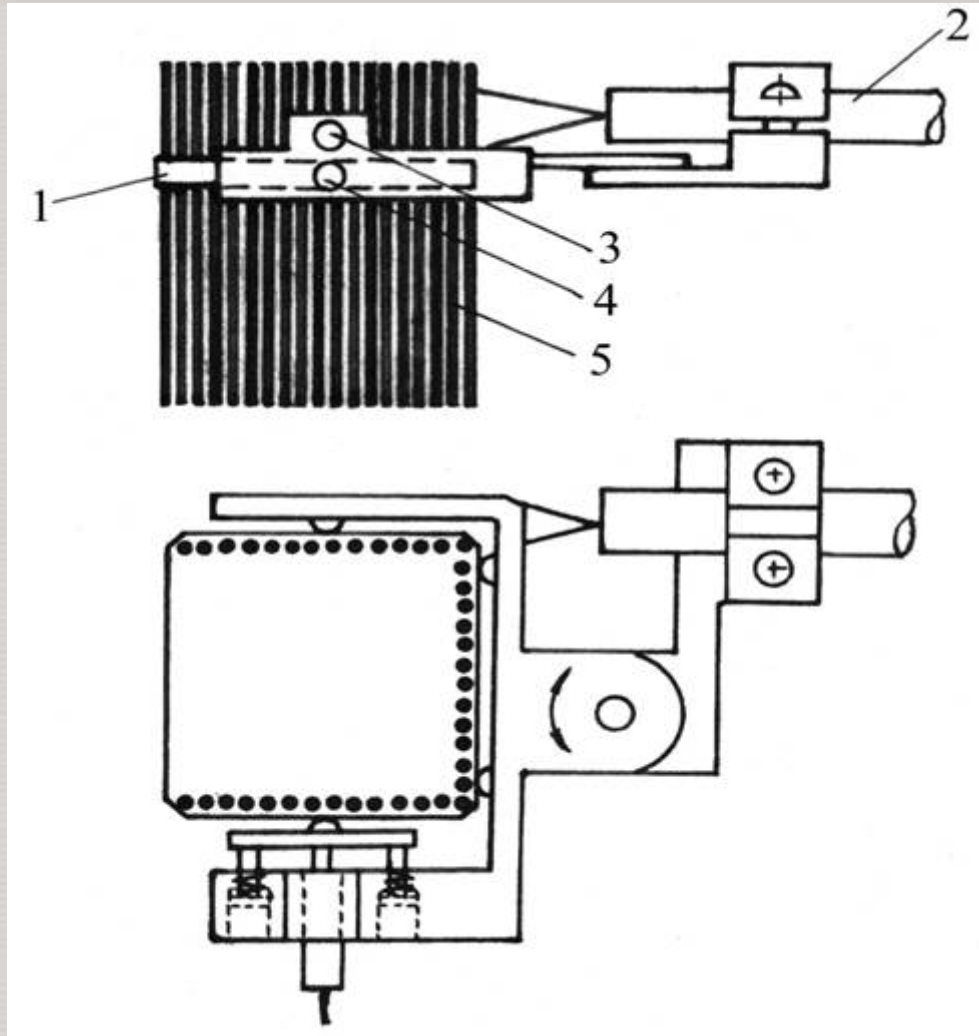
FA Dimensional Measurements (3) – Distance between Spacer Grids (SG) – Siemens-KWU

1-SG; 2-TV camera; 3-LVDT; 4-pneumocylinder; 5-FA

U-form jointer with one detector comes up to the SG and it is pressed to it by pneumocylinder. Device allows to measure distance between SGs with error within ± 0.01 mm.

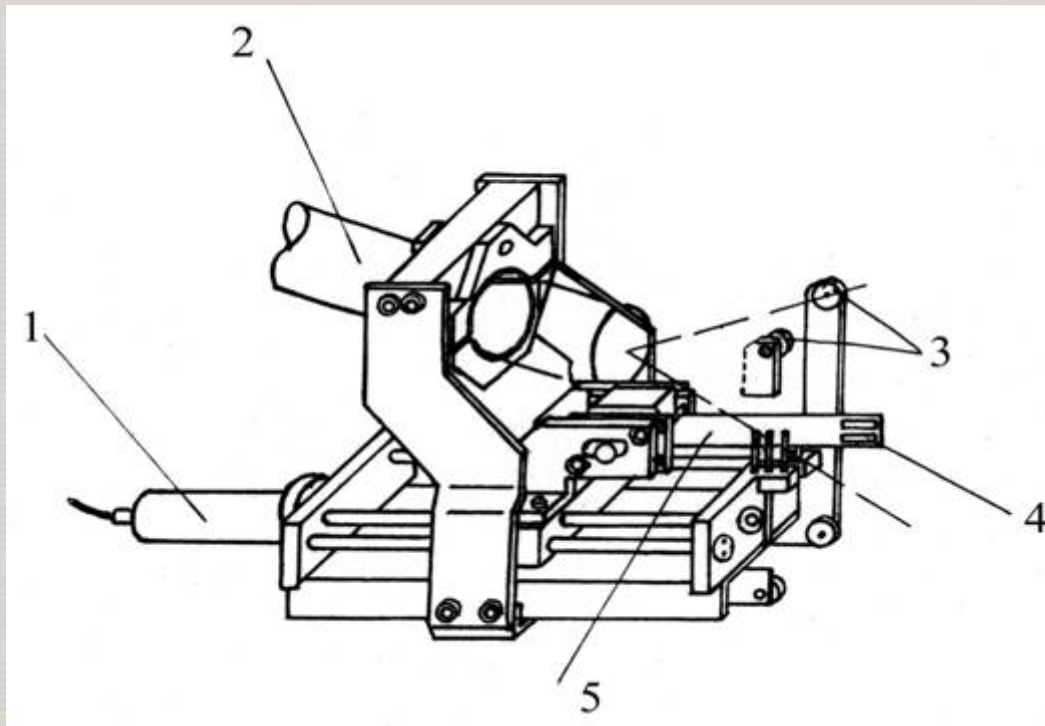
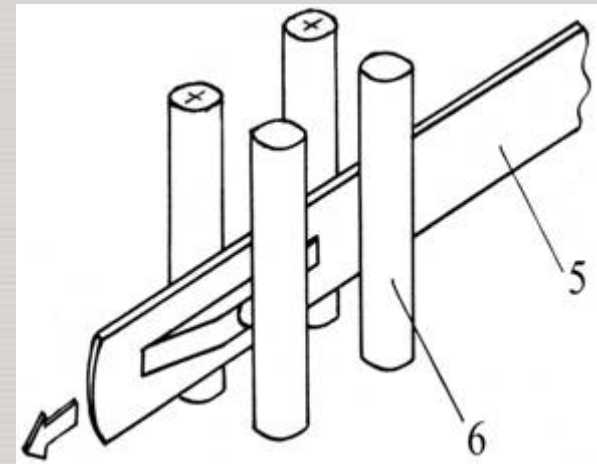
Fuel Assembly Dimensional Measurements (4) – FR's Gap

1-motor; 2-TV camera; 3-guide rollers; plate springs; 5-probe; 6-FR

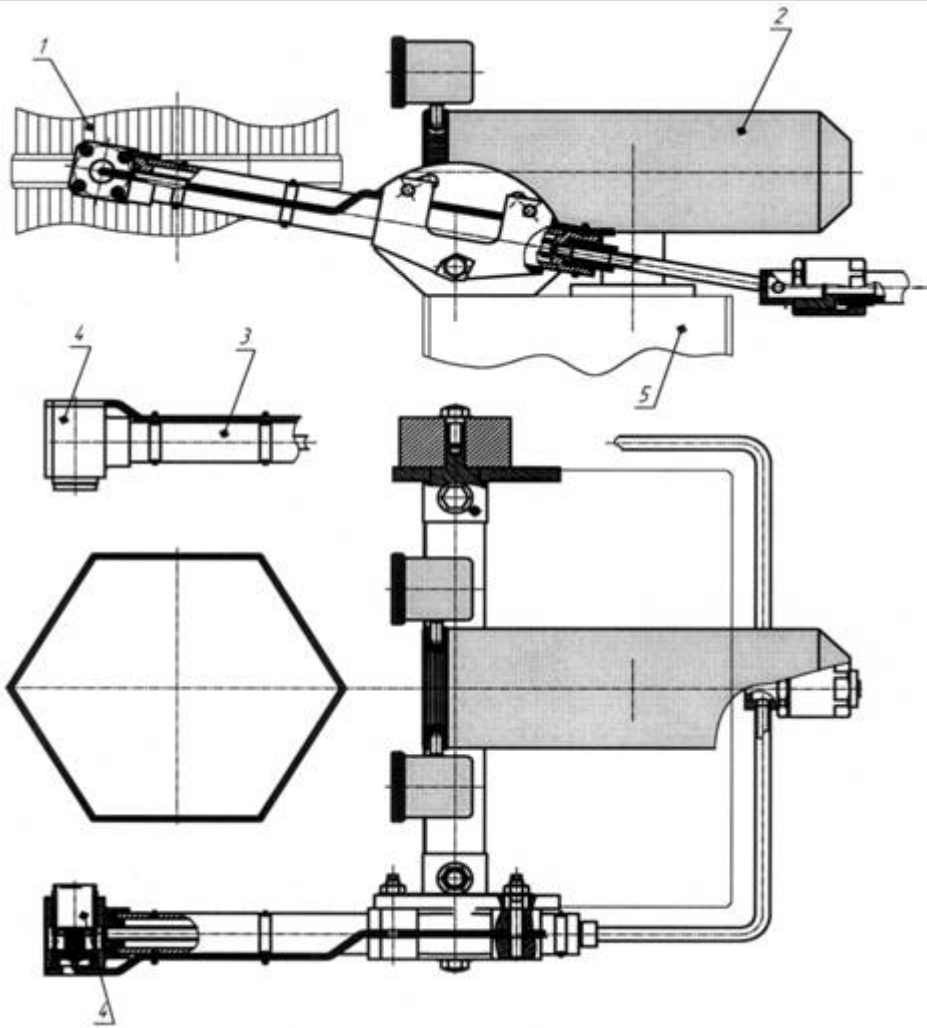
FA Dimensional Measurements (4) – RIAR, Russia

1-FA; 2-TV camera; 3-cramp; 4-ultrasonic detectors; 5-motion table

Device allows to measure FA bowing and twisting, what is necessary in case of S-shape FA bow. Error of the determination of the distance between the detectors and FA surface does not exceed $8 \mu\text{m}$, and twisting angle- 0.03 degrees.

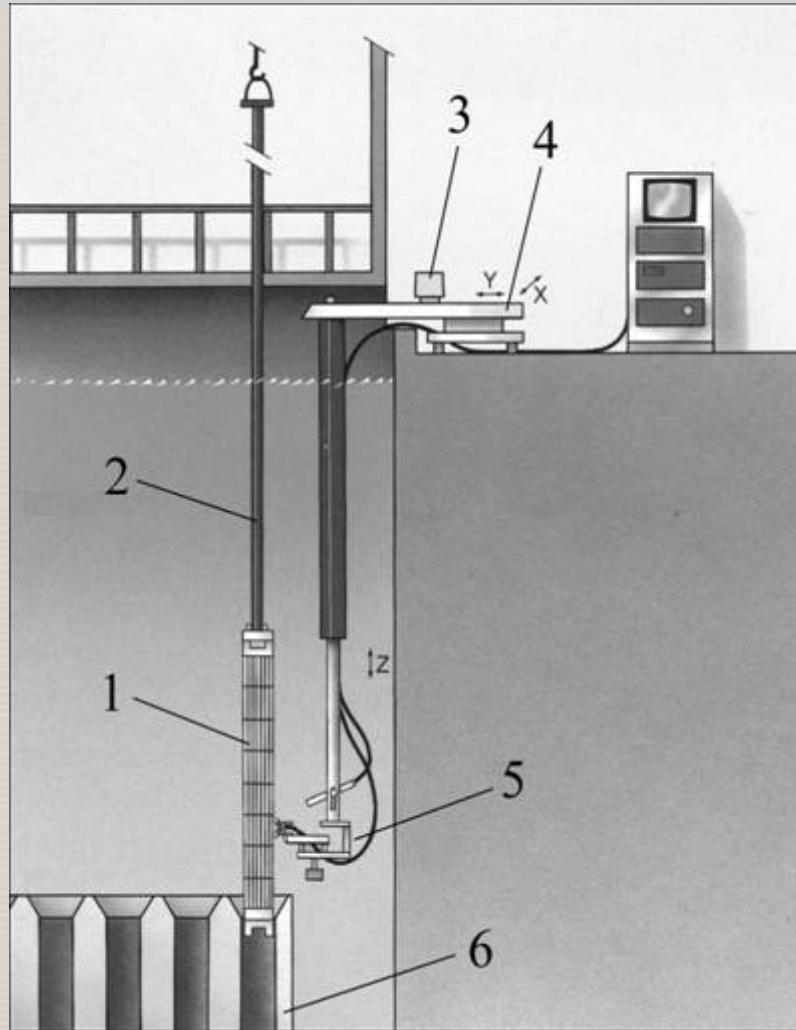
Measurement of Oxide Layer Thickness on FA

1-FA; 2-handling tool; 3-Z-motor; 4-X-Y-table; 5-EC probe

High-frequency electromagnetic field generated by a probe induces EC in the FR sub-surface layer.

Amplitude of these ECs is a function of oxide thickness and causes variation in probe impedance. Measurement channel evaluates this variation and supplies signal proportional to the thickness. Usually EC probe is included brush device.

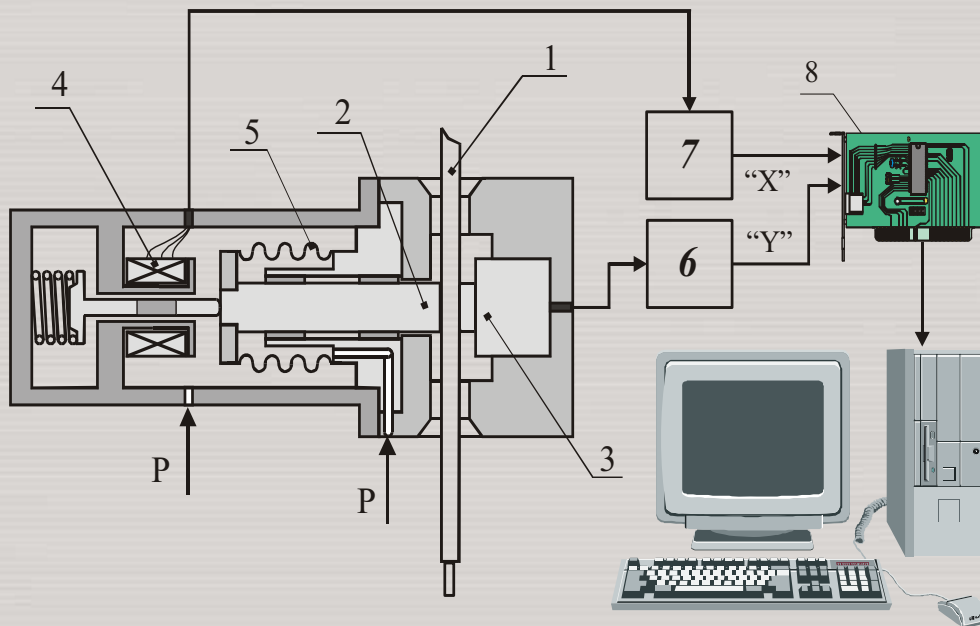
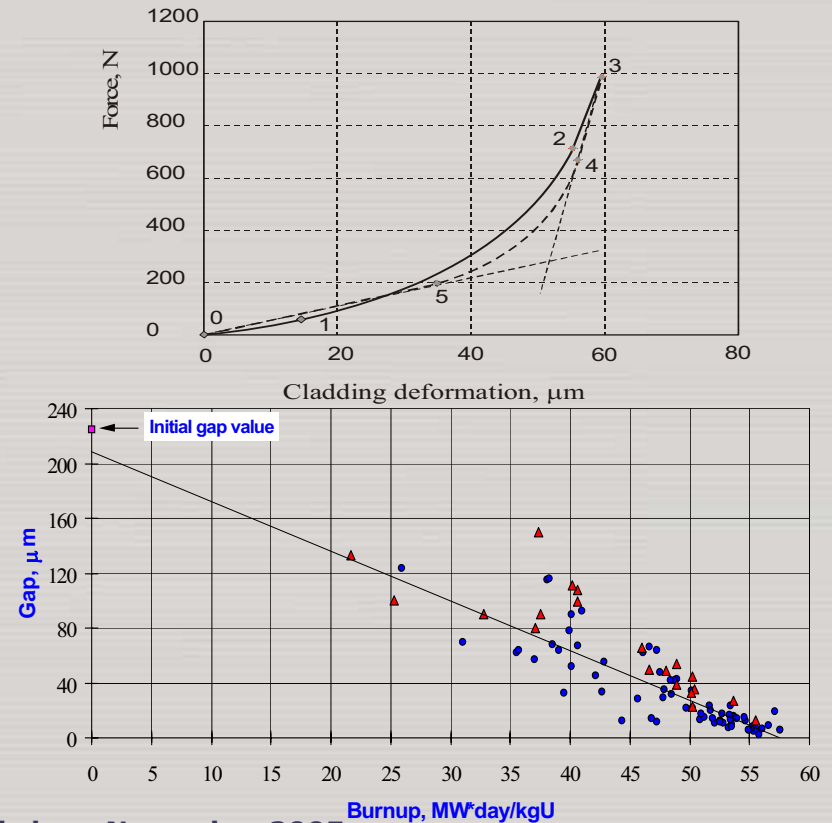
Measurement of Cold Gap on FR –RIAR, Russia

1-FR; 2-loading bar; 3-piezoelectric force transducer ; 4-LVDT; 5-bellows; 6-charge amplifier; 7-normalizing amplifier; 8-analog/digital converter

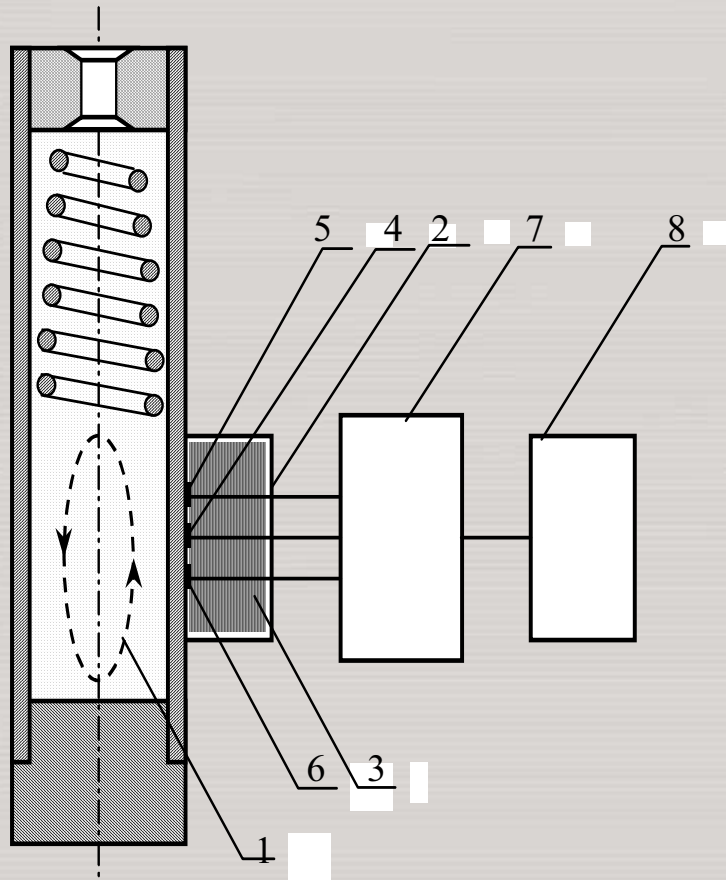
Measurement of FR Internal Gas (He and FPs) Pressure-VNIINM, Russia

1-gas plenum; 2-pressure probe; 3-rubber bed; 4-heater; 5,6-thermoresistors; 7-power/measurement block; 8-PC

Range of gas pressure measurement, MPa-0.1-5.0

Range of He pressure measurement, MPa-0.1-3.0

Error of total pressure measurement, MPa-0.15

Range of FP pressure measurement, MPa-0.1-2.0

Total time of one FR measurement, min-15

Environment-water or air

Data for WWER-1000 FR (3.6% U-235, 34.7 MWd/kgU, 3 years): Free volume-28 cm³; Total gas pressure-2.4 MPa; He-97.81%; Kr-0.22%; Xe-1.84%; N₂-0.11%; O₂-0.02%

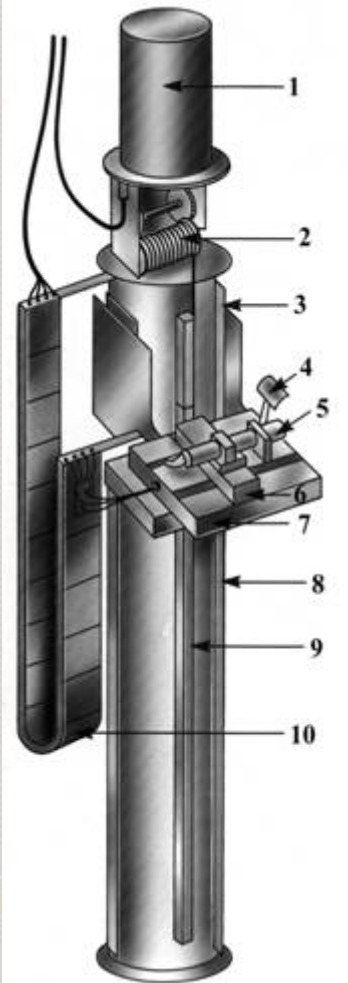
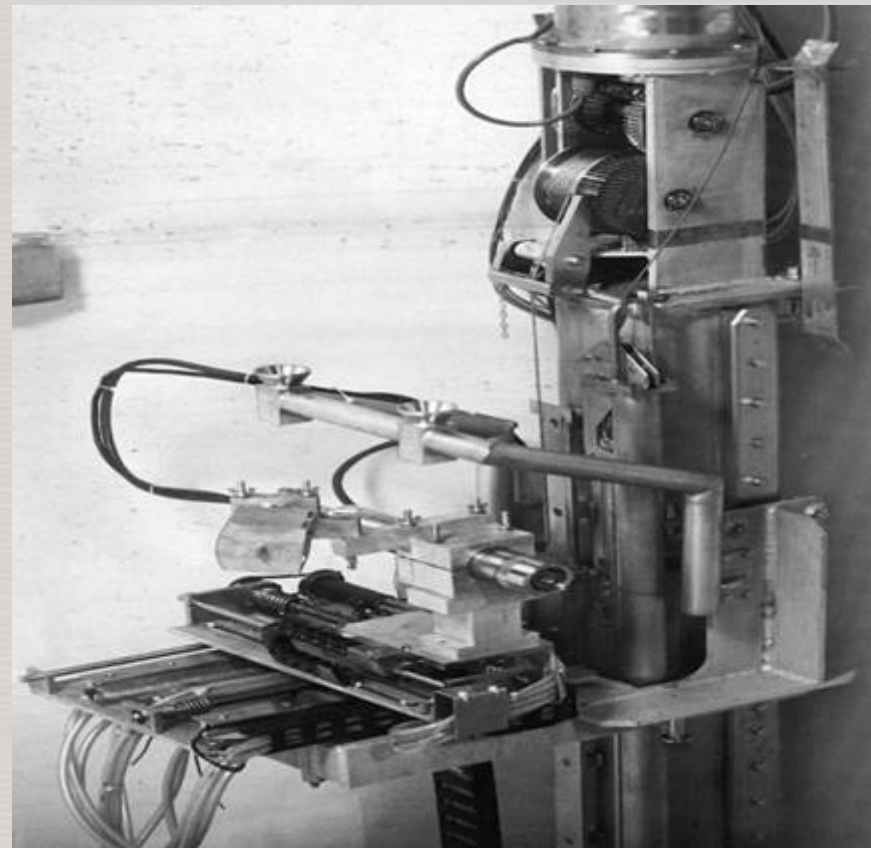
Multi-Site FRAGEMA Examination Stand

1-Z drive unit; 2-Z winch; 3-Z carriage; 4-projector; 5-TV camera; 6-Y carriage; 7-X carriage; 8-Z rails; 9-Z beam; 10-cable chain

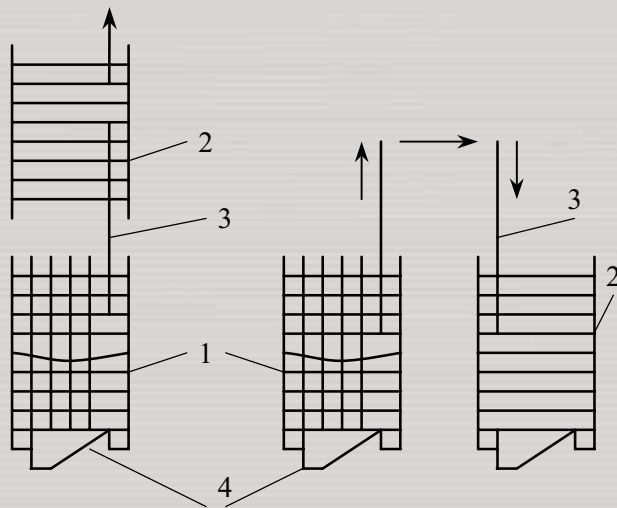
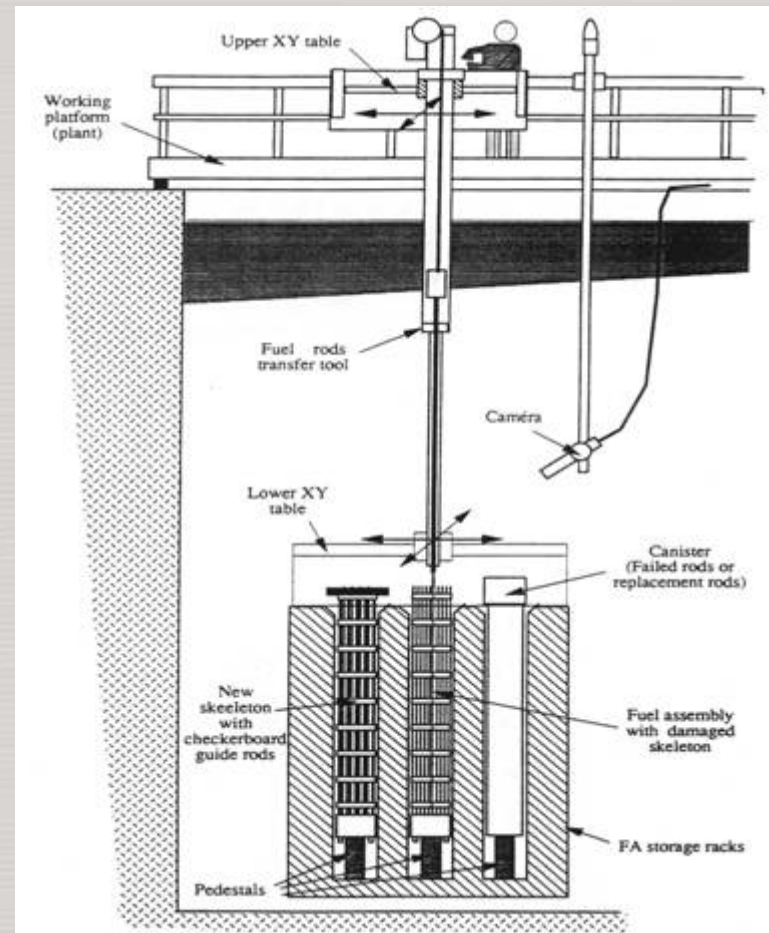
Fuel Assembly Reconstitution

(left-scheme of two methods, right-FRAMATOME stand

1-FA with damaged skeleton;
2-new skeleton; 3-FR, 4-top nozzle

- 1) In case of finding one or more leaky fuel rods in the FA, it might be repaired. **Repair** of FA assumes removal of the leaky rod/rods from the skeleton and insertion of the mock-up (usually Zr bar) or similar good fuel rod. Equipment for removal of separate fuel rods for examination might be used in this case.
- 2) In case of significant damage of the FA skeleton (mainly Spacer Grids), Reconstitution might be carried out. **Reconstitution** assumes removal of intact fuel rods from the skeleton and their insertion into a new skeleton. Special equipment is required for this procedure.
