**Joint ICTP-IAEA Essential Knowledge Workshop on
Deterministic Safety Analysis and Engineering Aspects
Important to Safety**

Assessment of External Hazards

Javier Yllera

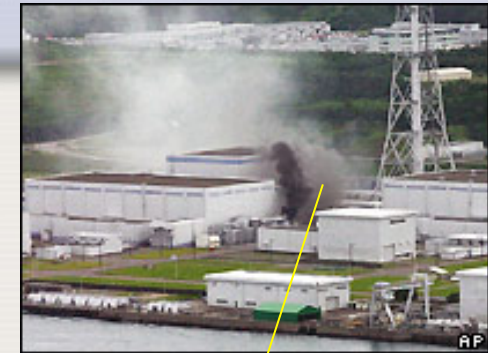
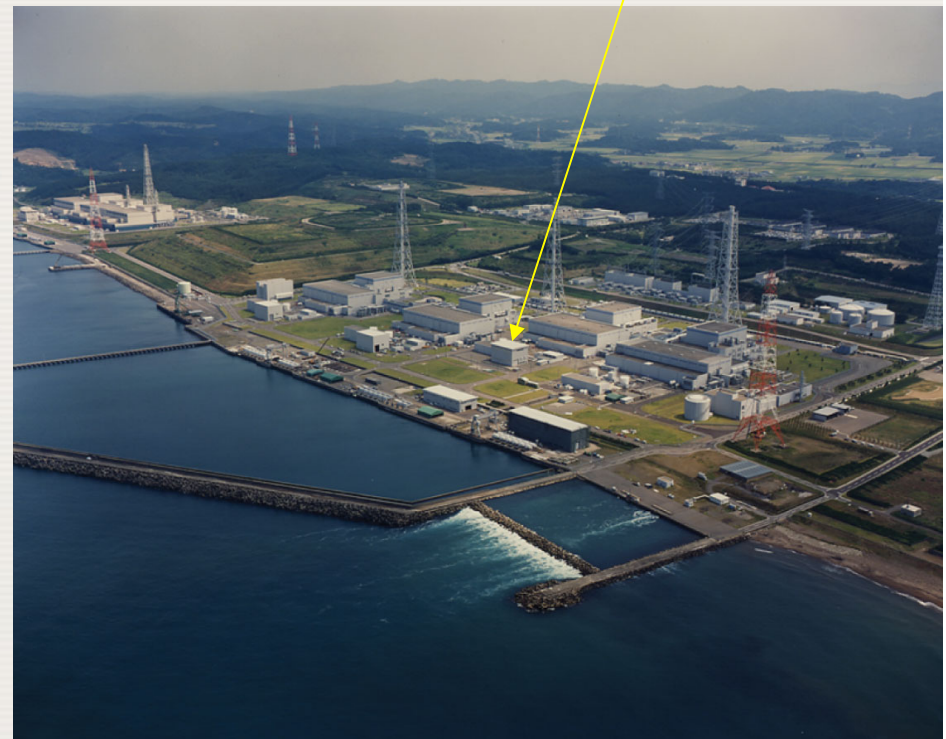
“NIIGATAKEN-CHUETSU OKI” – MAIN SHOCK:

- **Magnitude:** 6.8 I_{JMA} (6.6 Moment Magnitude)
- **Epicentre:** N37.5 , E138.6
- **Time:** 16 July 2007, 10:13(JST), i.e. 10:13 in the morning
National Holiday in Japan, 120 staff in plant (1000).
- **Depth:** 17 km
- **Distance to KK NPP:**
 - **Epicentre:** 16 km
 - **Hypocentre:** 23 km

Total output
8,212 MW
Biggest NPP in the
world

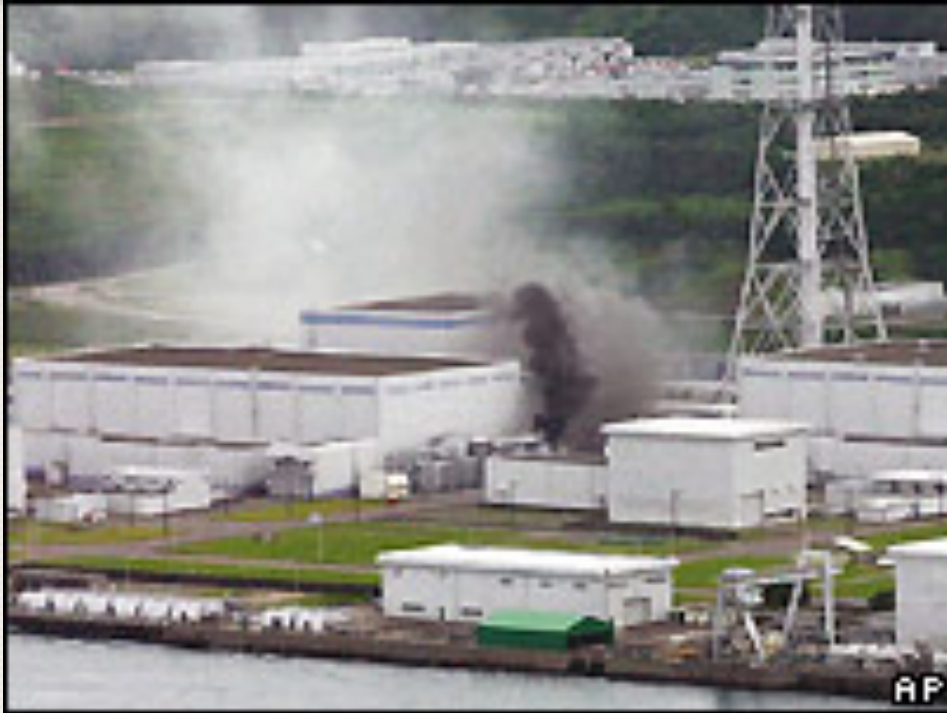
KK NPP: Fire at in-house electrical transformer

The fire was extinguished by an External Fire Brigade:

- Fire started at about 10:15 (smoke detected)
- Fire fighting: started at 11:30 (~75 min later)
- Fire extinguished at 12:10 (in ~40 min)

- **Seismically induced fires** are frequent events after an earthquake in urbanized areas.
- Experience from the Niigataken Chuetsu-Oki earthquake event in KK NPP, shows that seismically induced fires should be considered during the design of fire protection systems at nuclear power plants. Soil failures.
- The fire protection program should provide for reasonable fire fighting capacity to cope with this common cause, especially for multi-unit plants.
- All this experience and lessons are being reflected in the revision of current regulations in Japan as presented to the mission.
- A fire brigade is now at the site.

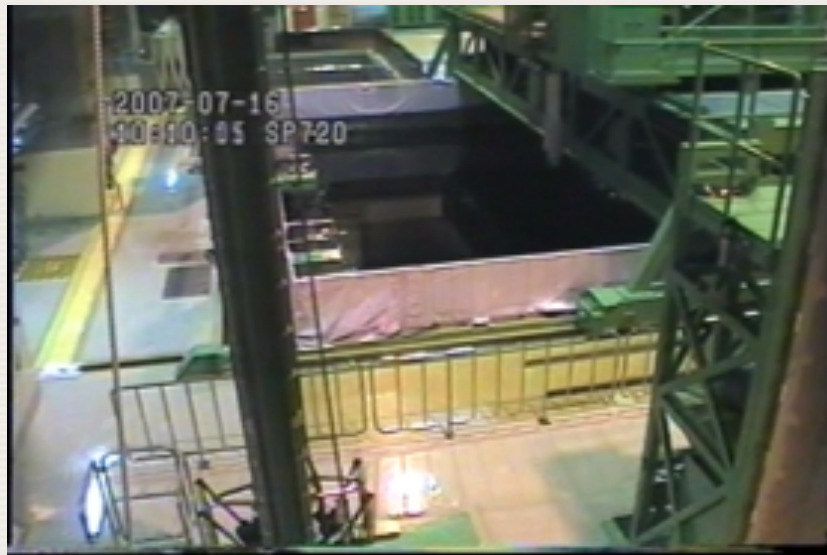
Normal Condition

Flooding of Spent Fuel Pool in Unit 3

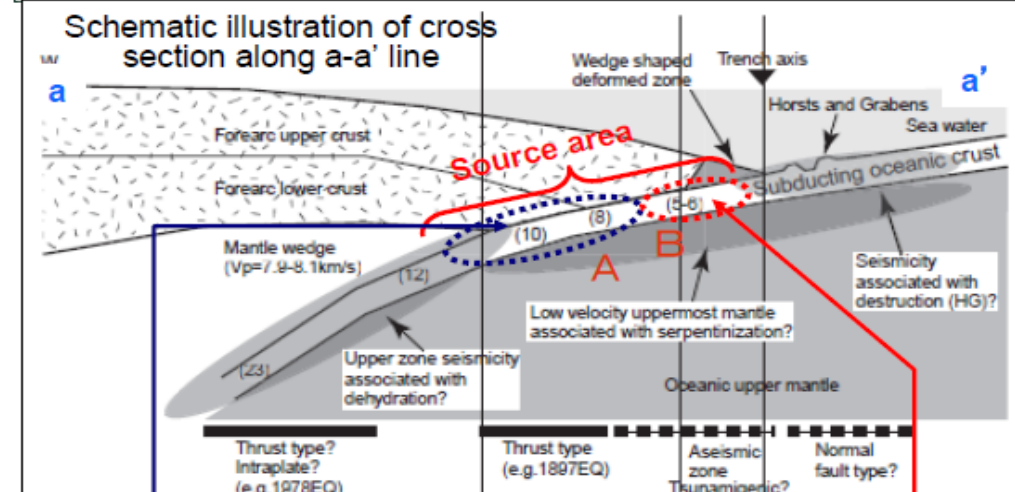
■ The source area & the multi-segment rupture

- The hypocenter was located in the **Off Miyagi** area. It is inferred that a multi-segment rupture started from the hypocenter, then propagated to the north (the sea area off Iwate Pref.), and to the south (the sea area off Fukushima Pref. and Ibaraki Pref.).
- Rupture around the hypocenter: this quake ruptured the shallow portion along Japan trench, close to the source area of the **scenario earthquakes A and B**.
- **Multi-segment rupture**: rupture propagated to the deep part (A) as well as the shallow part east to B. (The lower figure plots a cross-sectional view of the source area)
- **Large slip** was estimated to occur in the **shallow part** along Japan trench from the water area off the Northern Sanriku to the area off the Boso, with the largest value above 20m.

Deep portion of interplate: smaller slip than that at shallower portion and generating strong motion due to near land

Shallow portion of interplate: Large and slow slip and generating great tsunami

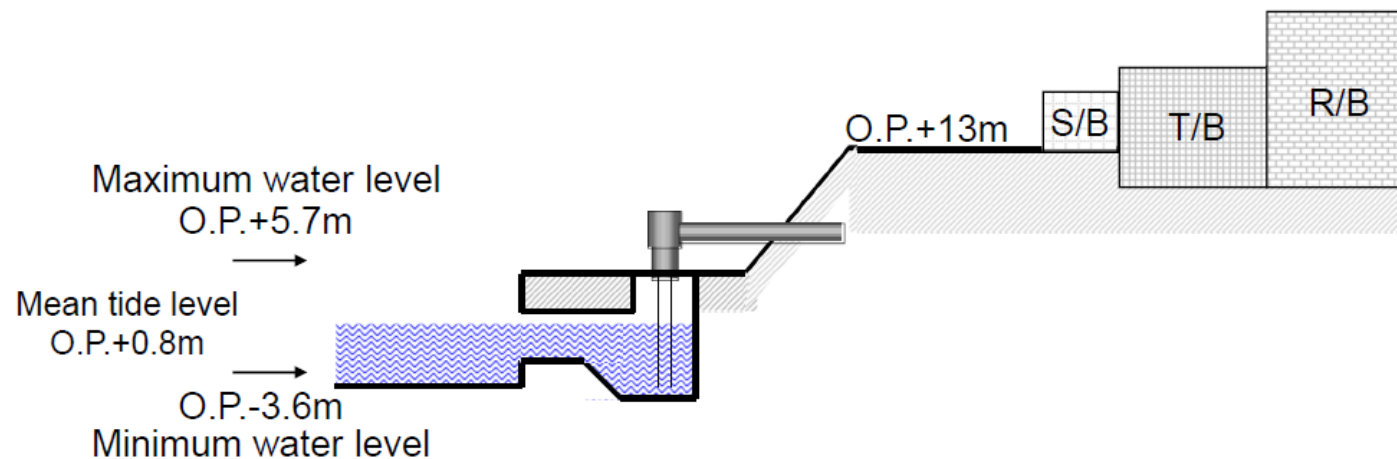
Estimated Tsunami Height at Back check

Summary of Evaluation

Maximum water level = $4.4 + \text{O.P.} + 1.3 = \text{O.P.} + 5.7\text{m}$

Minimum water level = $-3.6 - \text{O.P.} = \text{O.P.} - 3.6\text{m}$

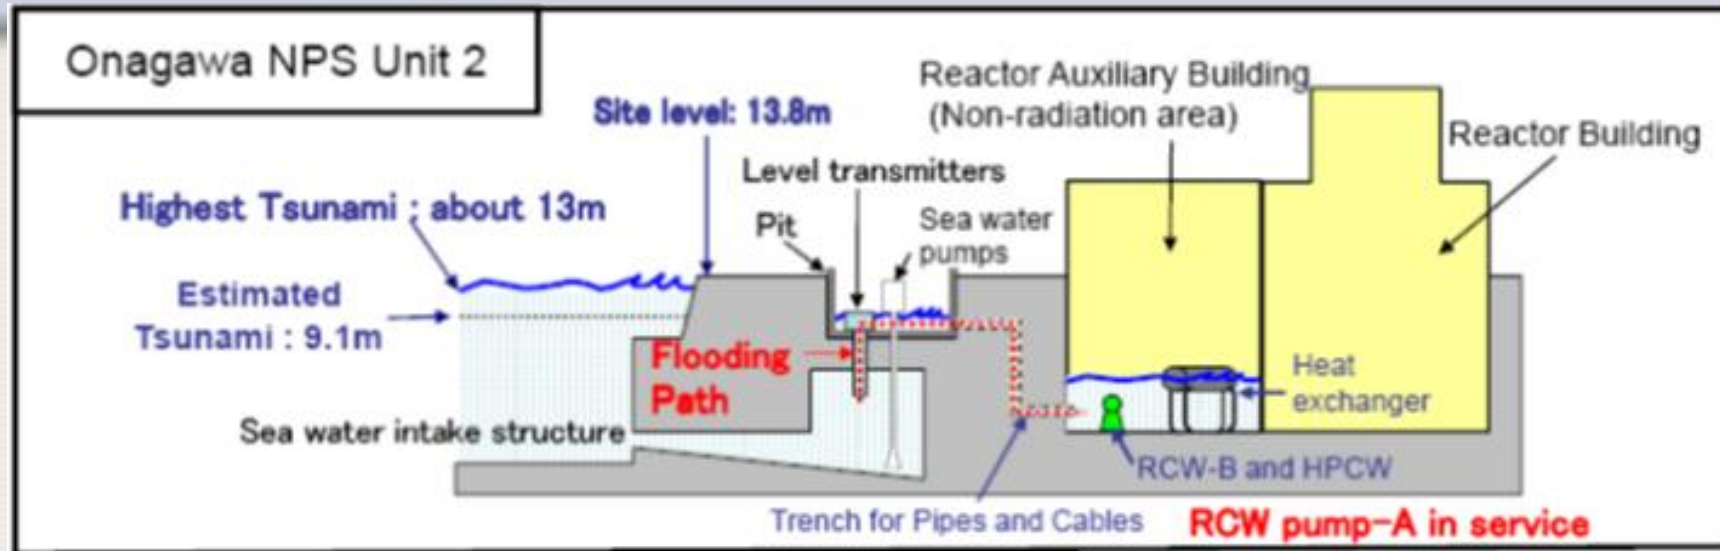
Broken Sea water level transmitter box

LESSONS LEARNED - TSUNAMI
