**The Abdus Salam
International Centre for Theoretical Physics**

**Advanced School on Non-linear Dynamics and Earthquake
Prediction**

Crusader castle torn apart by earthquake at dawn, 20 May 1202

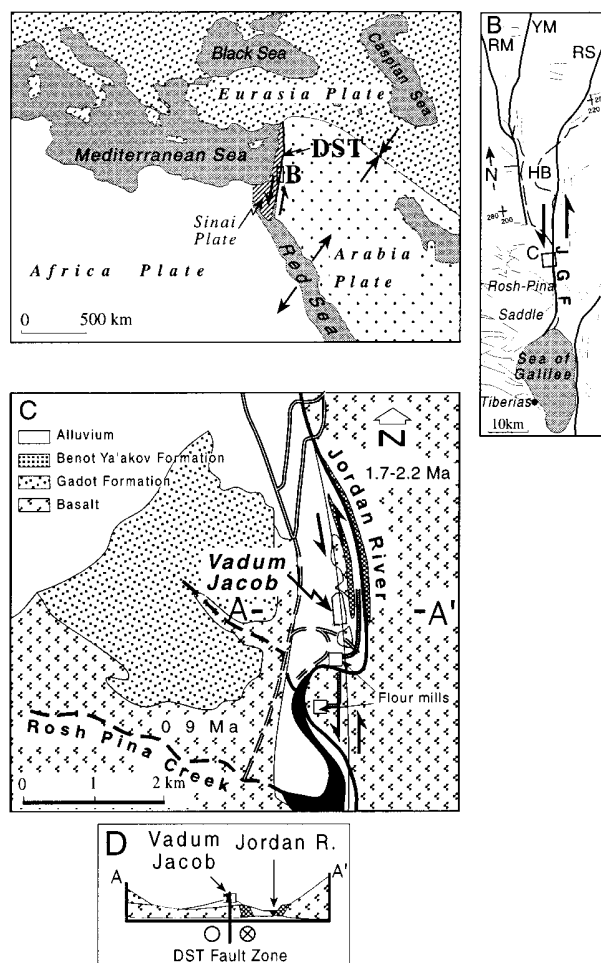
Figure 1. Location maps: A. Tectonic plates of Middle East. Dead Sea Transform (DST) is boundary between Sinai and Arabia plates. B. Dead Sea Transform zone showing main faults (solid lines) and secondary, mostly normal, faults (slim lines). JGF—Jordan Gorge Fault, RM—Roum Fault, YM—Yammuneh Fault, RS—Rashaya Fault, HB—Hula Basin (after Bartov, 1990). C. Geologic map of Vadum Jacob area showing Pliocene to Pleistocene basalt flows with K-Ar ages (Goren-Inbar and Belitzky, 1989; Heimann and Ron, 1993), Quaternary lacustrine sediments of Gadot and Benot Ya'akov Formations, and Holocene alluvium (partly after Belitzky, 1987). D. East-west section across Vadum Jacob showing a fault through fortress. Circles indicate out-of-plane motion: empty circle—toward, crossed circle—away.

The castle of Vadum Jacob (Jacob's Ford) was strategically established on a hill overlooking a ford on the Jordan River (Fig. 1B). It was one of the largest castles in the Latin Kingdom of Jerusalem, spanning about 150 m by 50 m (Fig. 2A). Detailed historical records allow the history of Vadum Jacob to be dated with unusual precision: According to independent Latin sources (e.g., Ernoul, 1871; William-of-Tyre), Muslim chroniclers (Abu-Shama; Ibn-al-Athir; 'Imad al-Din; al-Isfahani), and others (Lyons and Jackson, 1982, p. 140–141), the foundation stone of the castle was laid in October 1178; the partially constructed castle was besieged and destroyed 11 months later, on 30 August 1179. The castle is surrounded by a 4-m-thick wall composed of a parallel pair of meticulously laid ashlar supports, enclosing an ~3 m fill of cemented basaltic cobbles. These walls, built by highly skilled Crusader masons, were erected with great precision along smooth, straight lines. Thus, they serve as excellent strain gauges for deformation after 1179.

The Dead Sea Transform accommodates sinistral motion between the Arabia and Sinai tectonic plates, transferring extension in the Red Sea to the Arabia-Eurasia collision zone (Fig. 1A). South of the Sea of Galilee, the Dead Sea Transform offsets a variety of pre-Miocene geologic features by 105 km (Freund et al., 1968; Garfunkel, 1981; Quennell, 1956). Between the Sea of Galilee and the Hula pull-apart basin to the north is the Rosh-Pina Saddle, a structural and topographic high. North of the Hula, the displacement is distributed among the Roum, Rashaya, and Yammuneh faults (Fig. 1B); the latter links the Dead Sea Transform to the collision zone. Where the Jordan River crosses the Rosh-Pina Saddle it forms a narrow gorge. Exposures of fault planes of the main trace of the Dead Sea Transform along the Jordan Gorge have not been reported, but the termination of rock units and the different geometry of secondary faults on both sides, along with morphologic indicators, suggest that the main transform fault here follows the gorge (Garfunkel et al., 1981; Harash and Bar, 1988; Heimann and Ron, 1993). A seismic reflection survey showed that the fault zone has a flower structure with the main active fault coinciding with the Jordan Gorge (Rotstein and Bartov, 1989).

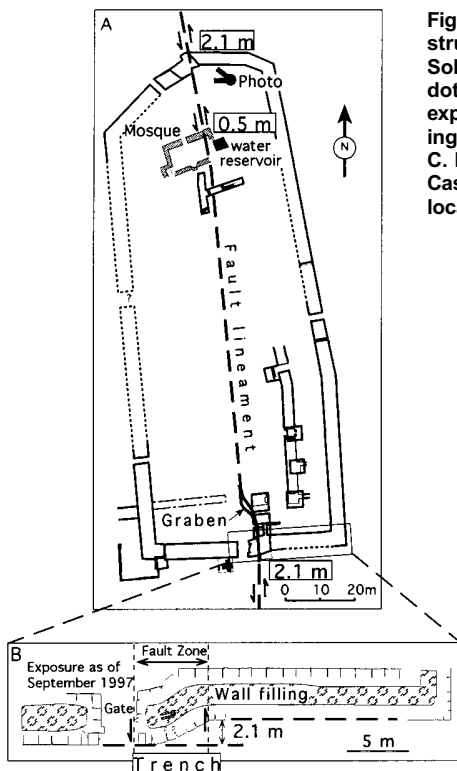
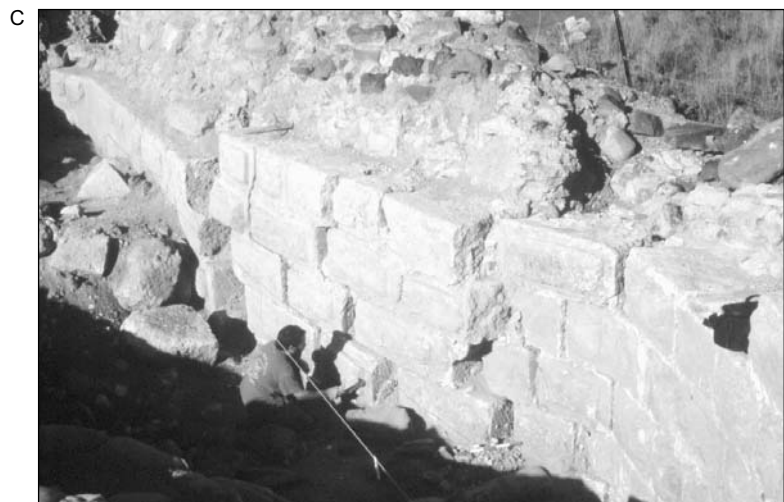
Figure 2. Location of offset human-made linear structures. A. Plan of Vadum Jacob fortress. Solid lines mark well-exposed parts of walls; dotted lines denote unexposed or partly exposed walls. B. Map of southern wall showing displacements and rotations of masonry. C. Photo of deformation in northern wall of Castle of Vadum Jacob. Line marks pre-faulting location of wall.

We discovered offset archaeological remains at four excavated locations within the castle (Fig. 2). Three of these locations are Crusader structures and the fourth is a late medieval-early modern Muslim structure. The offset, fully expressed in the southern and northern defense walls, reaches 2.1 m in sinistral displacement with <5 cm of vertical slip (Marco et al., 1997). The 50-m-long walls crossing the hill are ideal baselines, having meticulously laid masonry and a fault-perpendicular (east-west) orientation. The displacement measured on the walls records the cumulative slip on the fault since 1179, the year the castle was conquered by Saladin. Displacement is distributed over about a 10-m-wide zone, and the deformation is accommodated primarily by small offsets and rotations of the carved limestone blocks. All the displacements on the southern wall are purely horizontal (all the blocks retain their original level), and all the rotations are about vertical axes. A minor vertical component of slip, up to 10 cm, is observed in the northern wall. North of the southern main gate, the fault trace bends westward and a Crusader floor is torn, forming a 2-m-wide graben (Fig. 2A). The geometry of the graben is compatible with a small left bend in the trace of the fault.

In the northern part of the castle, we also unearthed a Muslim mosque whose northern wall is displaced sinistrally by 0.5 m. A mihrab (the Muslim praying apse) is well preserved in the southern wall. According to the study of the pottery, the mosque was built, destroyed, and rebuilt at least twice: the initial structure was built in the Muslim period (12th century) and later rebuilt once or twice during the Turkish Ottoman period (1517–1917). The 0.5 m displacement is observed in the northern wall of the latest building phase. The repetitive building of this site might be due to earthquakes.

In order to date the slip events at Vadum Jacob, we excavated a trench adjacent to the offset southern wall of the fortress (Fig. 2). Sediments ex-

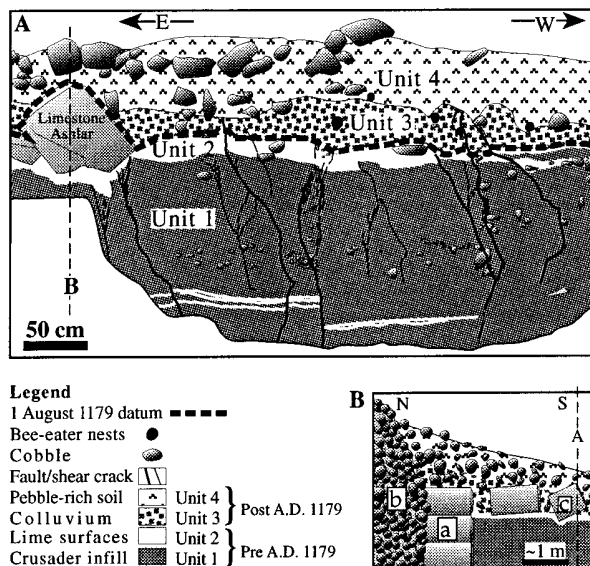
Figure 3. A. Log of a trench wall, parallel southern face of castle. Unit 1, composed of pressed alluvium, and unit 2, a lime pavement, were laid by Crusader masons as wall was built and were used as ramp for hauling heavy building blocks. Unit 2 was at surface on day of Muslim conquest and provides a horizon precisely dated as 30 August 1179 (bold dashed line). Unit 3 started to accumulate after conquest of castle. Degradation of wall infill is apparent in abundance of basaltic cobbles. Masoned limestone ashlar on left were fallen or tumbled there by Muslims who destroyed castle in 1179. Unit 4 is cobble-rich A-soil in which pedogenic processes are intense. Two sets of faults (thick lines) and shear cracks (thin lines) are evident: One terminates at top of unit 2 or lowermost few centimeters of unit 3; second crosses unit 3 entirely. Active bioturbation in unit 4 hinders preservation of cracks. B. Schematic north-south section in southern wall of castle: (a) exterior wall support; (b) wall infill of cemented, mainly basaltic, cobbles; (c) masoned limestone blocks that fell from exterior wall.

The trench was excavated into an artificial slope. Sections were made into the slope at several locations, and the pottery was studied and dated. The sediments exposed in the trench compose four primary stratigraphic units (Fig. 3). The lowest, unit 1, is composed of the sediments that were dumped by the builders at the time of castle construction; these bury the first six stone layers of the wall. At two distinct horizons the fill was leveled out and covered with a layer of lime. Unit 2 is the upper limy layer. We found building tools, mason stone blocks, arrowheads, and other remains of the siege immediately on top of the layer indicating that unit 2 was the surface level as of August 1179 and serves as an accurate time marker.

The trench (Fig. 3) exposed a system of faults and cracks that are coincident with the displacement of the Crusader wall. The faults extend to two different stratigraphic levels: One group of faults displaces the alluvium of unit 1 and the limy level of unit 2, but extends only a few centimeters into post-1179 unit 3; the second group of faults breaks much higher into the colluvial wedge, up to the base of the modern soil horizon, and possibly to the surface. These observations suggest that at least two earthquakes produced the 2.1 m offset of the southern wall that is now observed. One event occurred soon after the outer ashlar wall was removed, i.e., very soon after 1179. The second post-1179 earthquake also produced rupture at Vadum Jacob, but well after removal of the wall and the accumulation of the colluvium, probably much closer to the present.

The A.D. 1202 earthquake occurred fewer than 23 years after the capture of the castle and is almost certainly the source of the first set of interpreted ruptures breaking the lowermost part of unit 3. The later rupture(s) may be associated with the 1759 and/or the 1837 earthquakes. We adopt Ambraseys and Karcz’s (1992) view that
