**Advanced Conference on Seismic Risk Mitigation and Sustainable  
Development**

**EARTHQUAKE ENGINEERING LESSONS FROM STRONG EARTHQUAKES  
RELATED TO ADVANCED WAYS FOR SEISMIC RISK MITIGATIONS**

G. Rodolfo Saragoni  
*Universidad de Chile  
Santiago  
Chile*

# *THE 2010 CHILE, $M_w=8.8$ EARTHQUAKE*

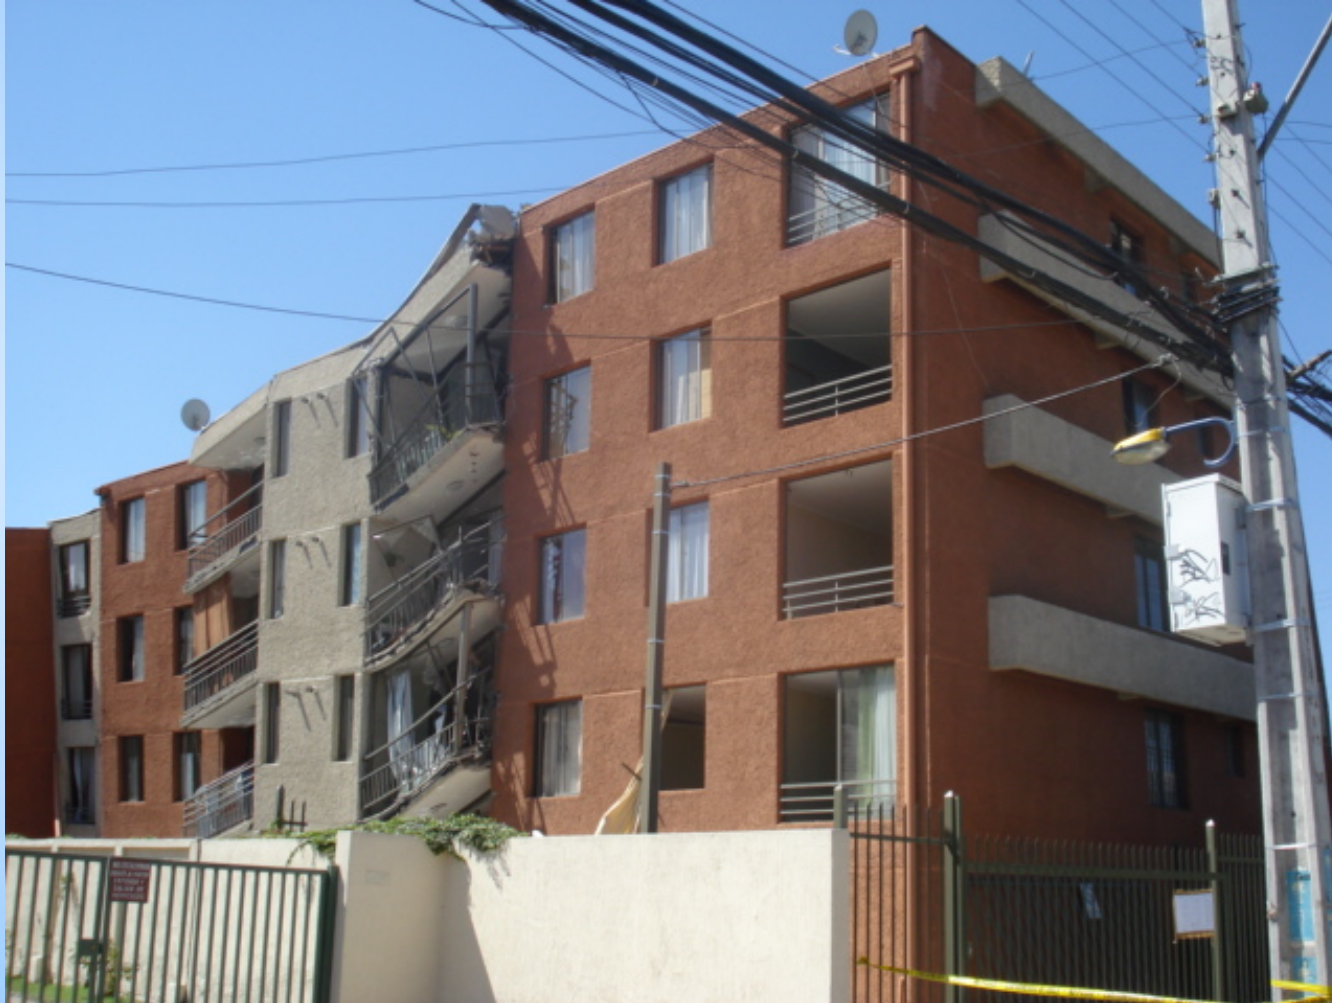
- THREE BUILDINGS COLLAPSED:  
ONE IN CONCEPCION  
TWO IN SANTIAGO

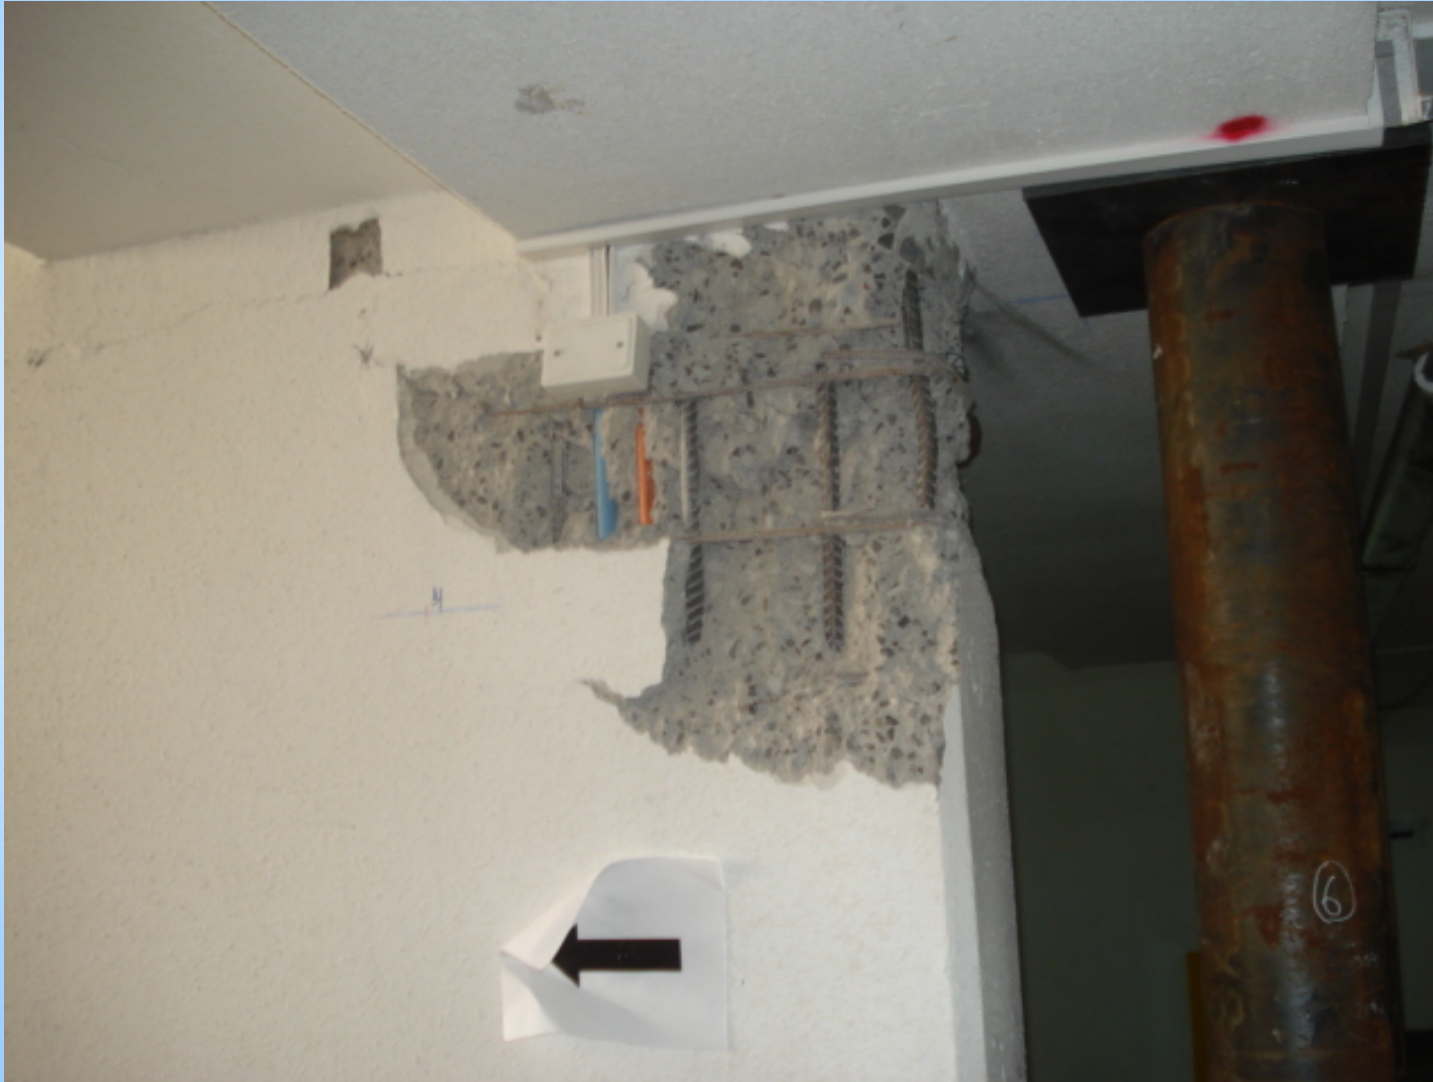
**CABEZAL DE MURO FALLADO INCEPIENTEMENTE:  
CON FALLA HORIZONTAL INCIPIENTE, MOSTRANDO GRIETA  
HORIZONTAL ,DESCASCARAMIENTO EN EL CABEZAL Y PANDEO  
DE BARRAS VERTICALES (EDIFICIO DECLARADO INHABITABLE)**

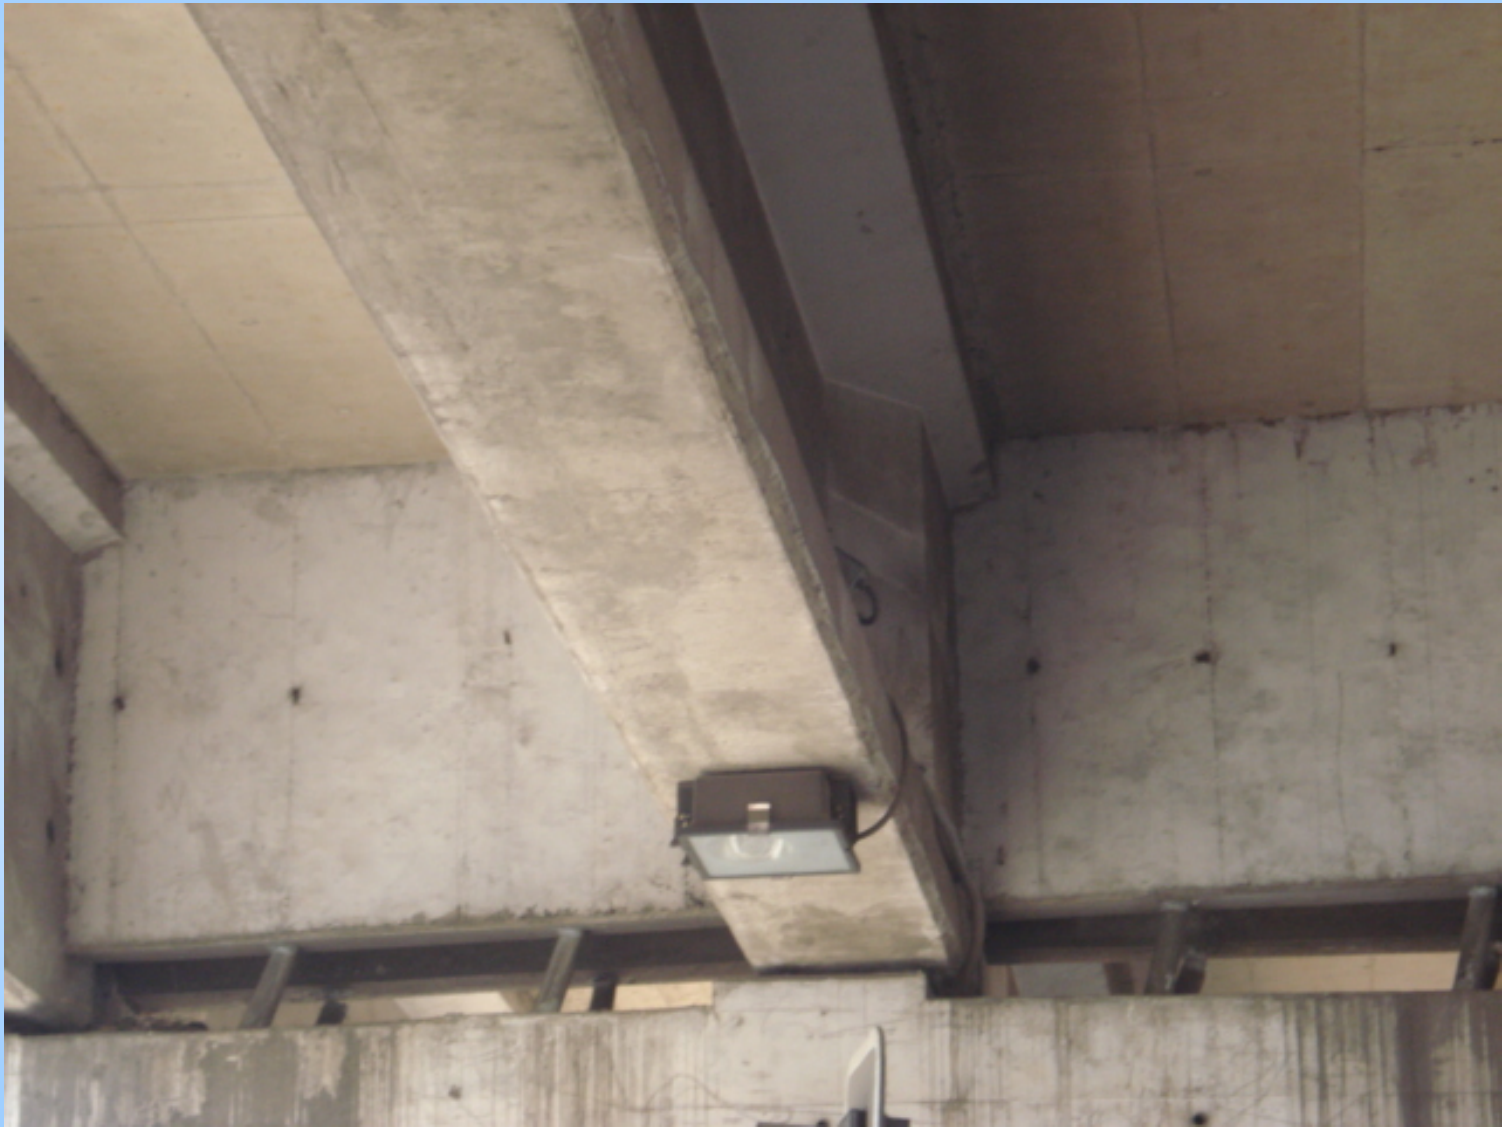
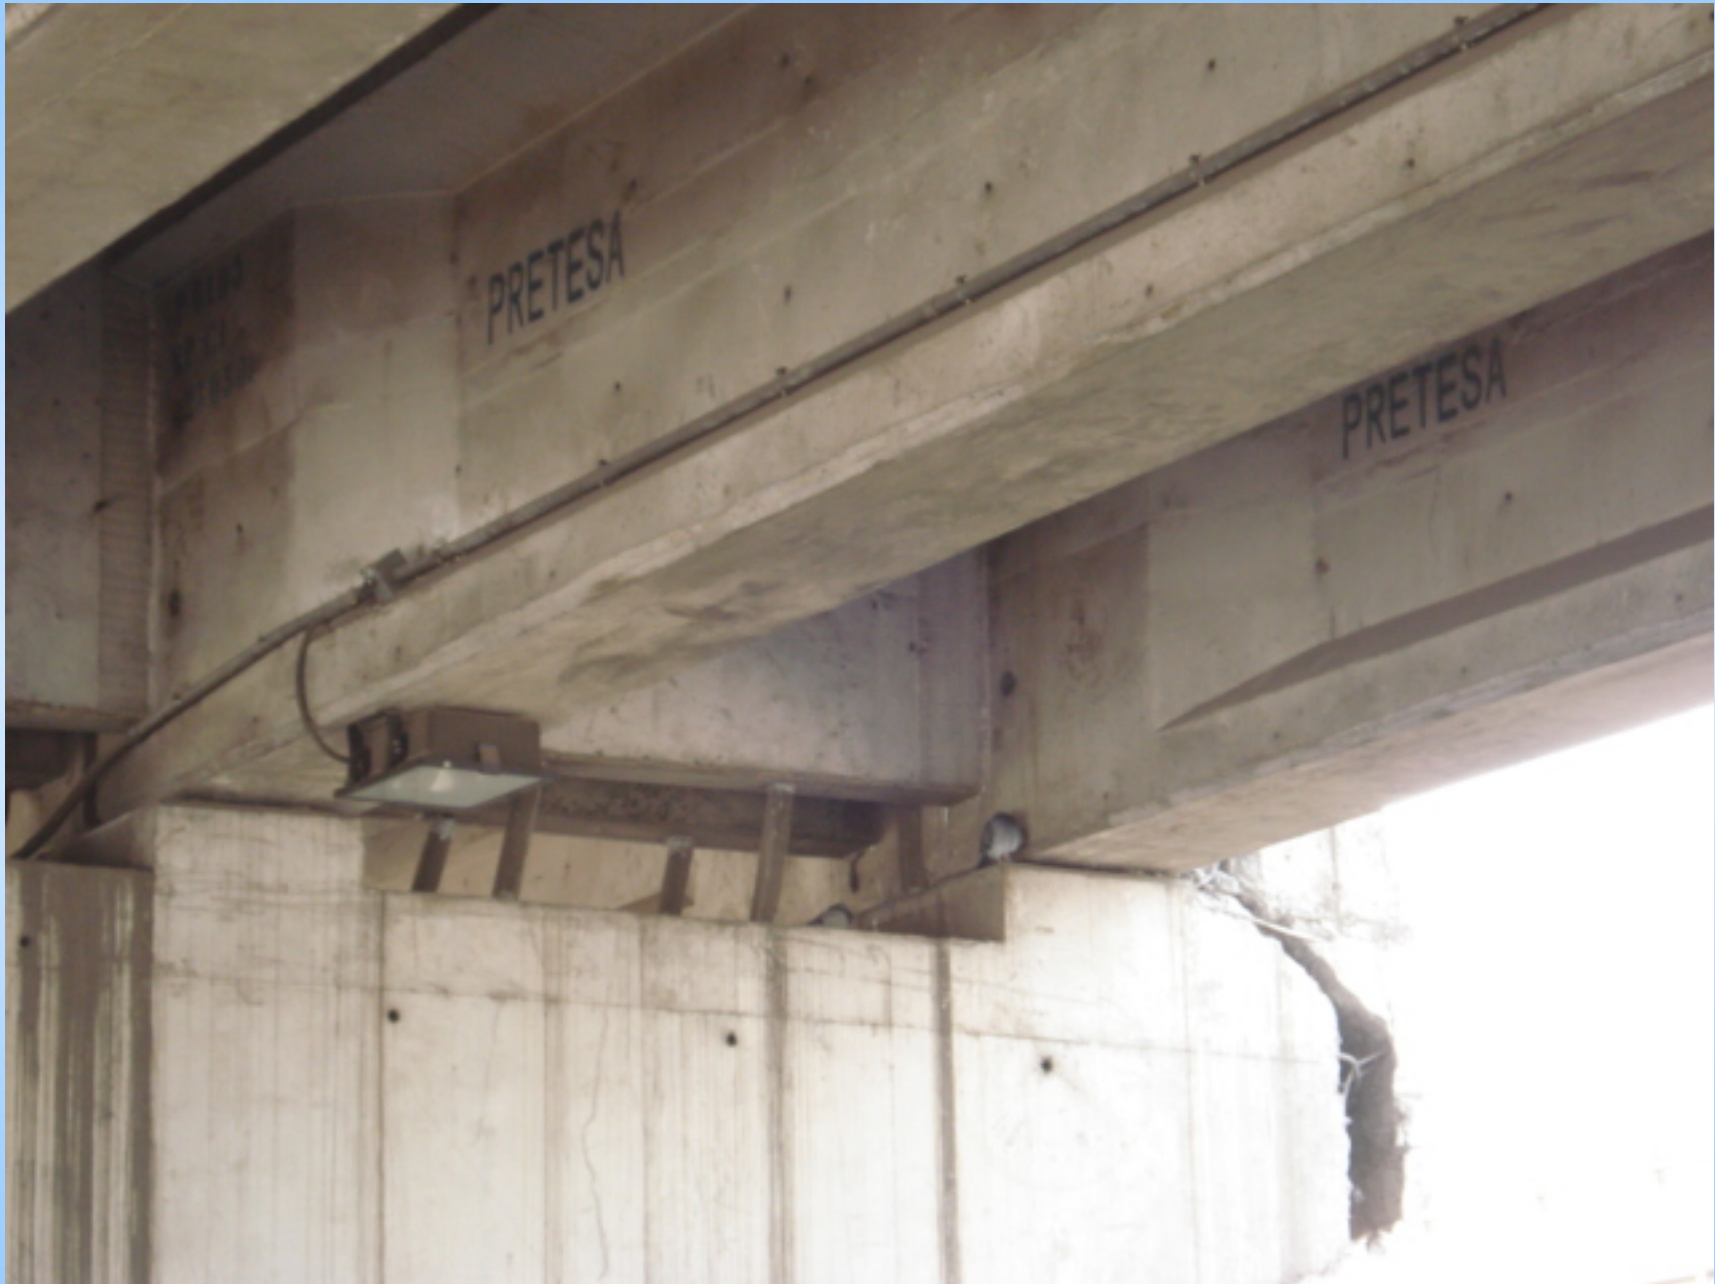
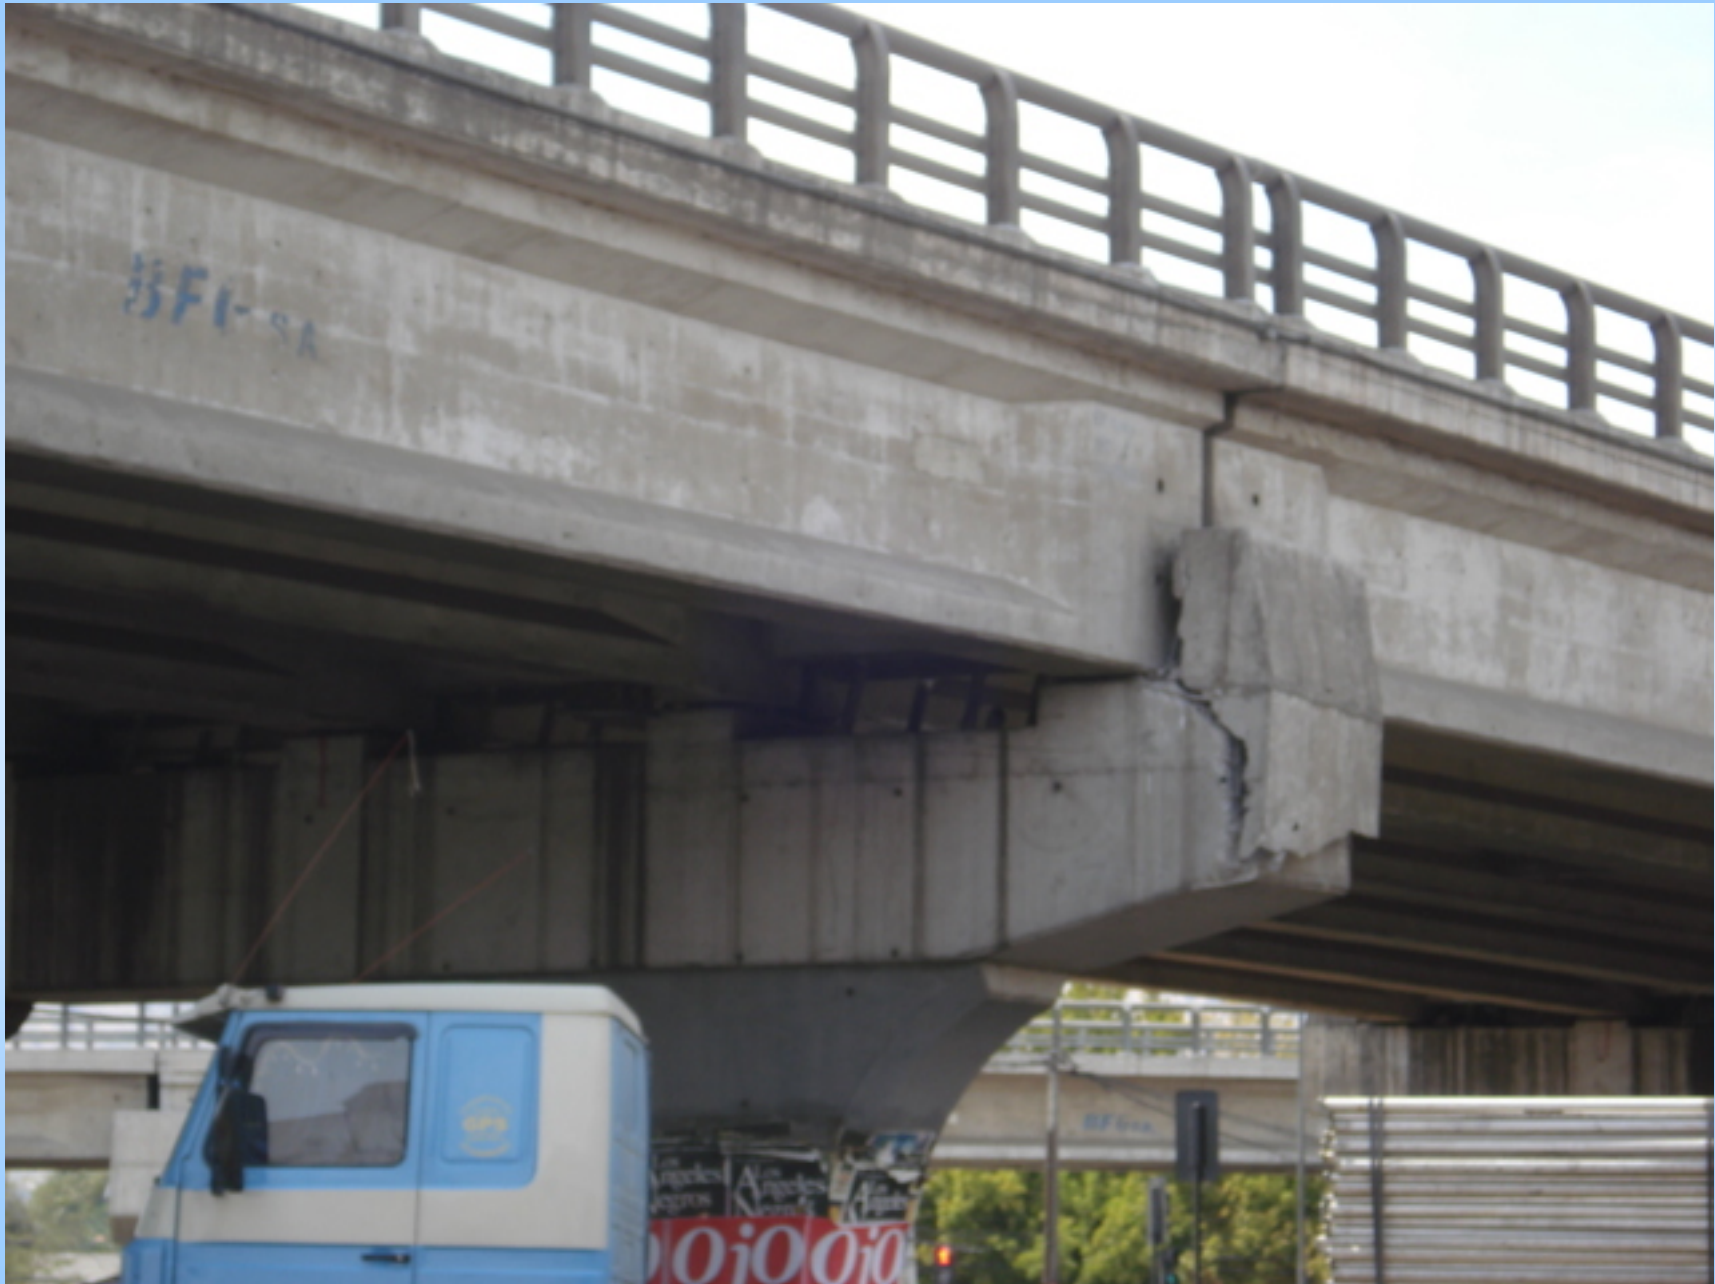
- MOST OF THE BRIDGES DESIGNED ACCORDING TO CHILEAN CODE FOR BRIDGES PERFORMED WELL

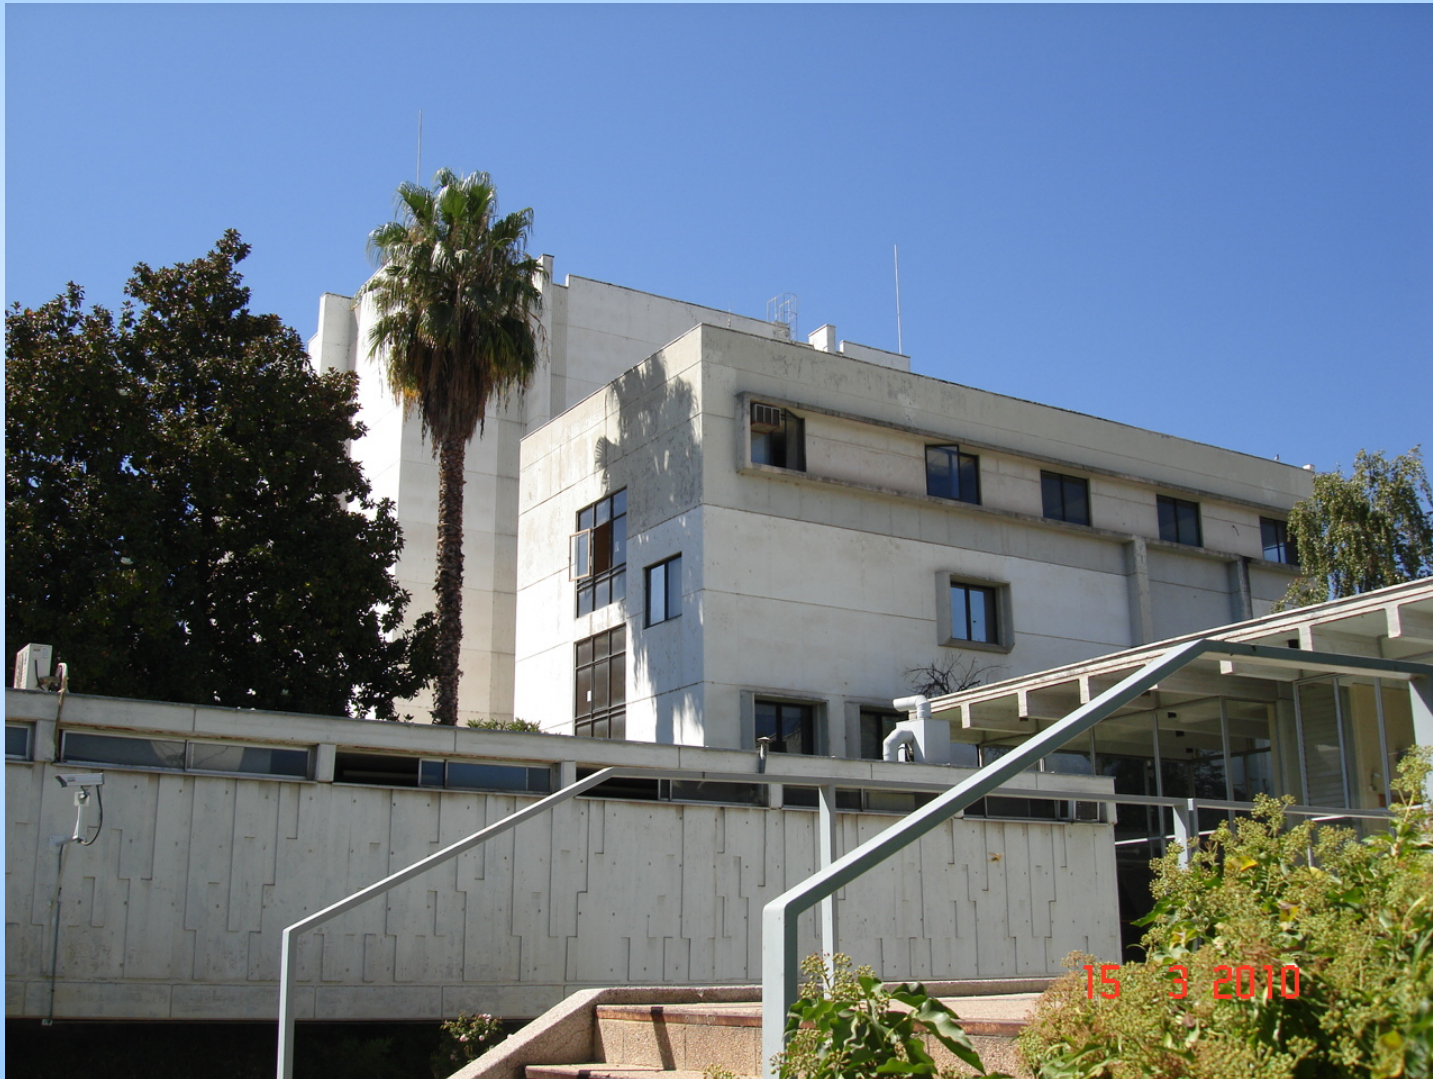
# RESEARCH NUCLEAR REACTOR LA REINA UNDEAMAGED (PGA = 0.2 – 0.3 g)

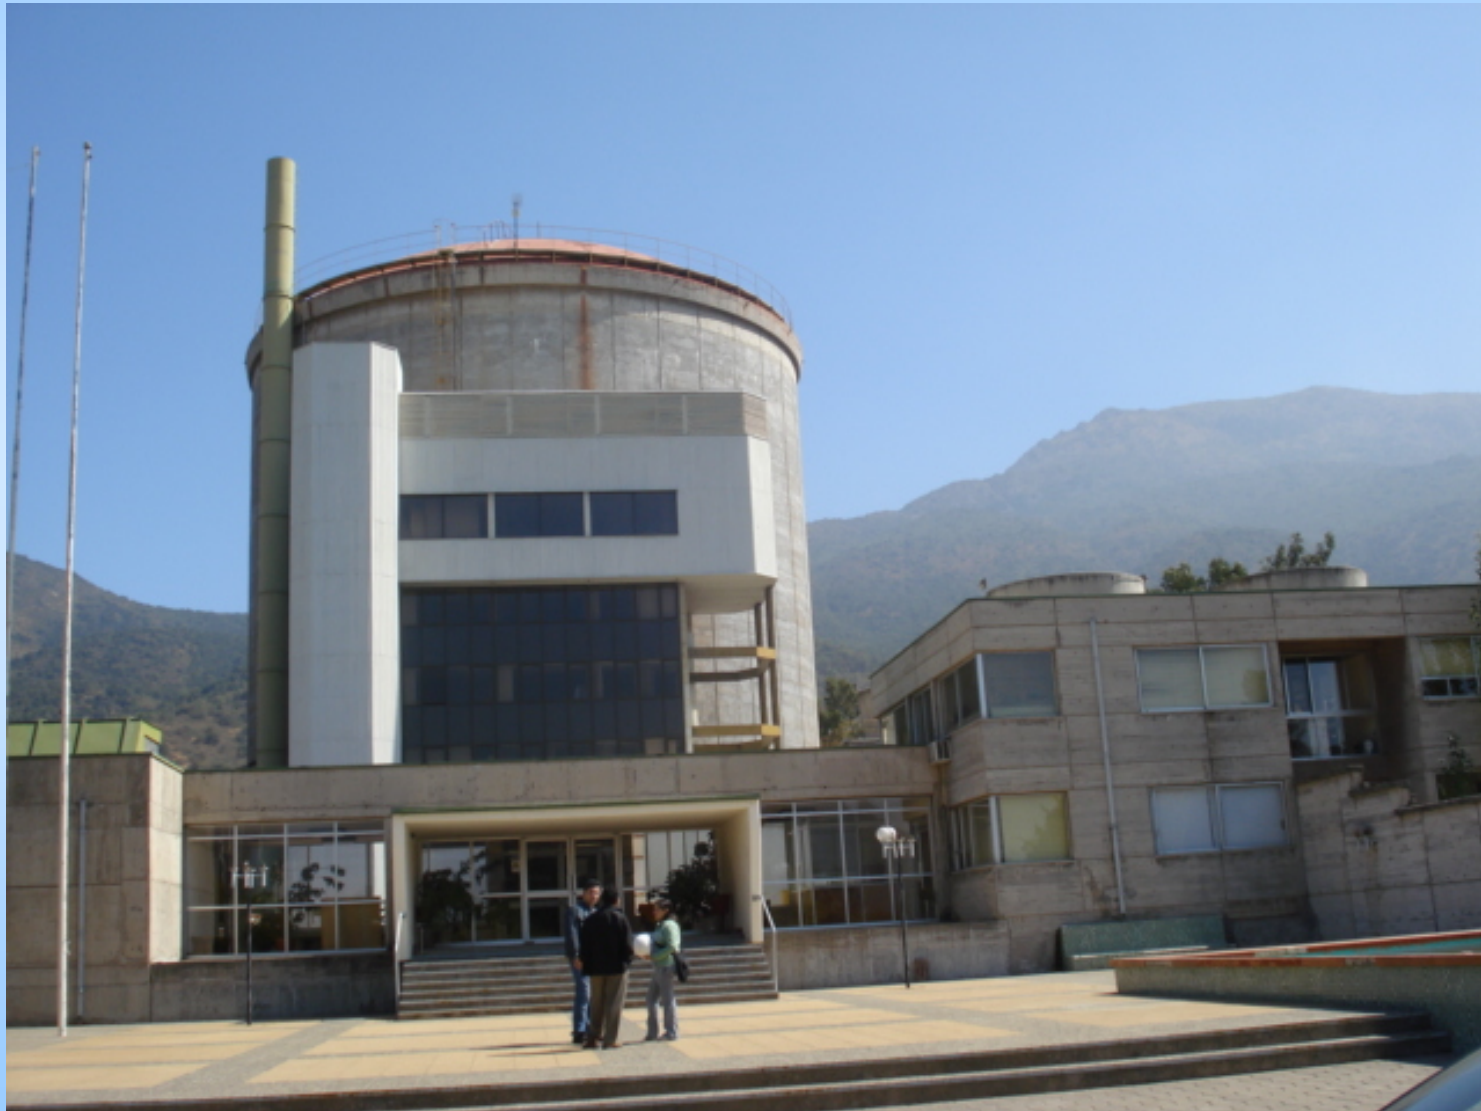
# RESEARCH NUCLEAR REACTOR LO AGUIRRE - SANTIAGO UNDAMAGED (PGA = 0.3 g).

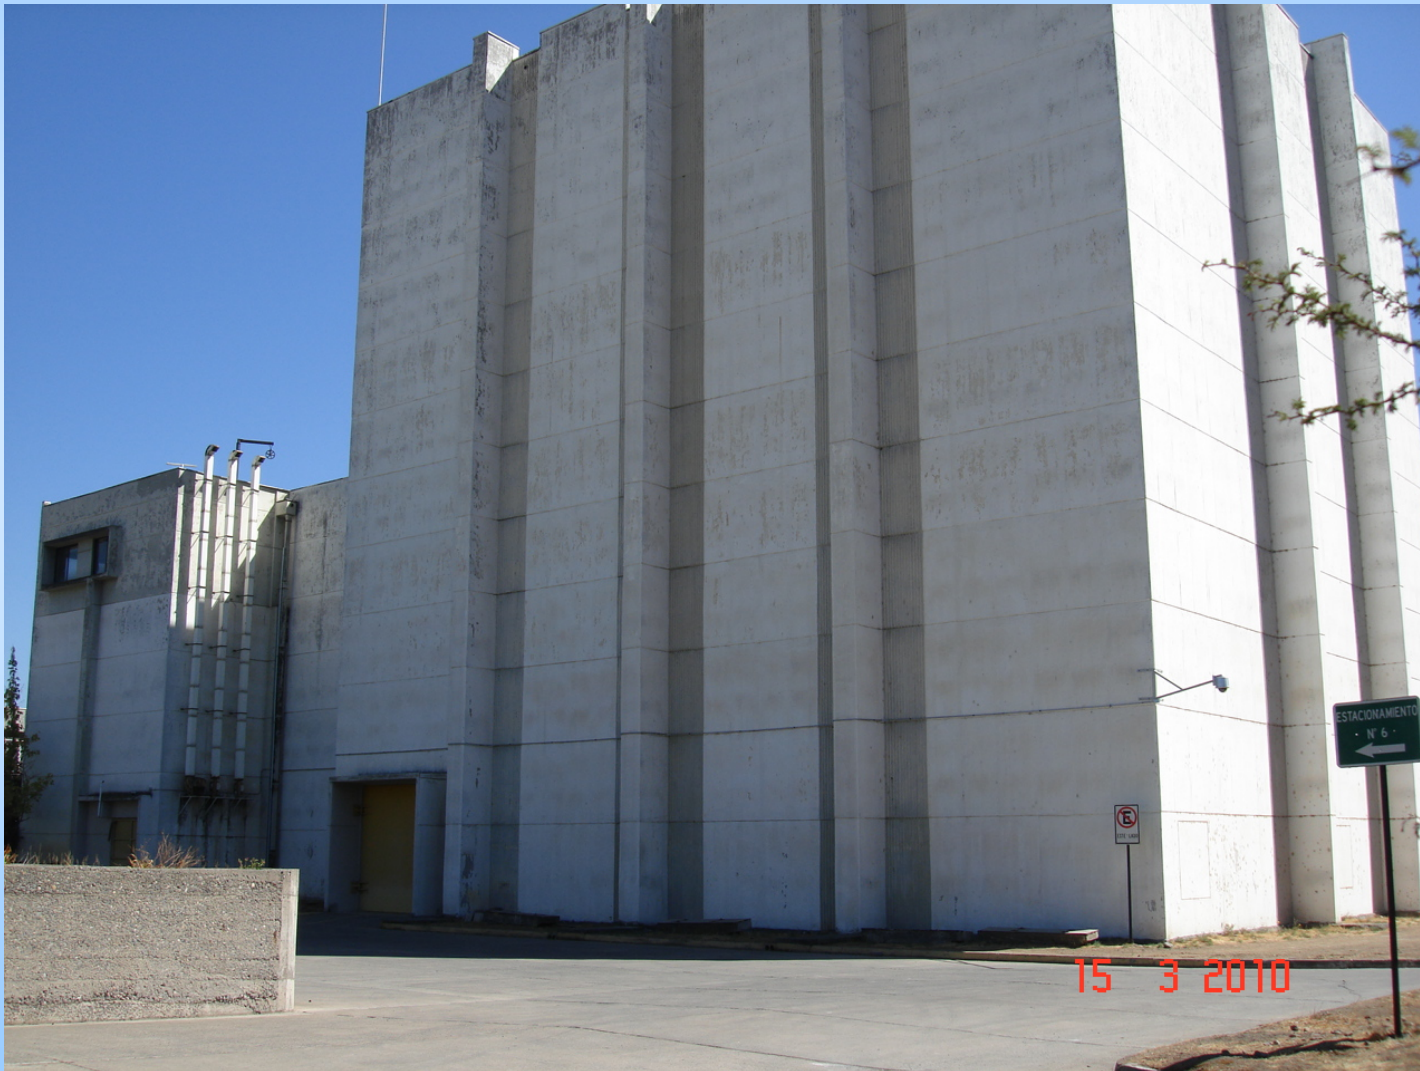
# RESEARCH NUCLEAR REACTOR LA REINA UNDEAMAGED (PGA = 0.2 – 0.3 g)

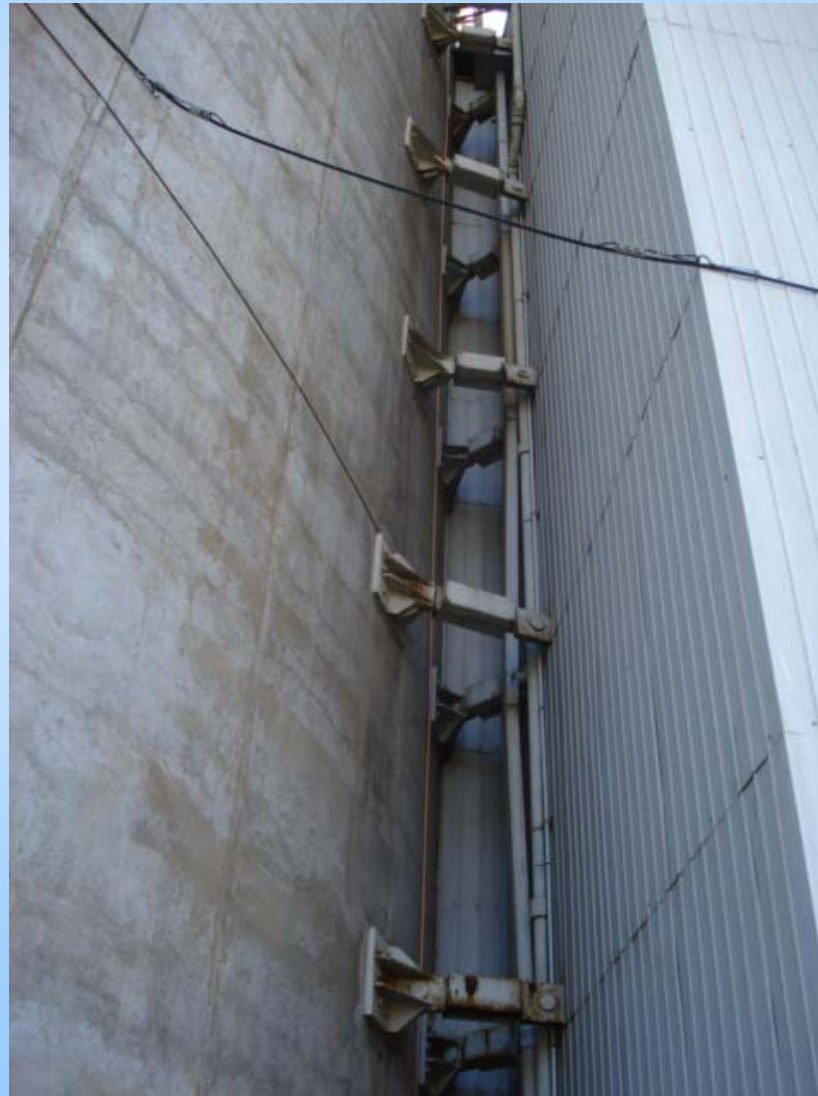
**CONNECTIONS BETWEEN MAIN AND SECONDARY BUILDINGS**

**RESEARCH NUCLEAR REACTOR LO AGUIRRE - SANTIAGO  
UNDAMAGED (PGA = 0.3 g).**

RESEARCH NUCLEAR REACTOR LO AGUIRRE - SANTIAGO  
UNDAMAGED (PGA = 0.3 g).  
CONNECTIONS BETWEEN MAIN AND SECONDARY BUILDINGS

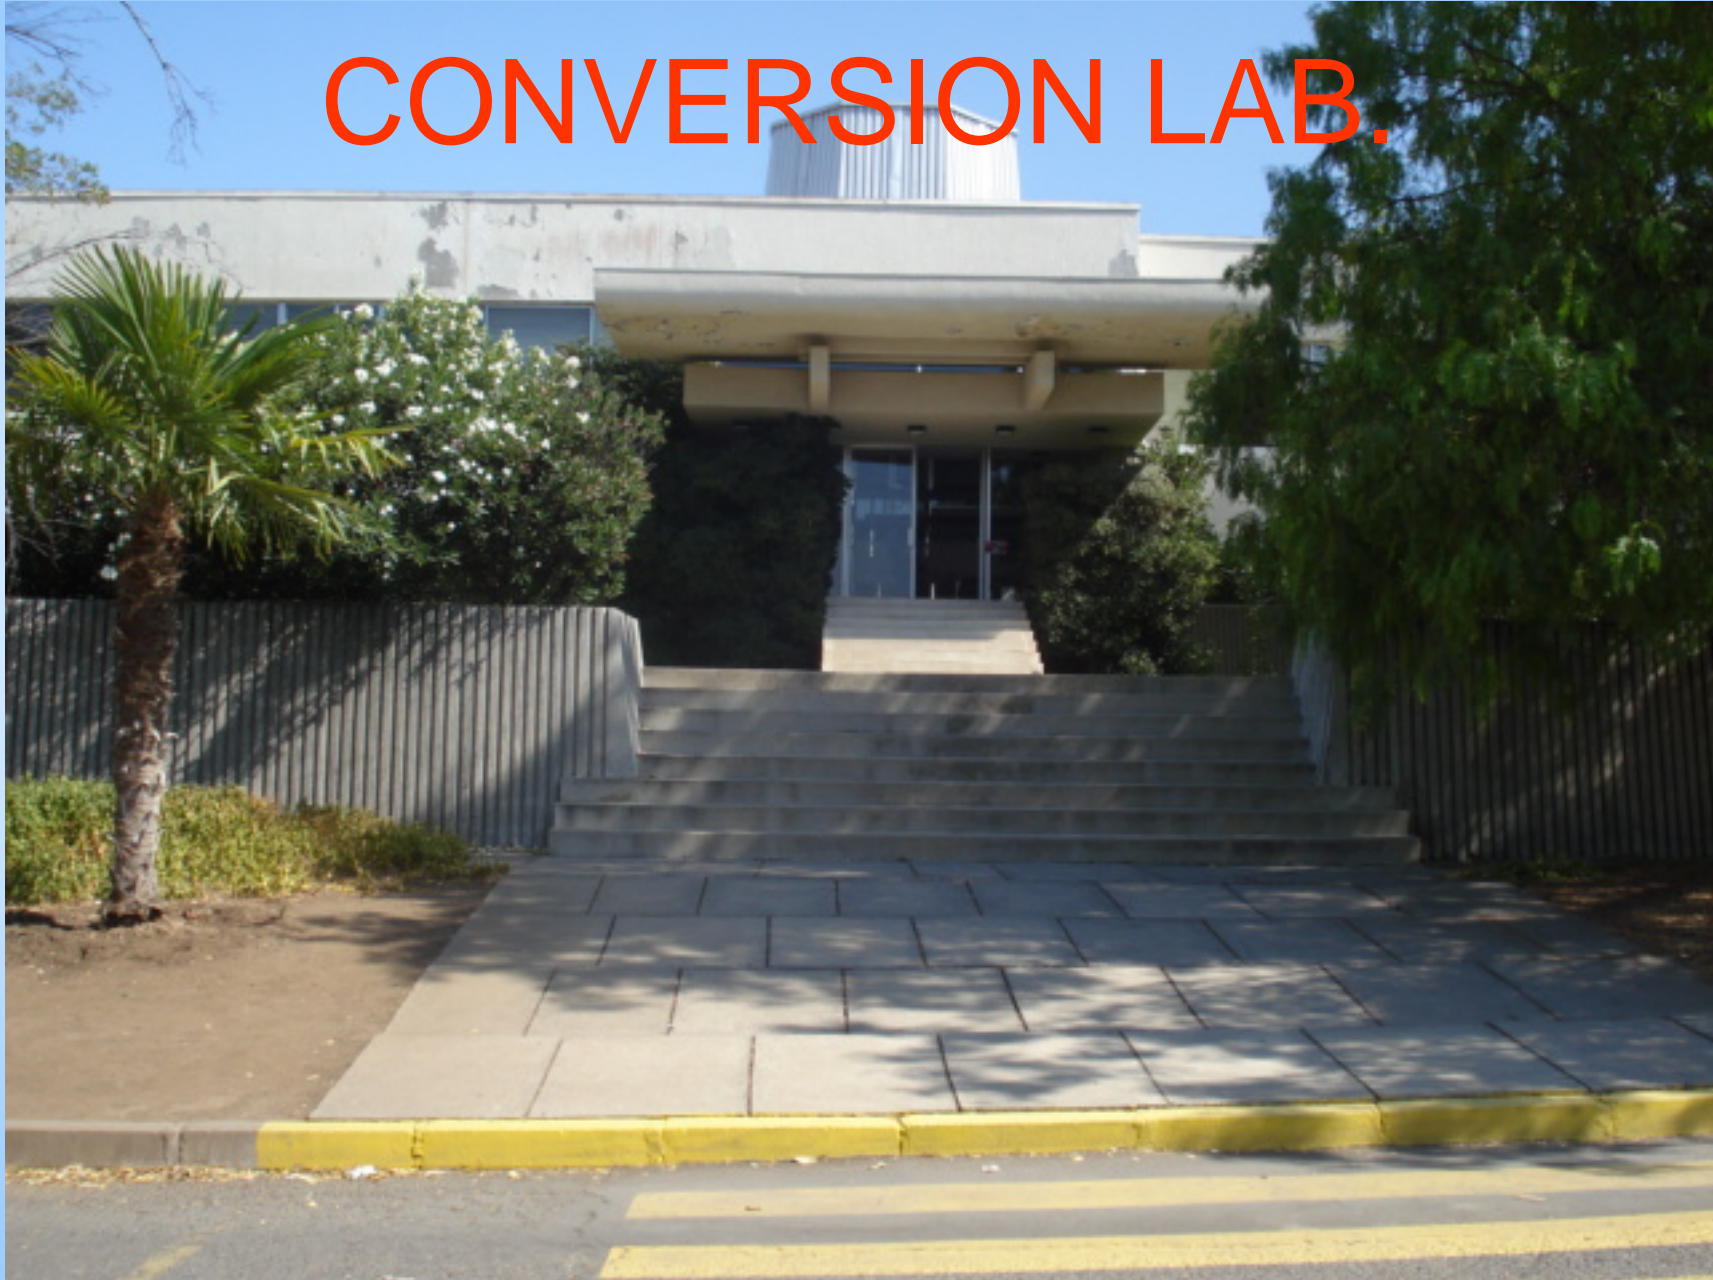
# CONVERSION LAB.

LOOSE CONCRETE IN ANCHOR BOLTS
