**Some remarks on the earthquakes in L'Aquila,  
Haiti and Chile. Seismology and damages**

Luis D. Decanini  
*Sapienza, Universita di Roma  
Dipartimento di Ingegneria Strutturale e Geotecnica  
Roma  
ITALY*

**Trieste, May 13 2010**

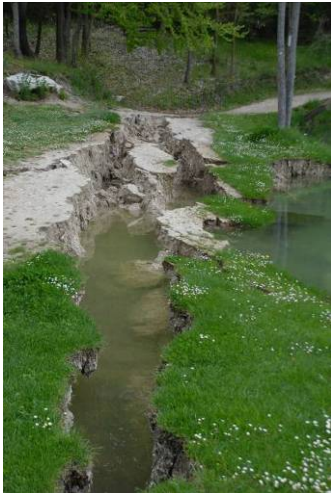
Hole in the ground

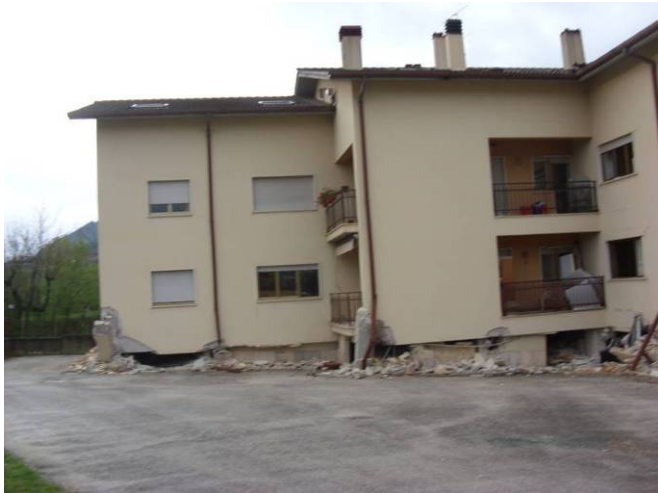
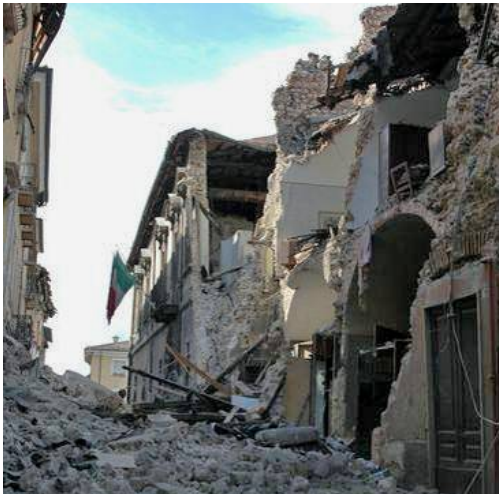
Masonry collapse

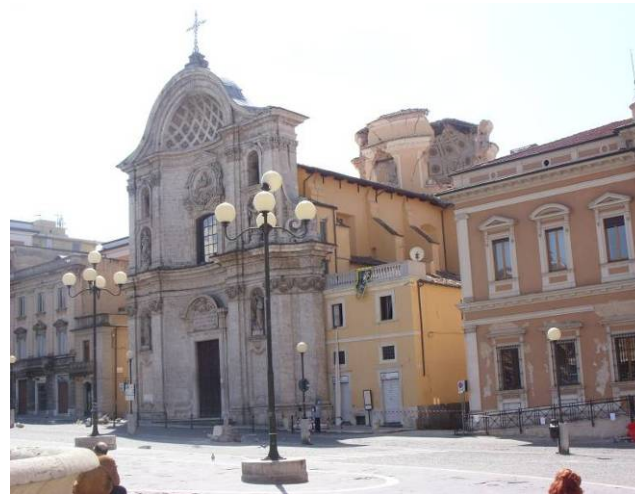
Damaged church

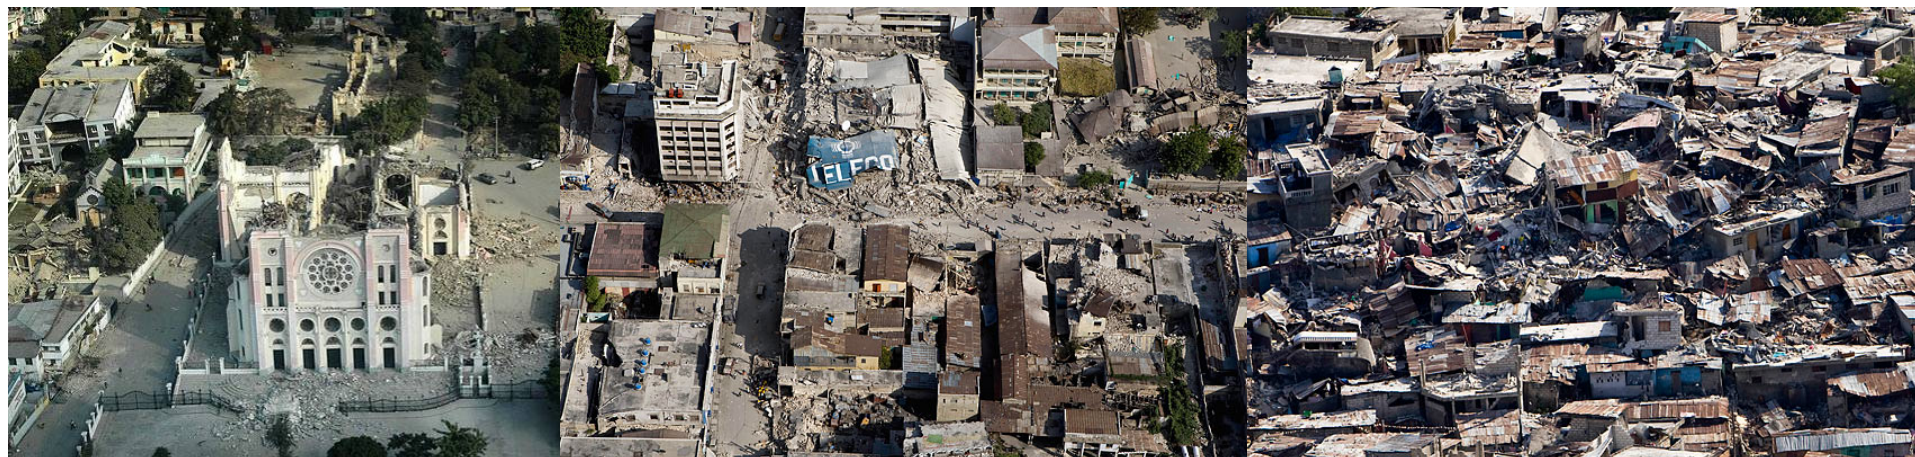
Extensive damage to poor edifices

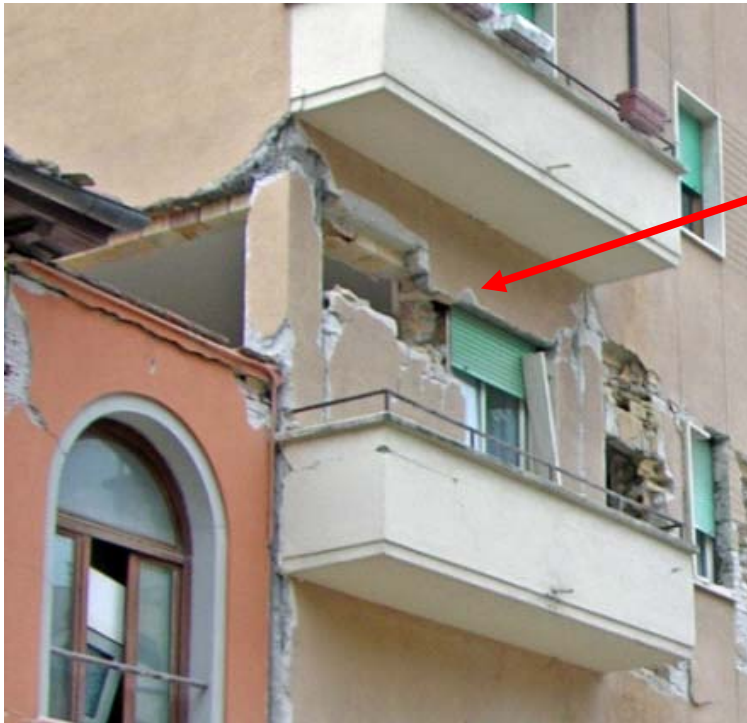
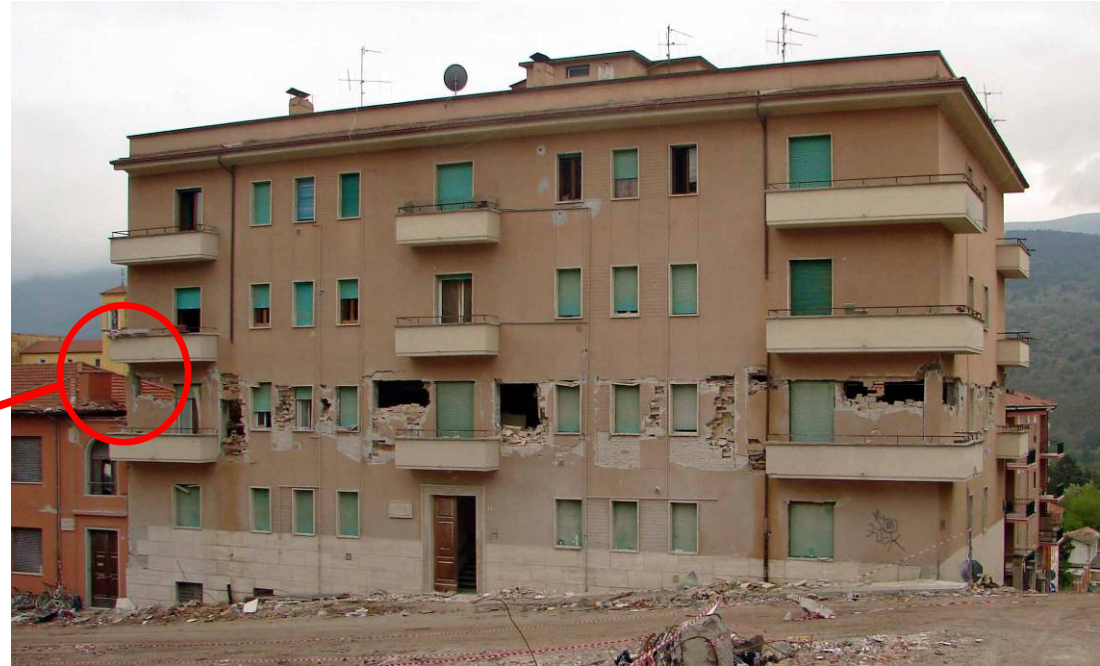
Pounding

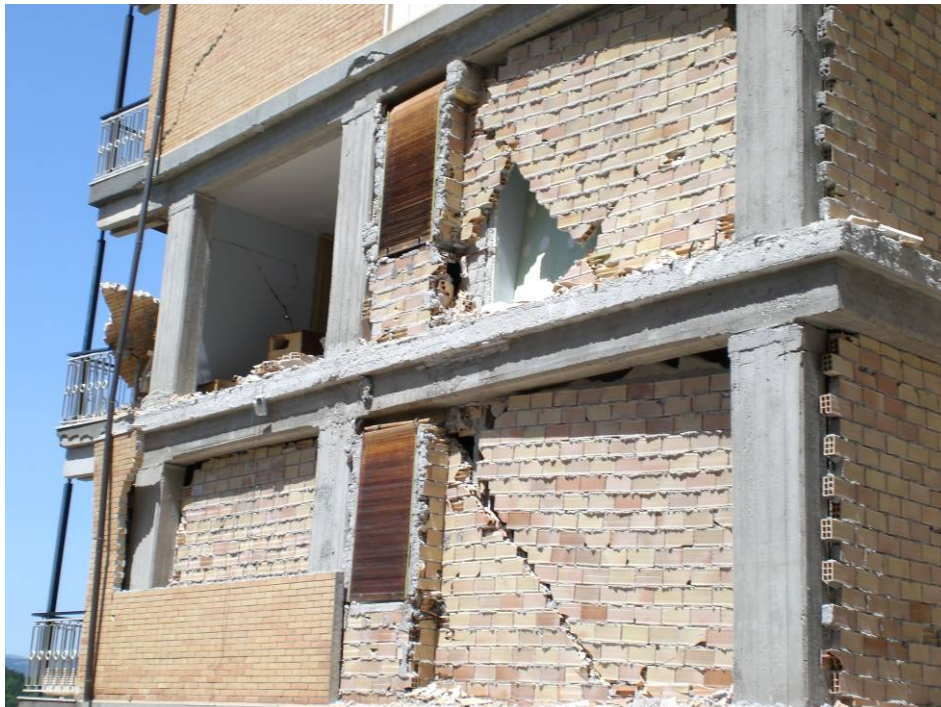
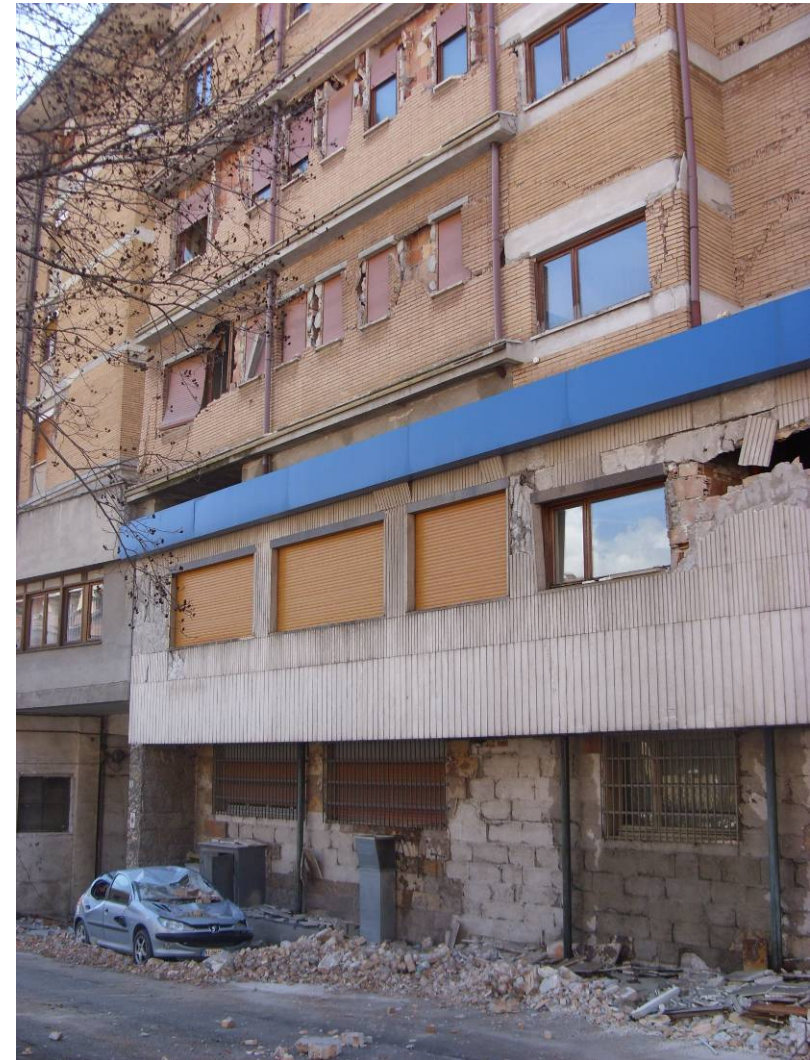
Typical damage to infill walls

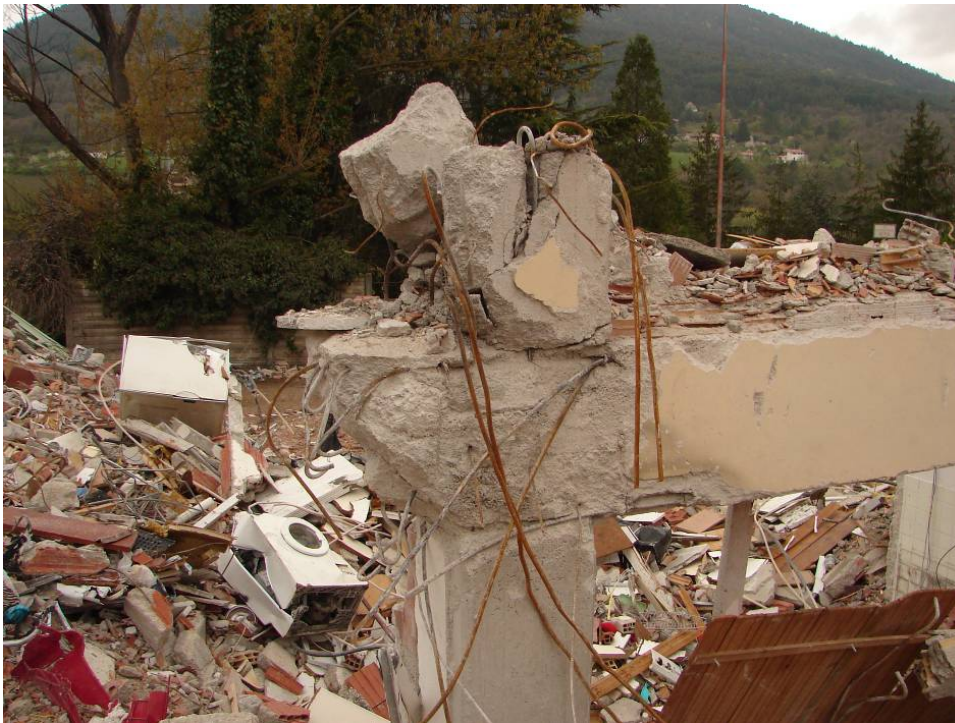
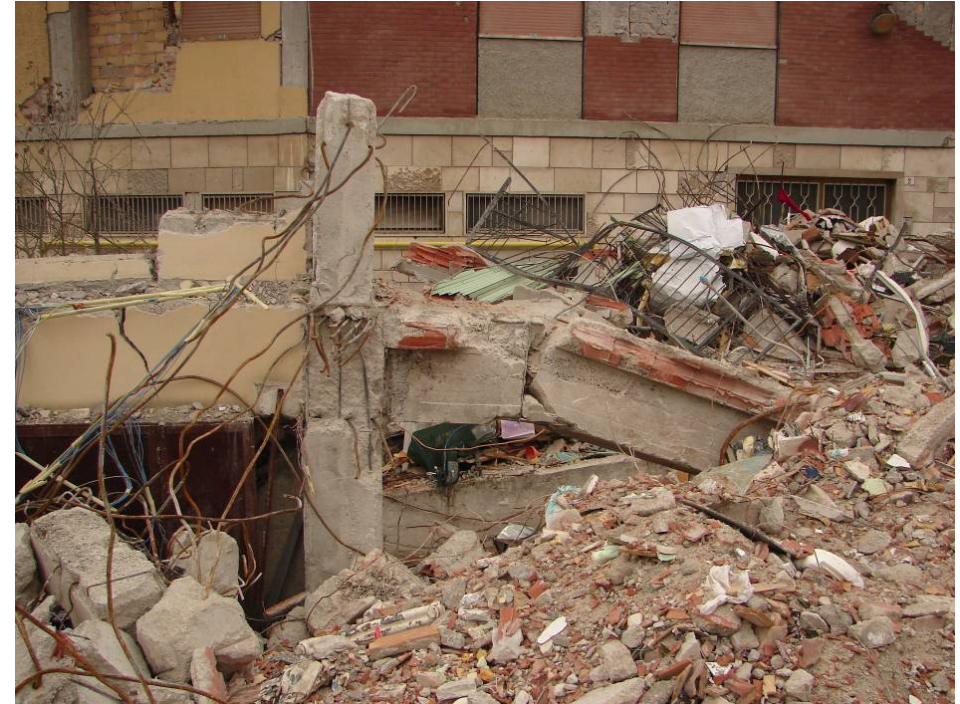
Edificio in via Poggio S. Maria 8

Lack of transverse reinforcement in joints

Weak columns - Strong beams

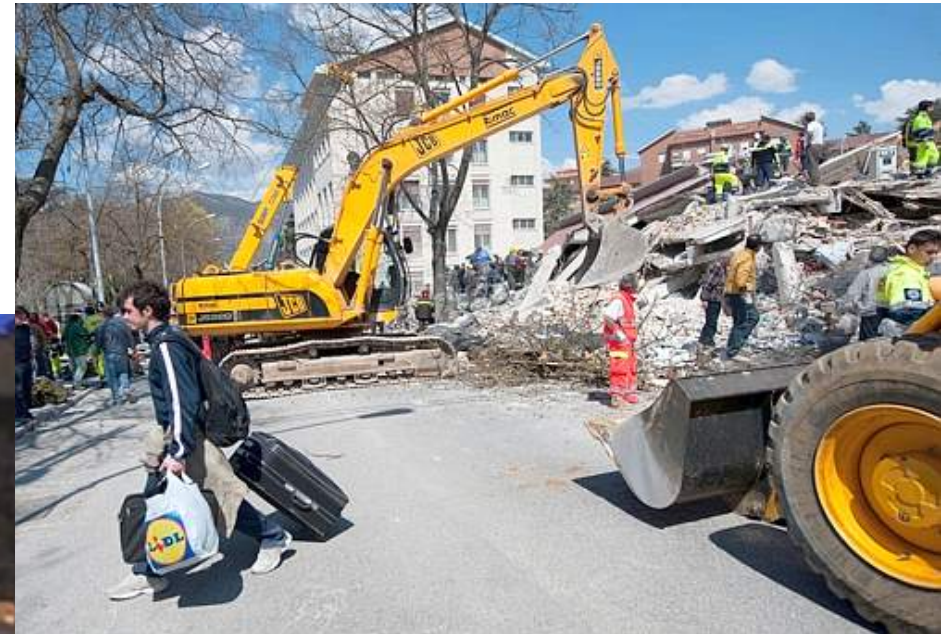
Edificio in via XX Settembre 123

Weak columns - Strong beams

Complete collapse (Corriere,  
Radio Sound City)

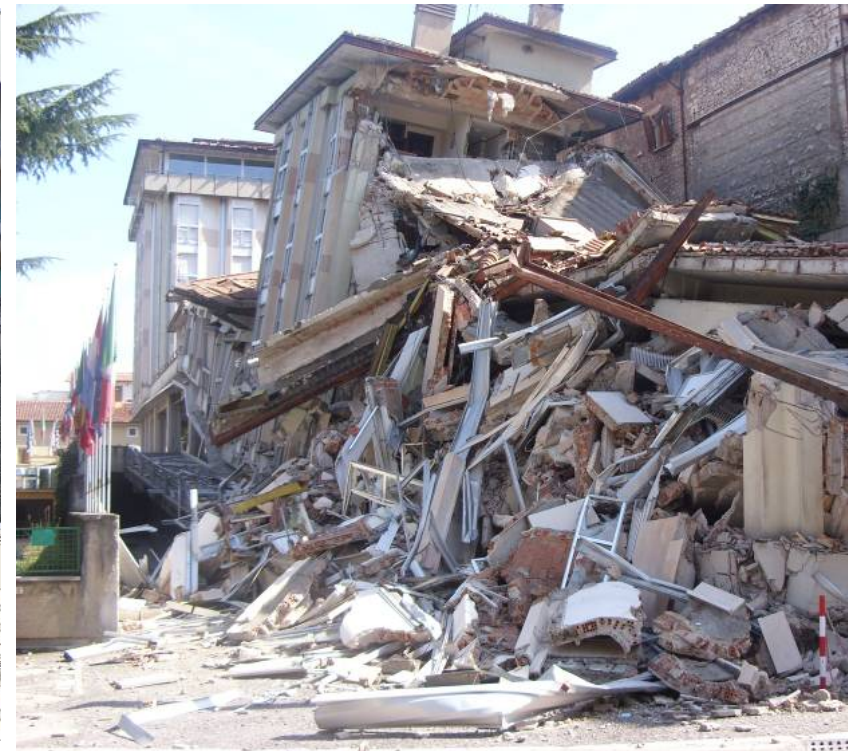
Hotel Duca degli Abruzzi, in Viale Giovanni XXIII,

Deficient structural layout, declivity

After earthquake

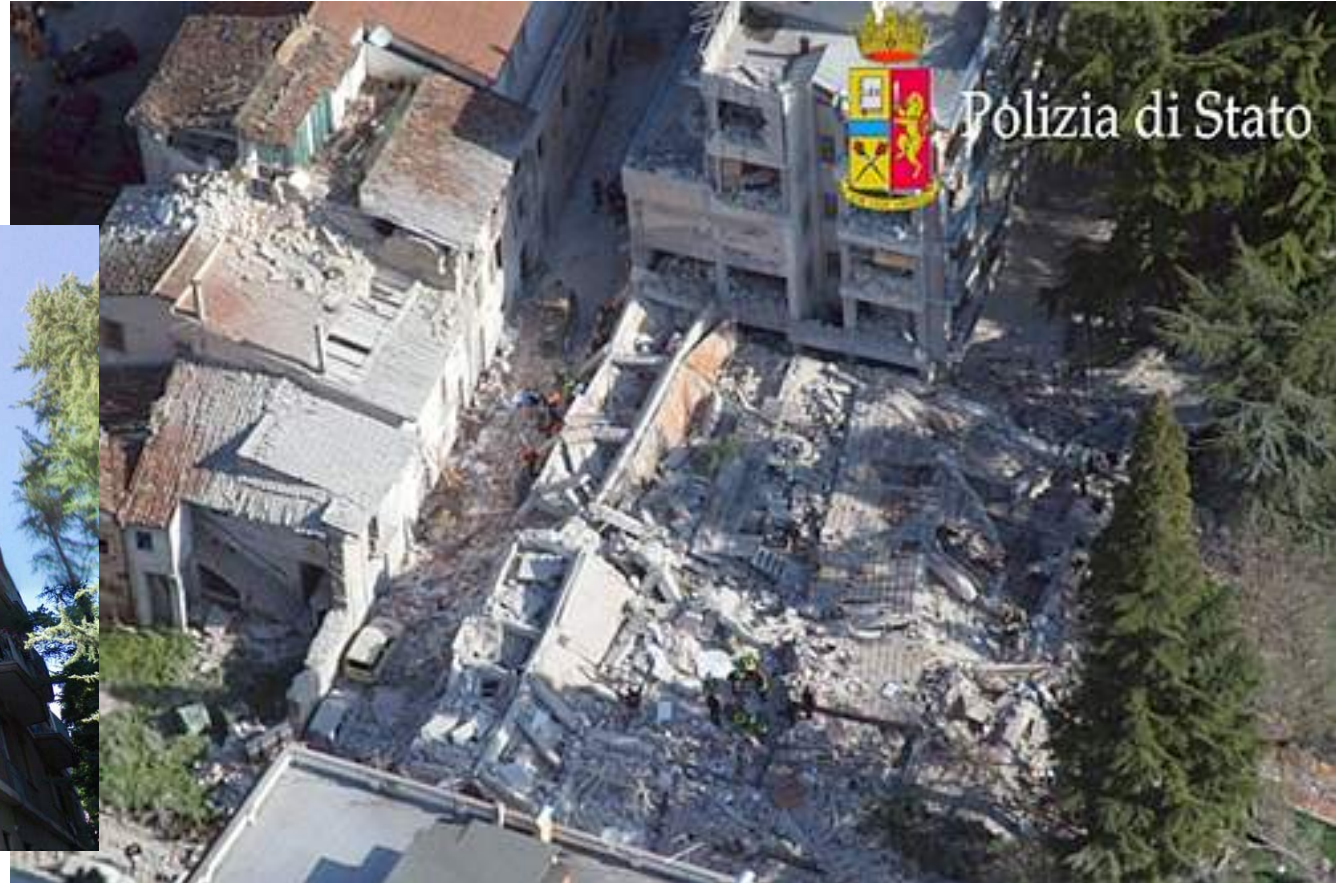
Building in via Campo di Fossa  
(Corriere)

Total collapse

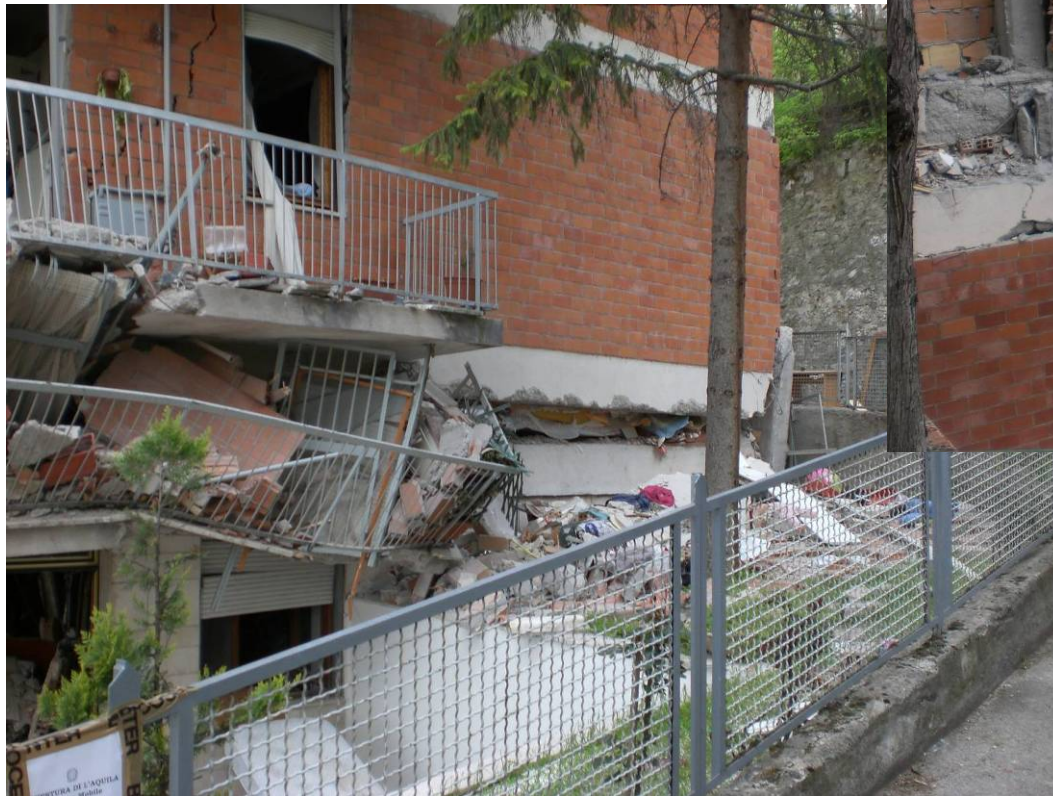
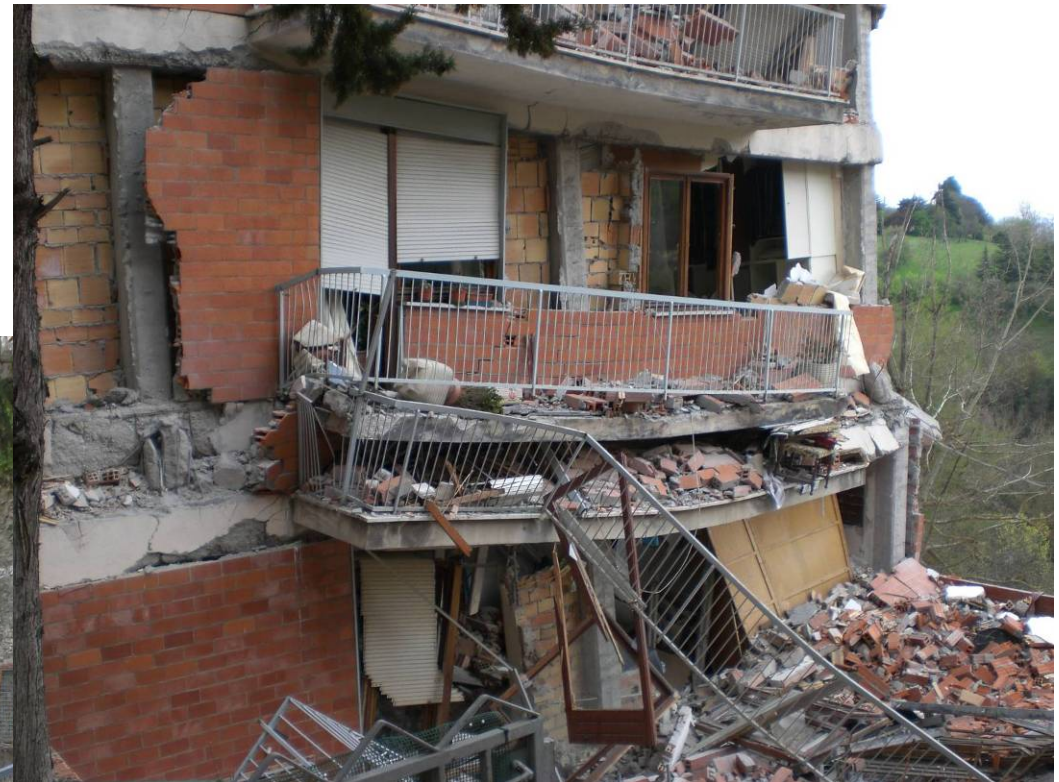
Building in via G. d'Ocre 12

Pancake collapse (third storey )

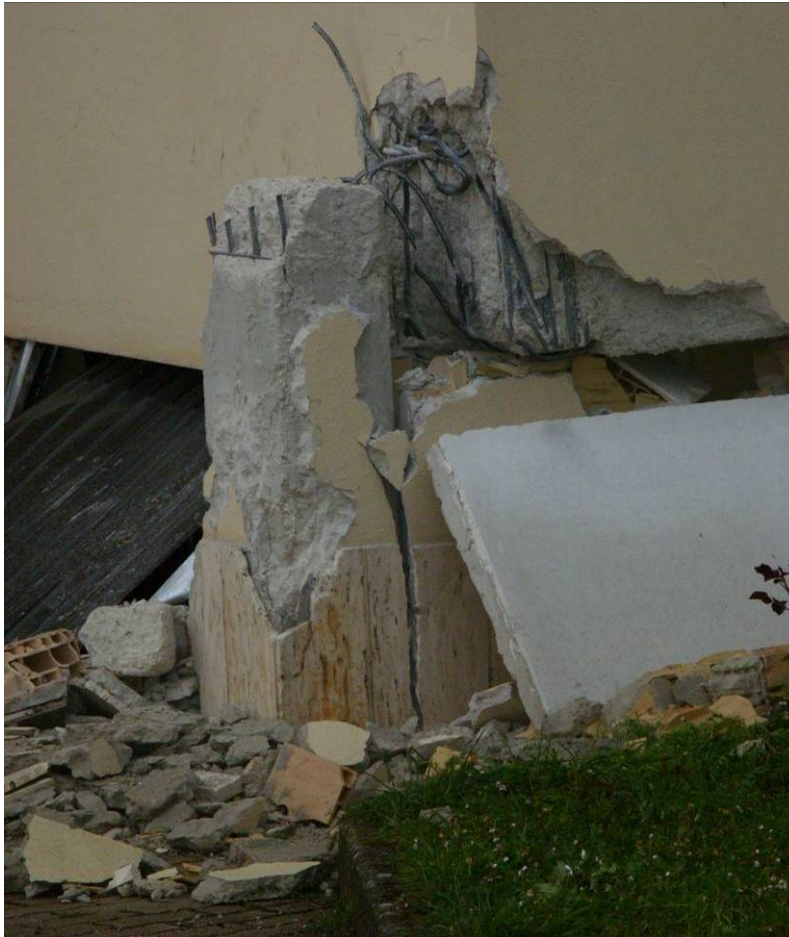
Building in via Dante Alighieri 2  
After earthquake

Soft storey

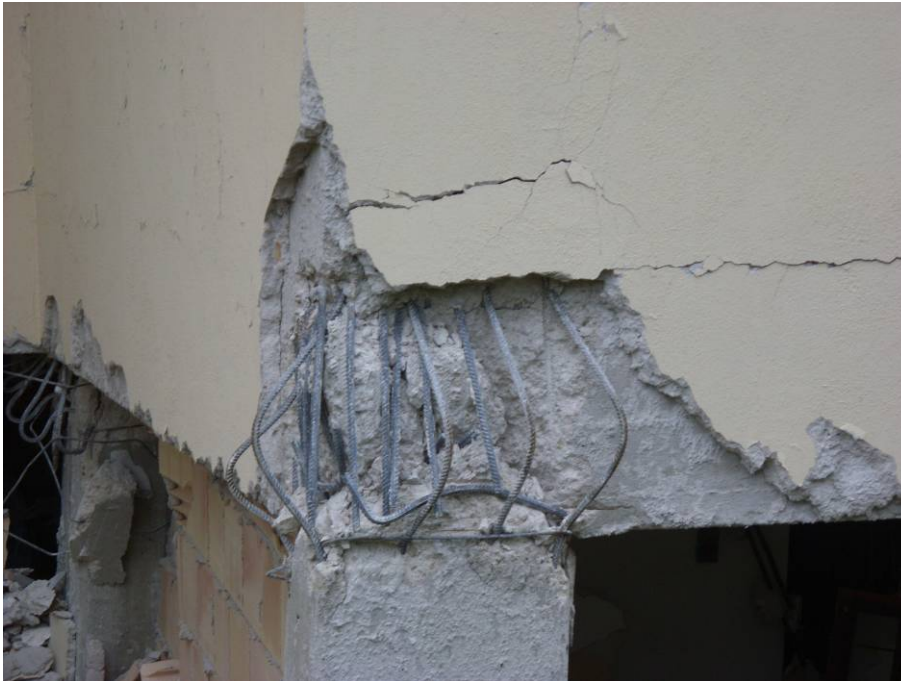
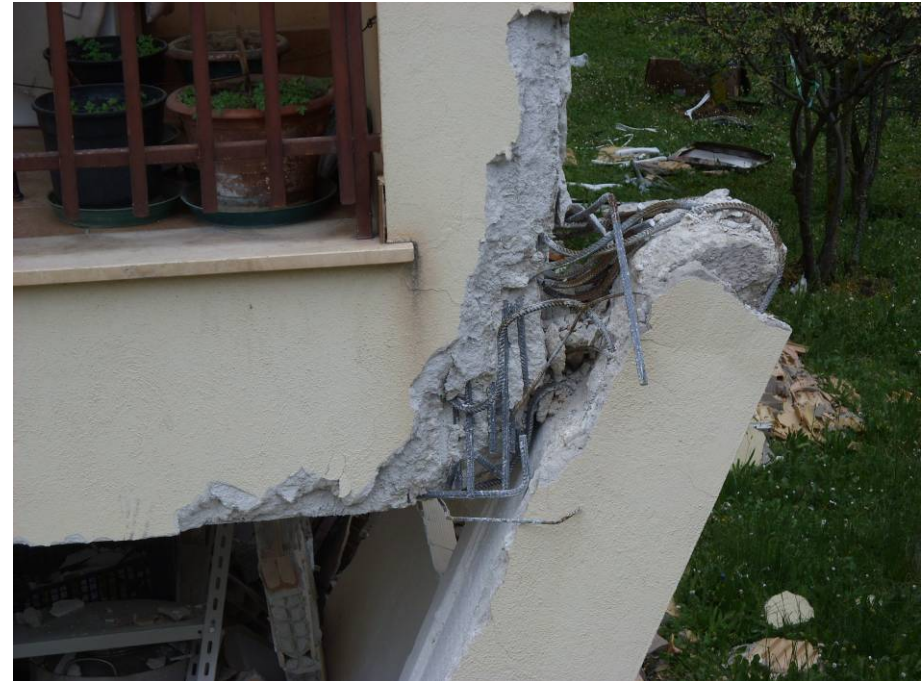
Building in via Dante Alighieri 2  
After earthquake

Soft storey

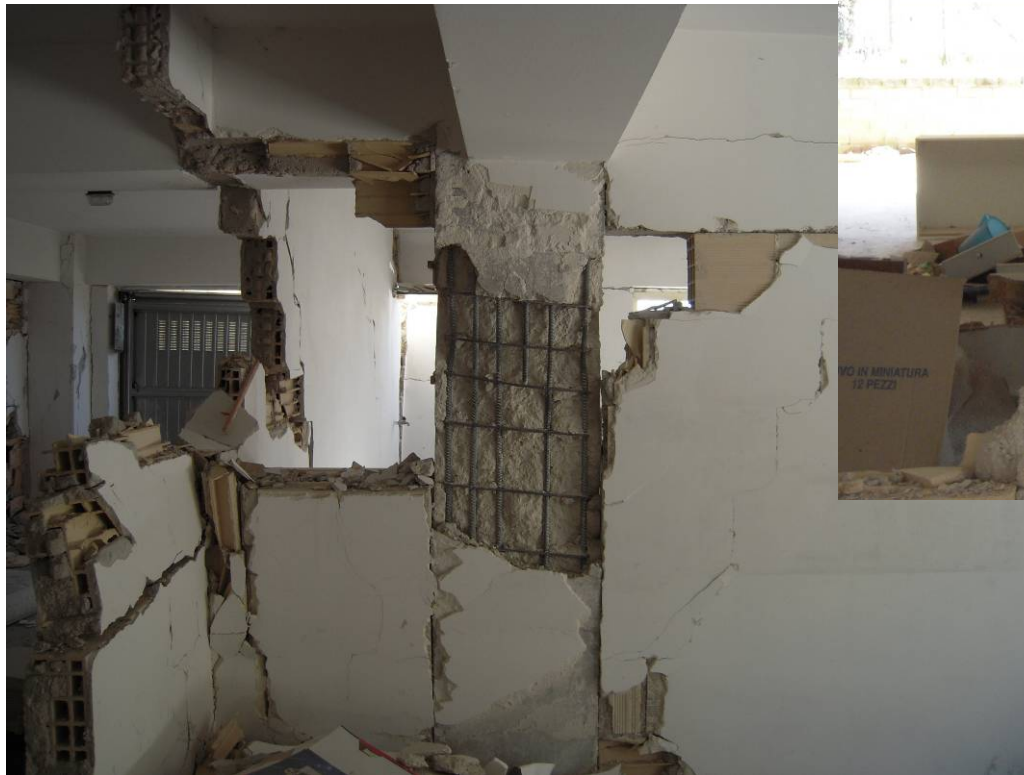
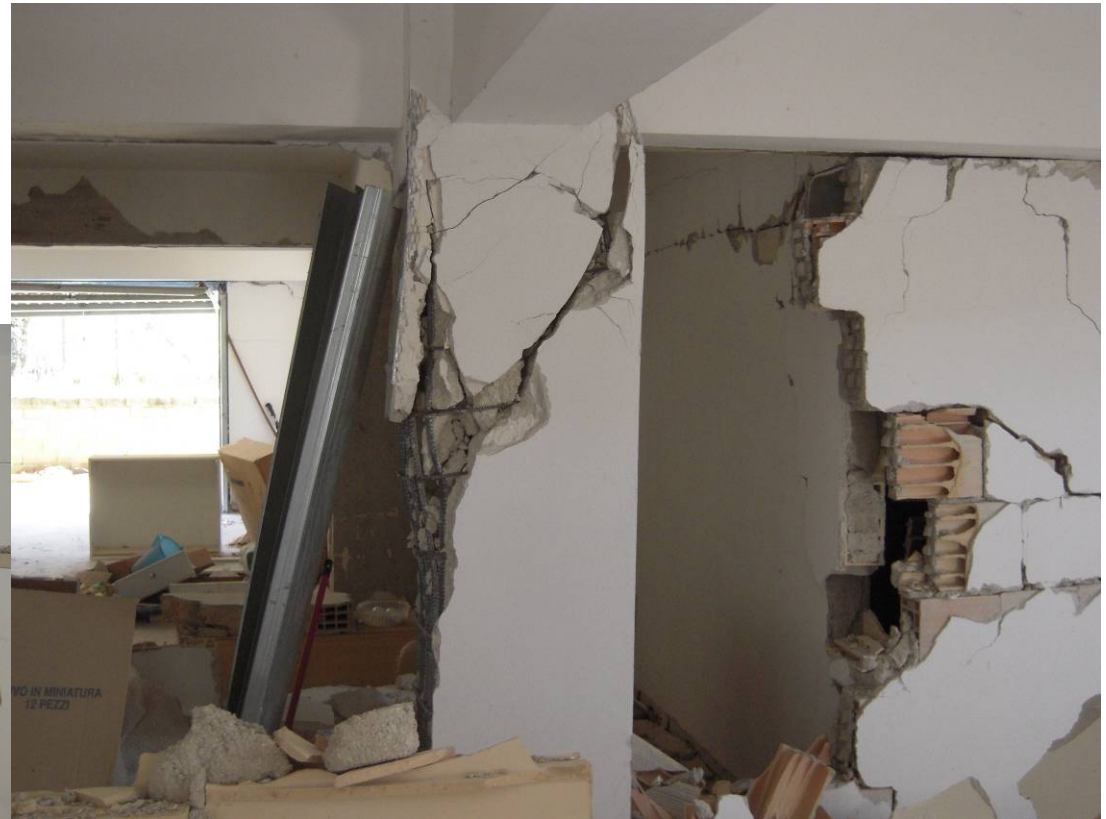
Damage to columns, lack of adequate transverse reinforcement

Shear failure

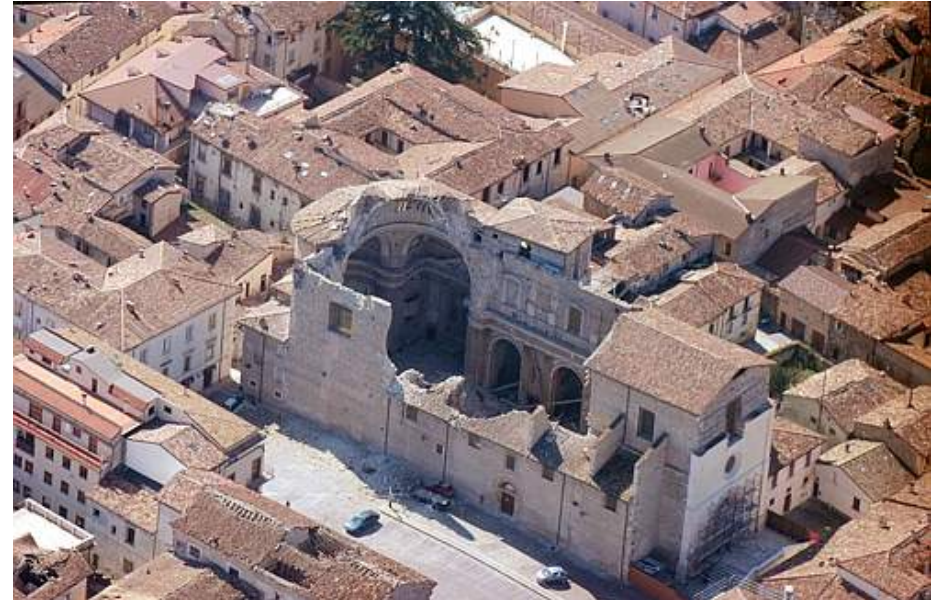
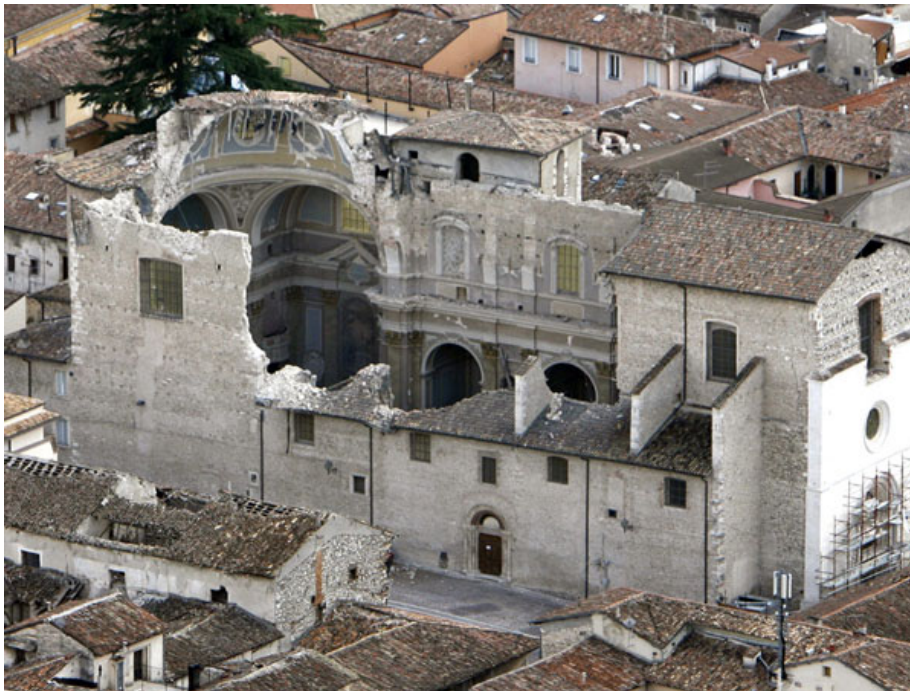
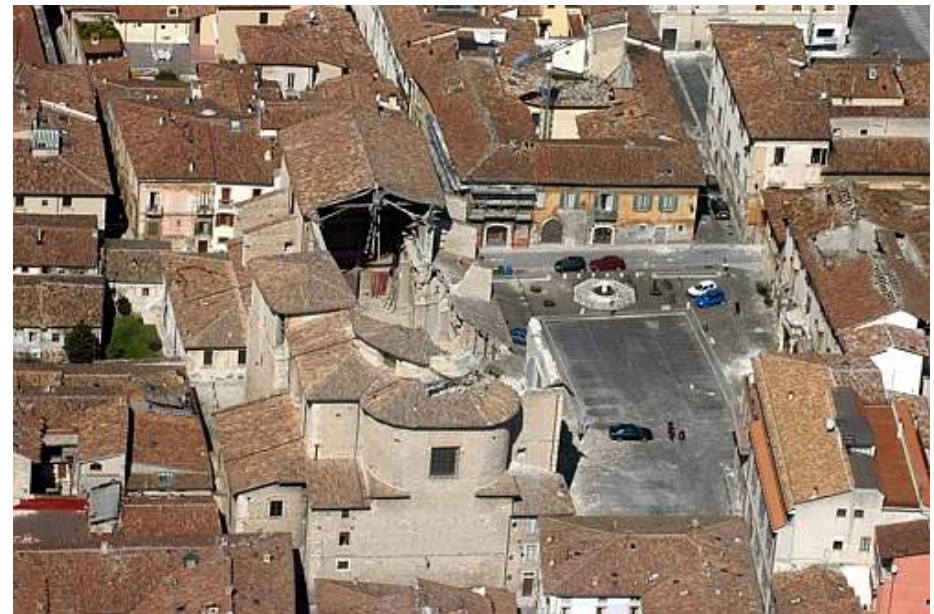
Santa Maria di Paganica

After EQ

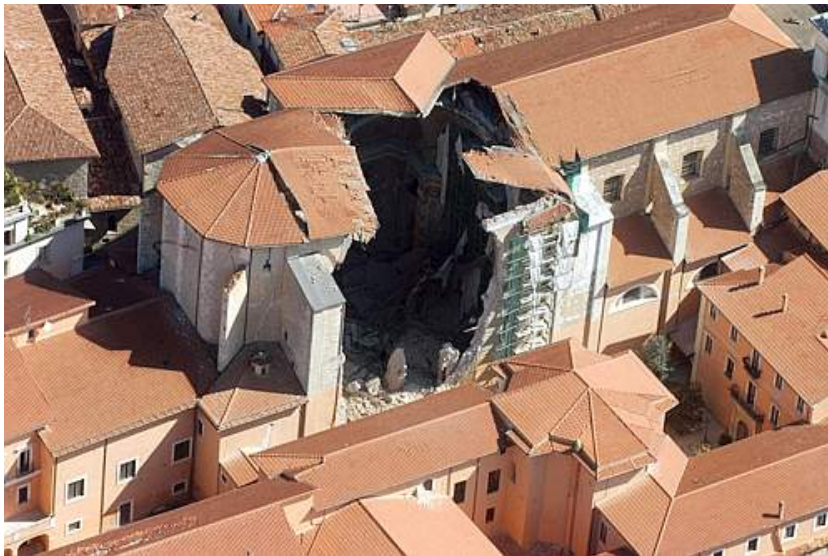
## Cathedral

Collapse of roof and vault  
of the left transept

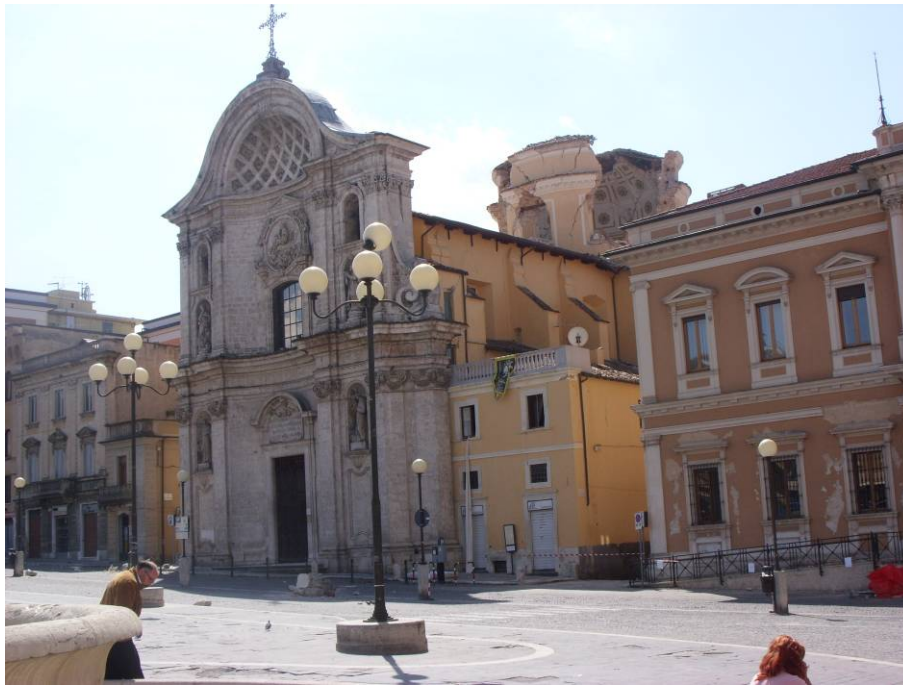
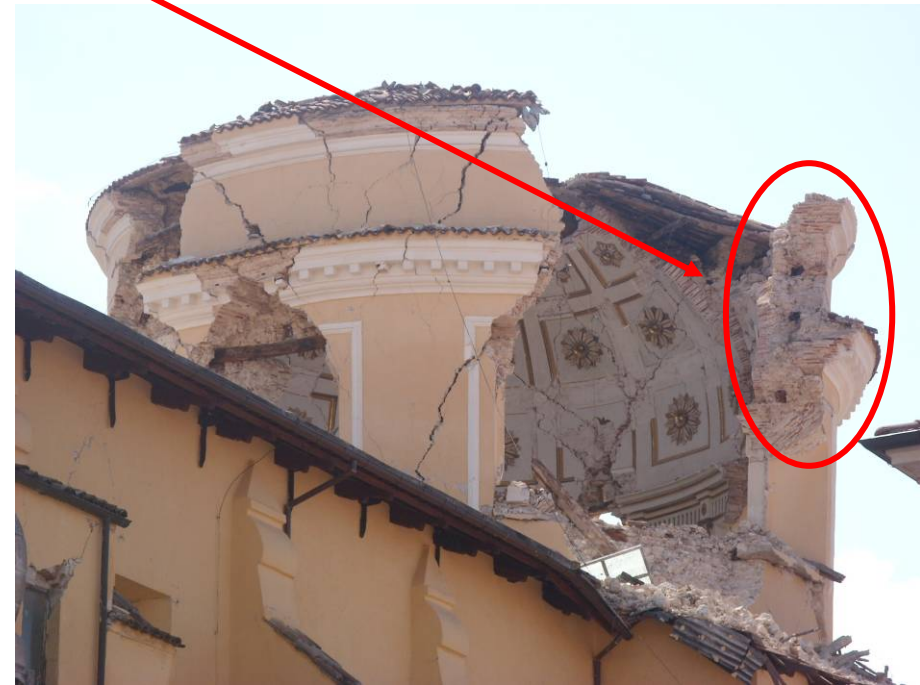
## Santa Maria del Suffragio

Collapse of the brick masonry drum and dome (April 7)  
Timber ring beams within the masonry

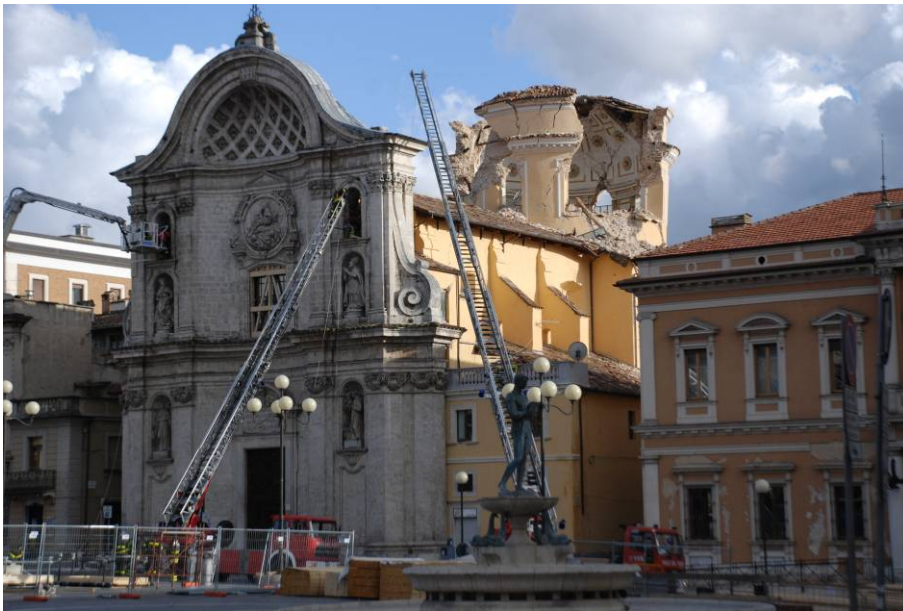
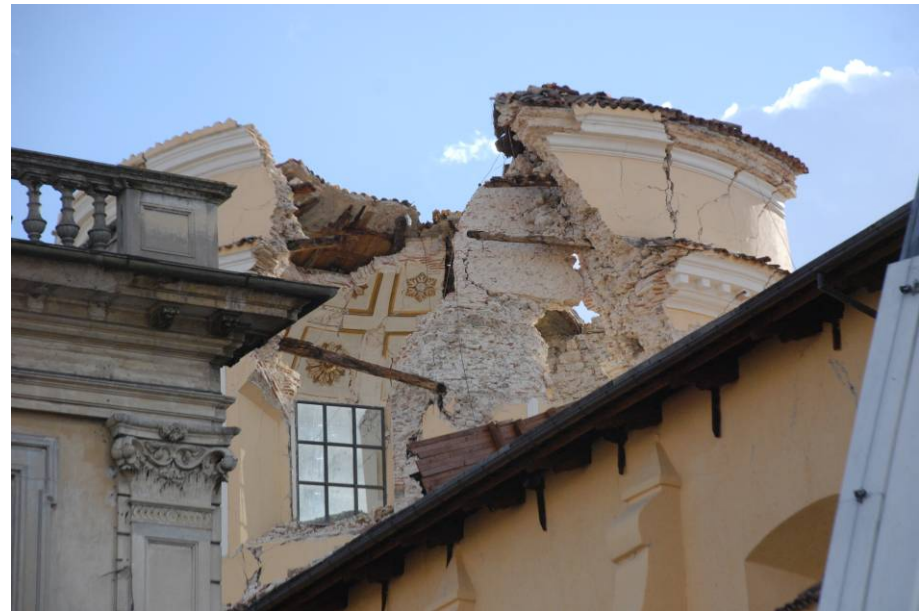
## Santa Maria del Suffragio

Damage accumulation (April 29)

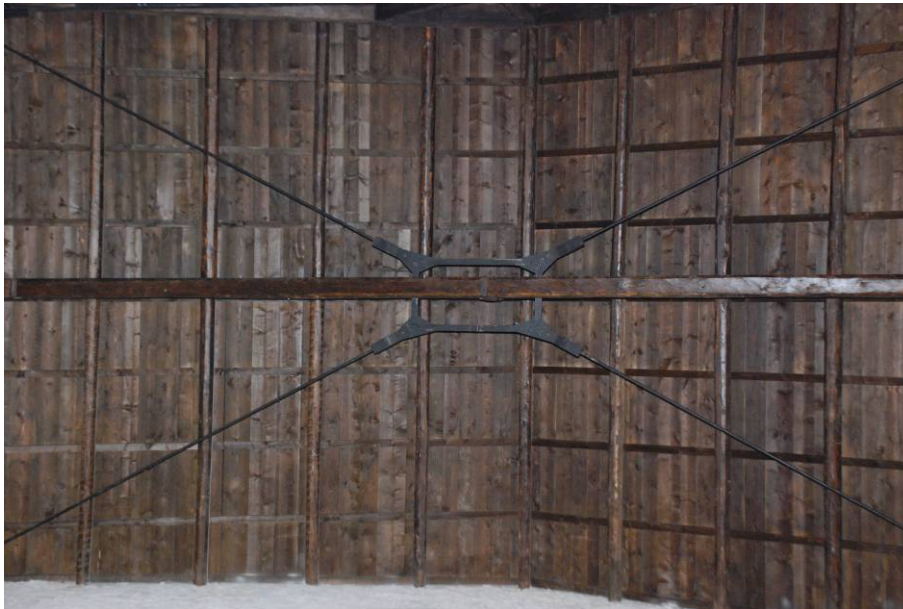
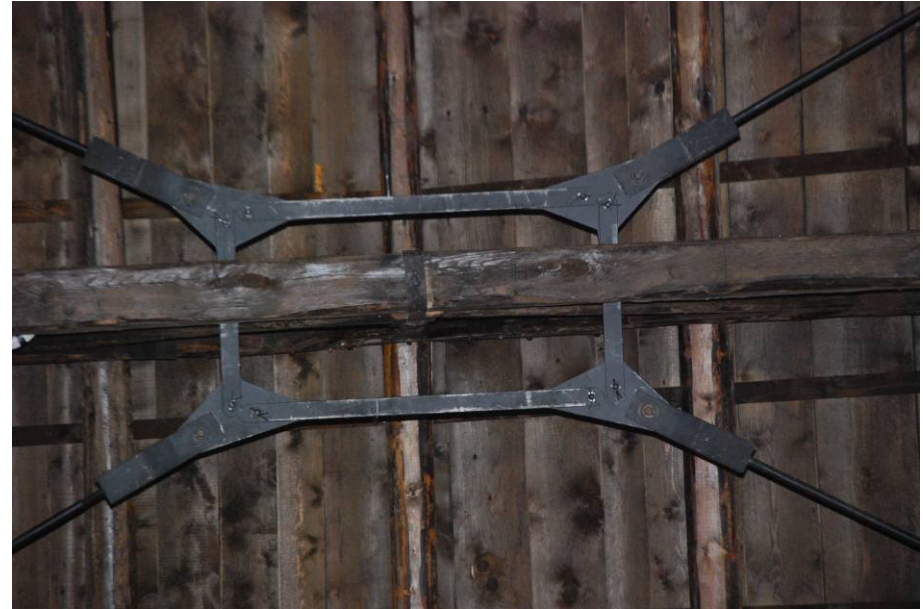
## Santa Maria di Collemaggio

Bracing dampers on the roof of the central nave.  
Not present in the transept.

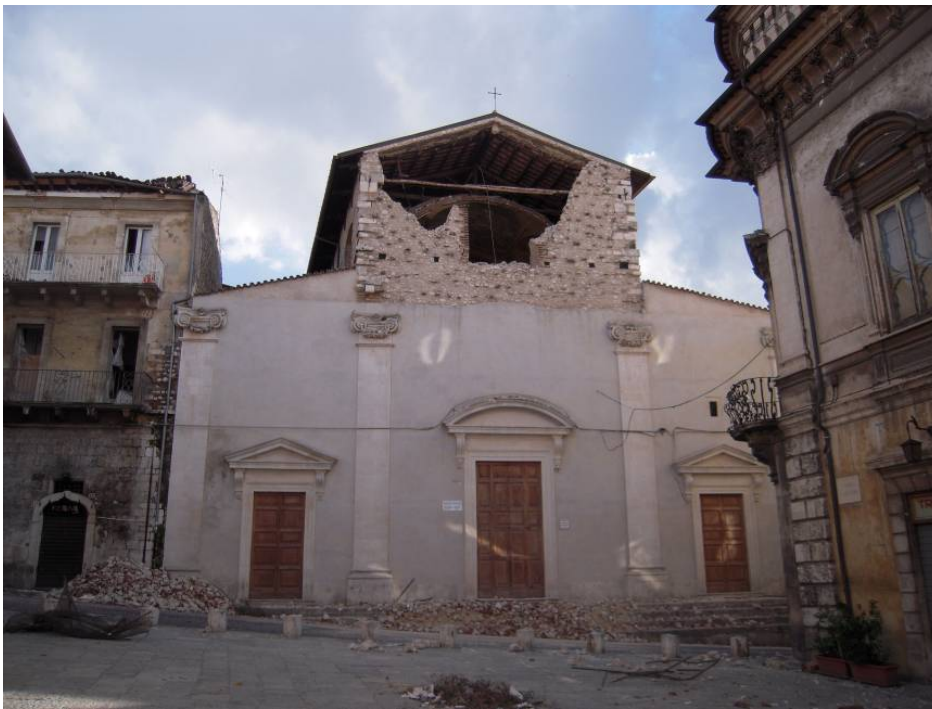
Collapse of the façade gable.

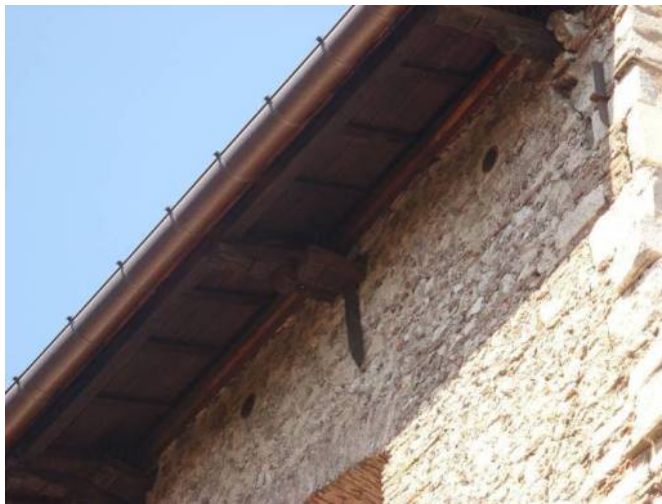
San Biagio

Evidence of historical earthquake-resistant details.

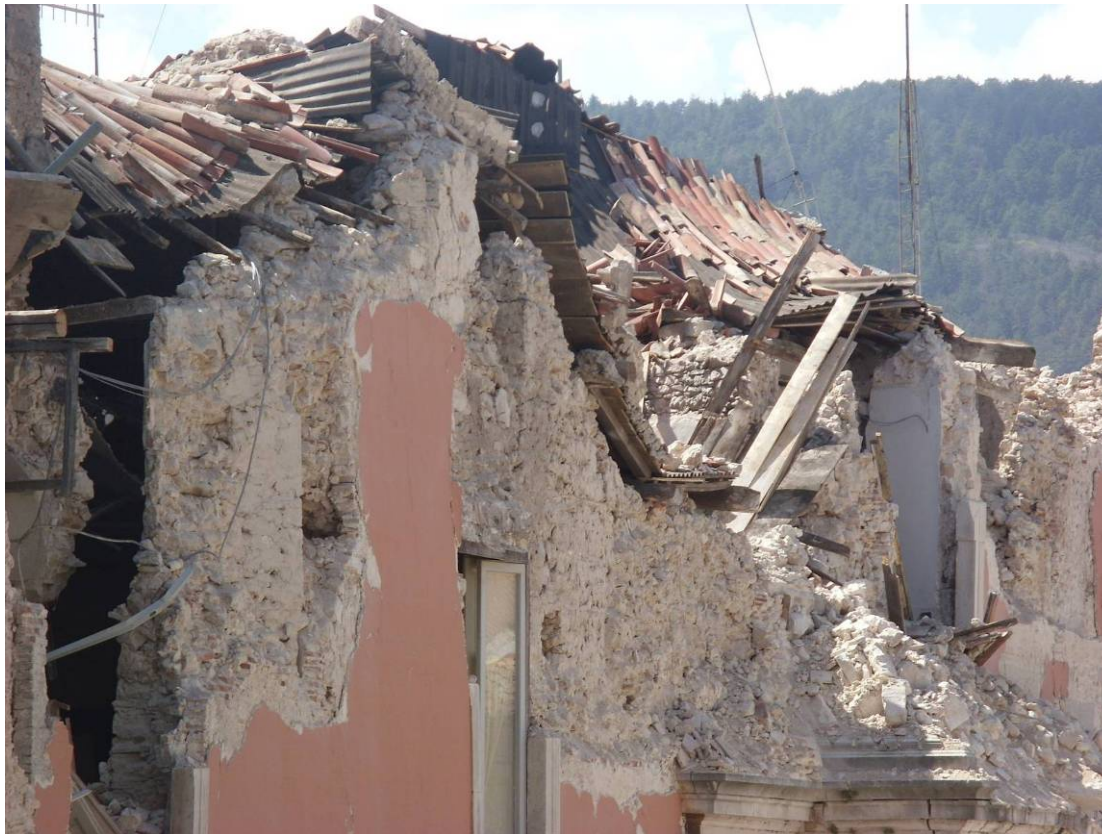
Palazzo del Governo

Poor masonry quality

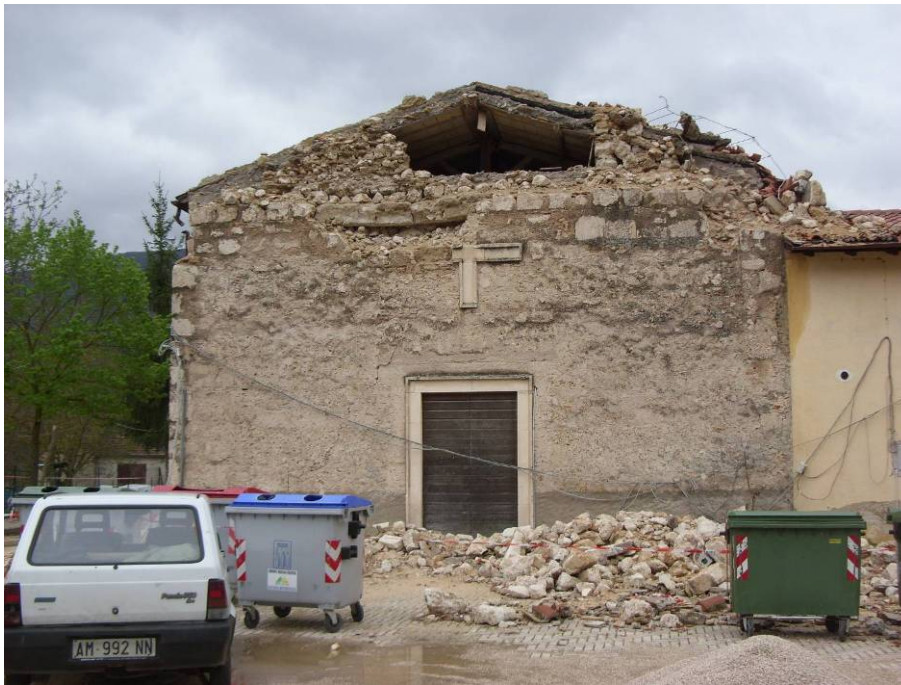
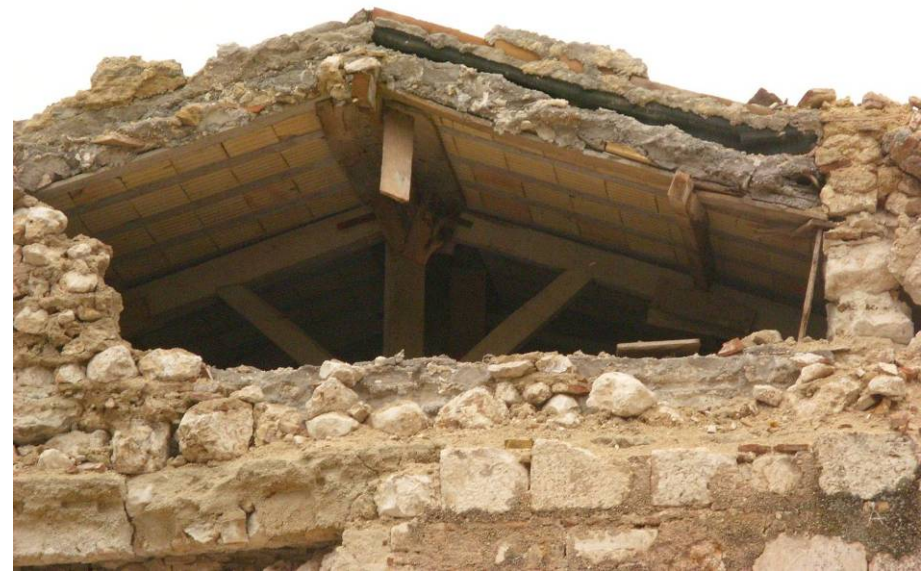
Santi Giovanni Battista ed Evangelista in Succiano

Damage due to roof made heavy
