**Some remarks on the earthquakes in L'Aquila,  
Haiti and Chile. Seismology and damages**

Luis D. Decanini  
*Sapienza, Universita di Roma  
Dipartimento di Ingegneria Strutturale e Geotecnica  
Roma  
ITALY*

**Trieste, May 13 2010**

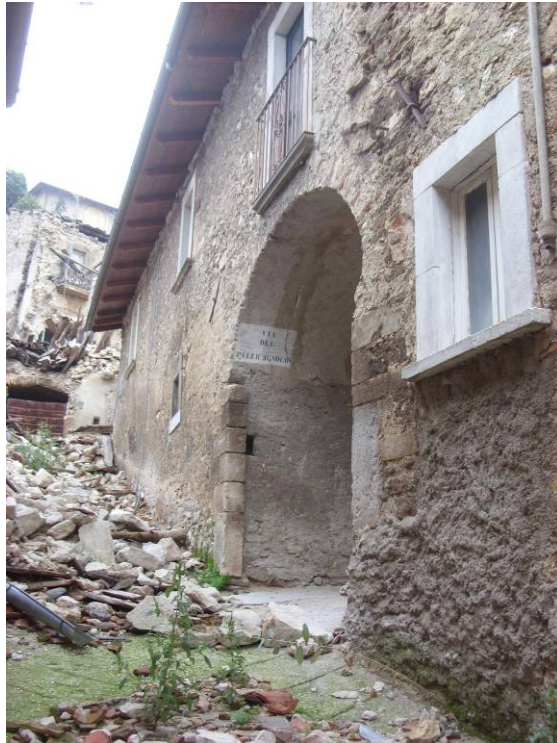
Prospetto su vico del Gallo

# Paganica (AQ) Historical Buildings. Via degli Angeli, Damages

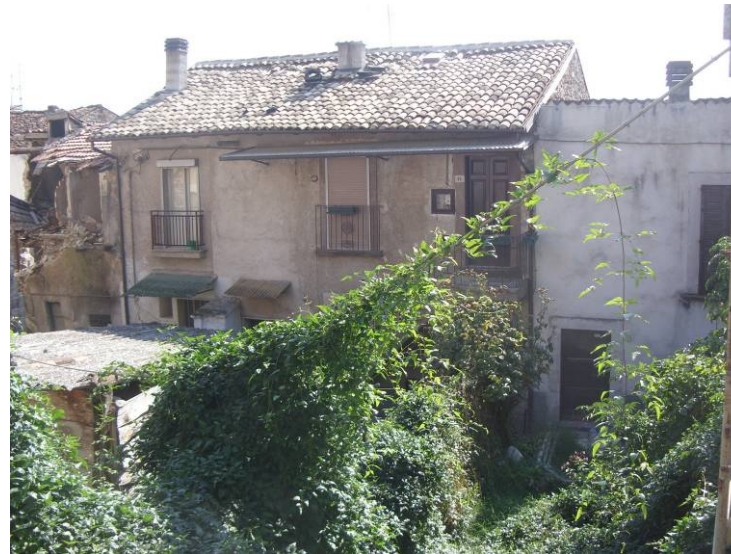
Testata d'angolo su via del Pizzicagnolo

Interni. Collasso degli orizzontamenti

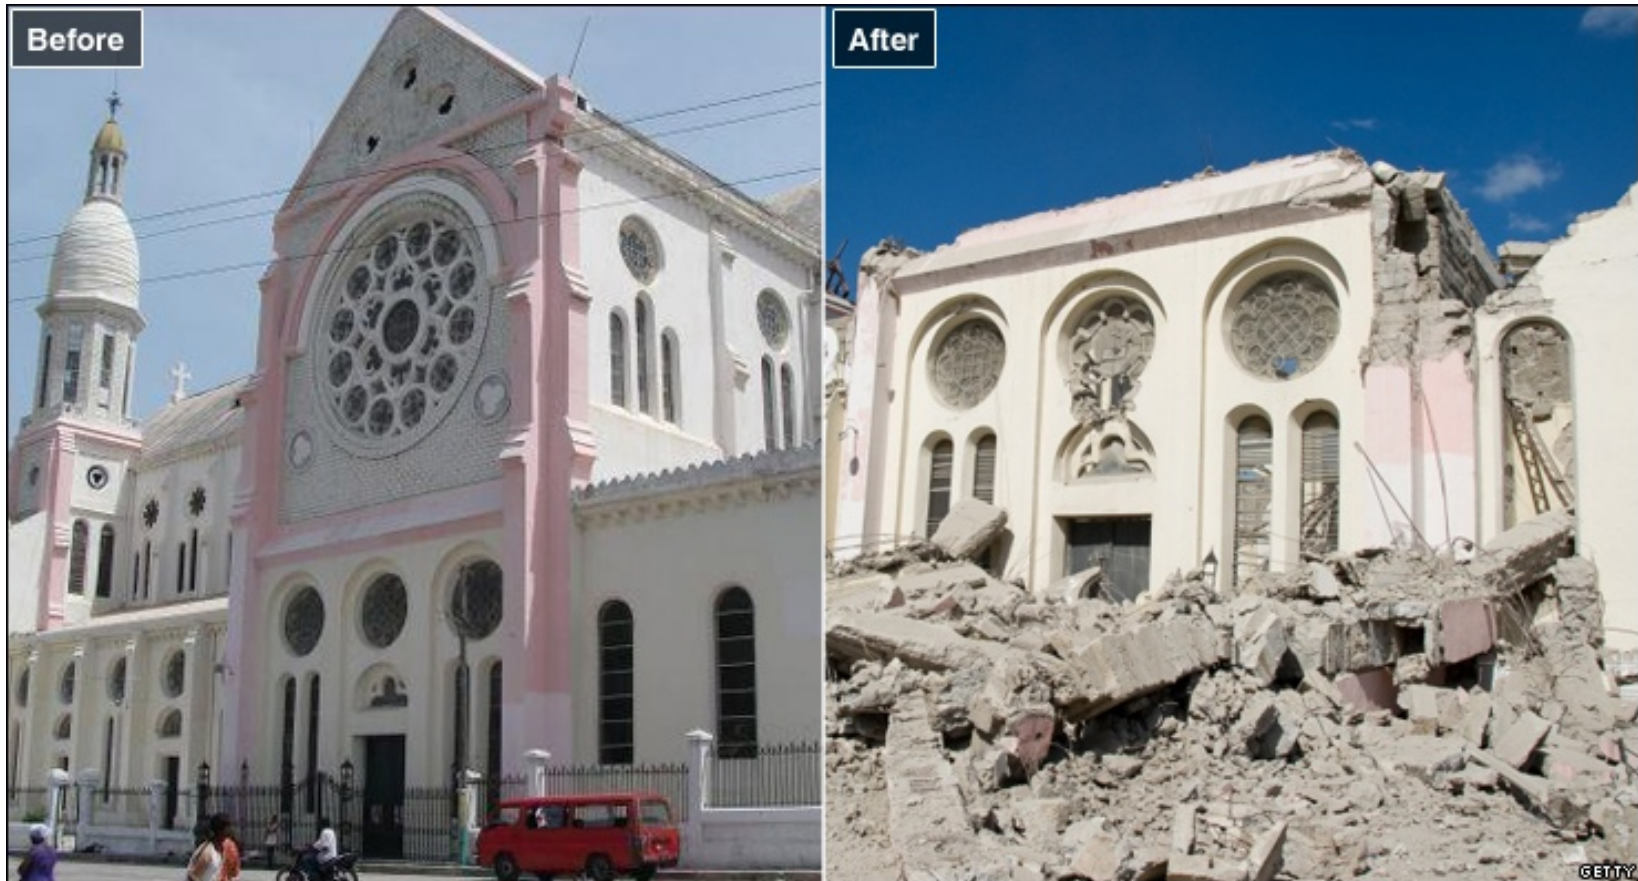
Port-au-Prince, Cathedral

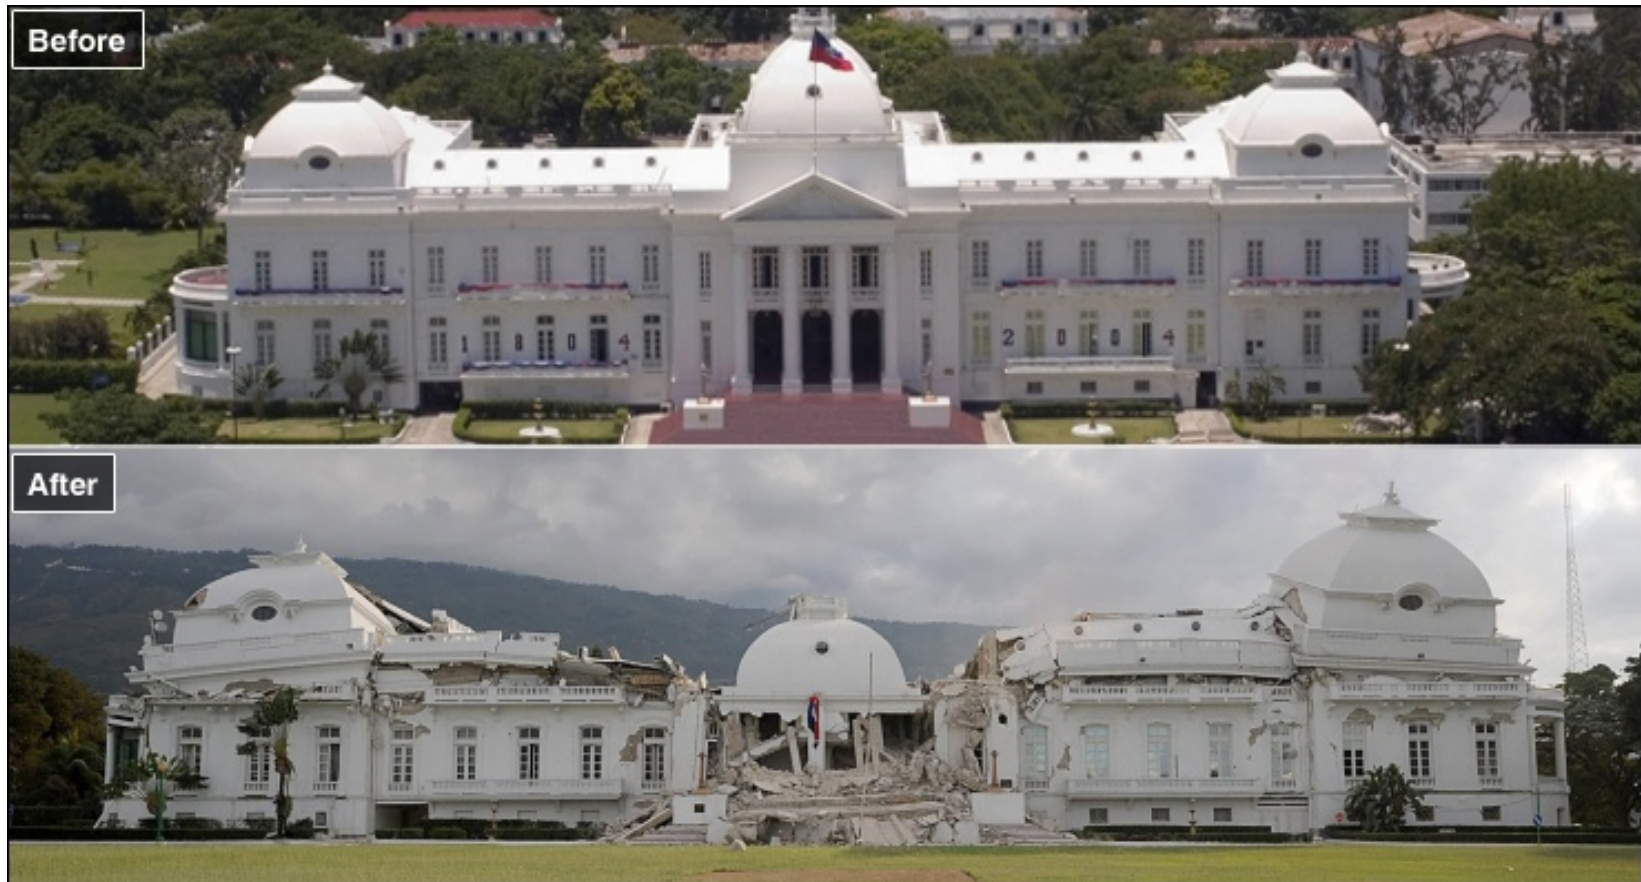
Port-au-Prince, Presidential Palace

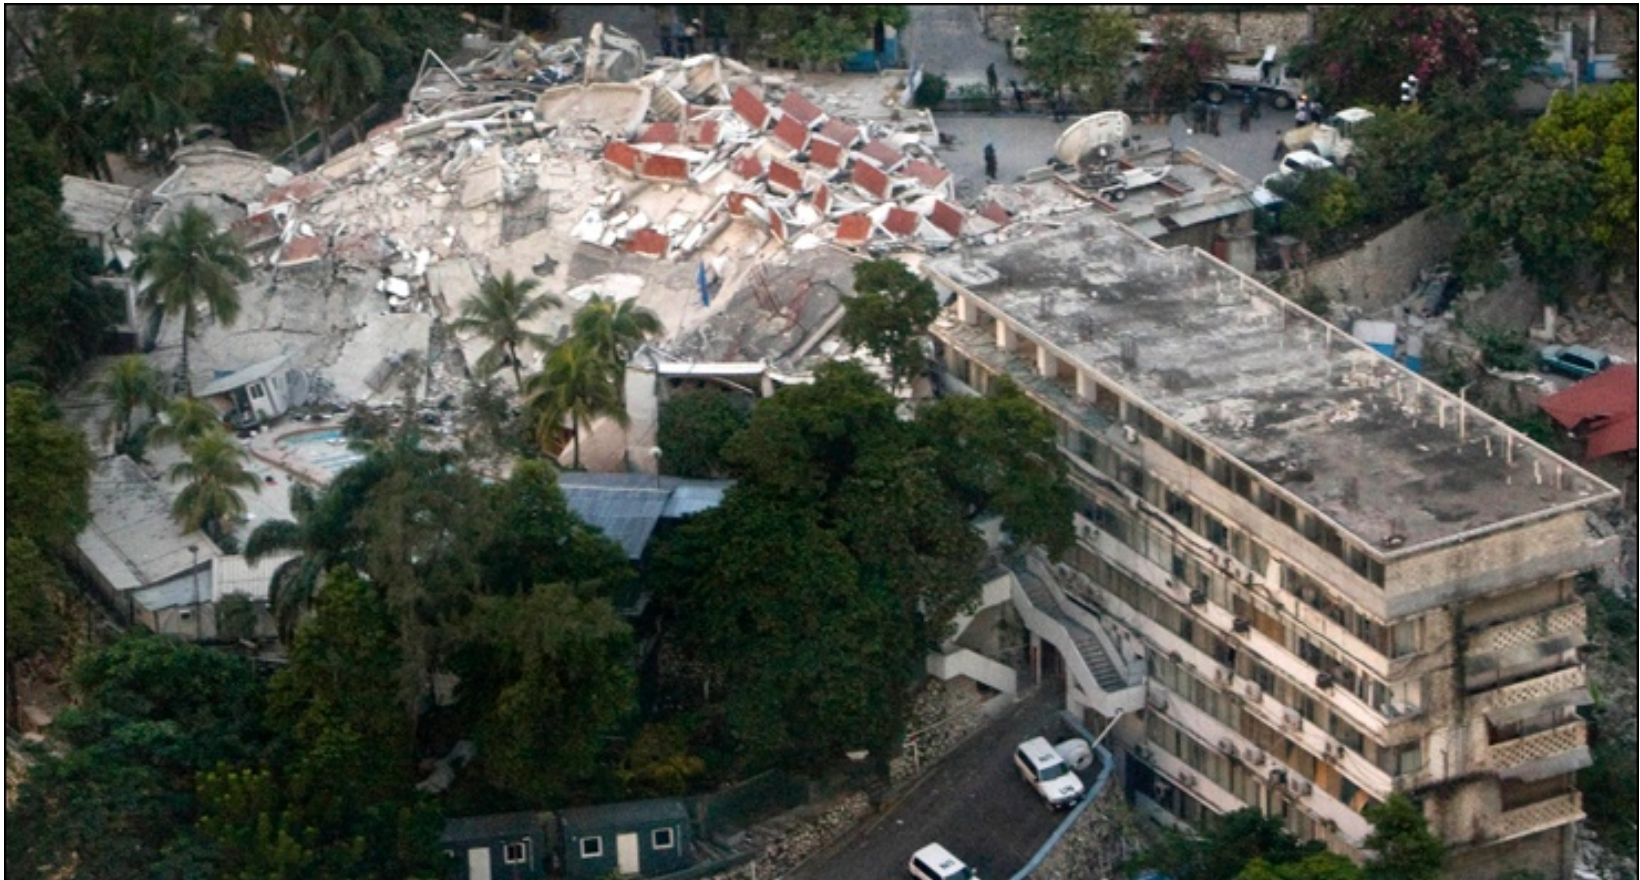
Port-au-Prince, United Nations mission

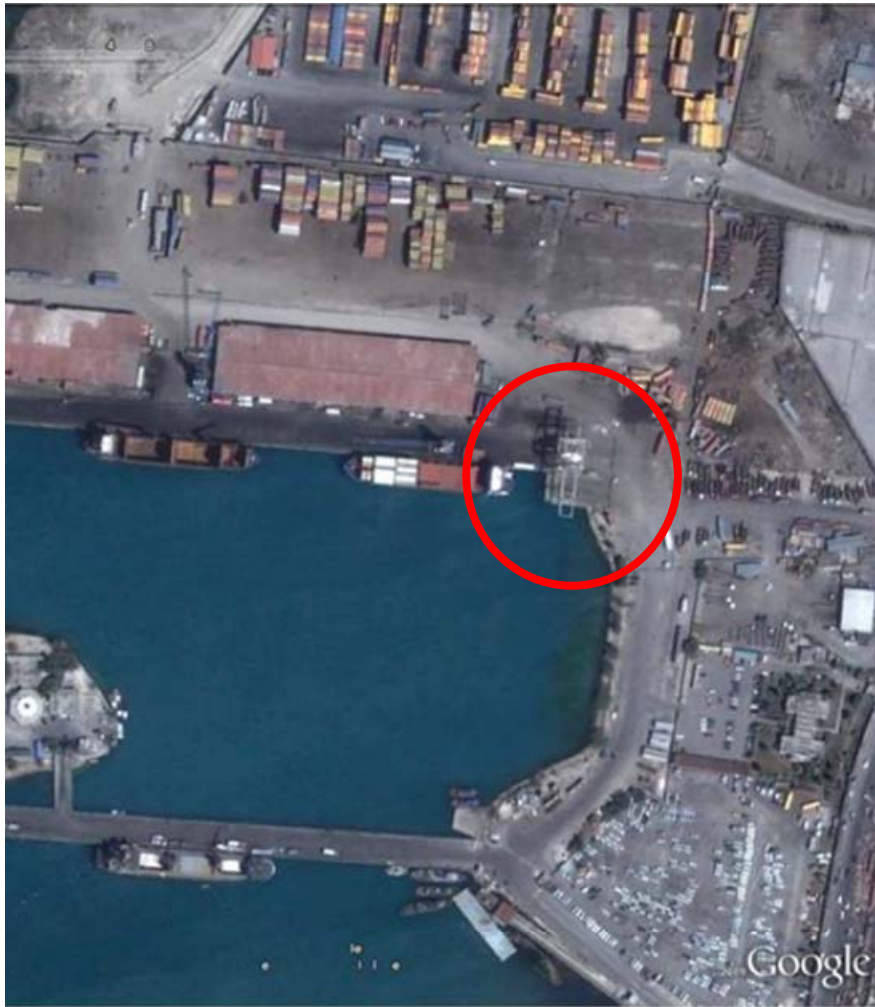
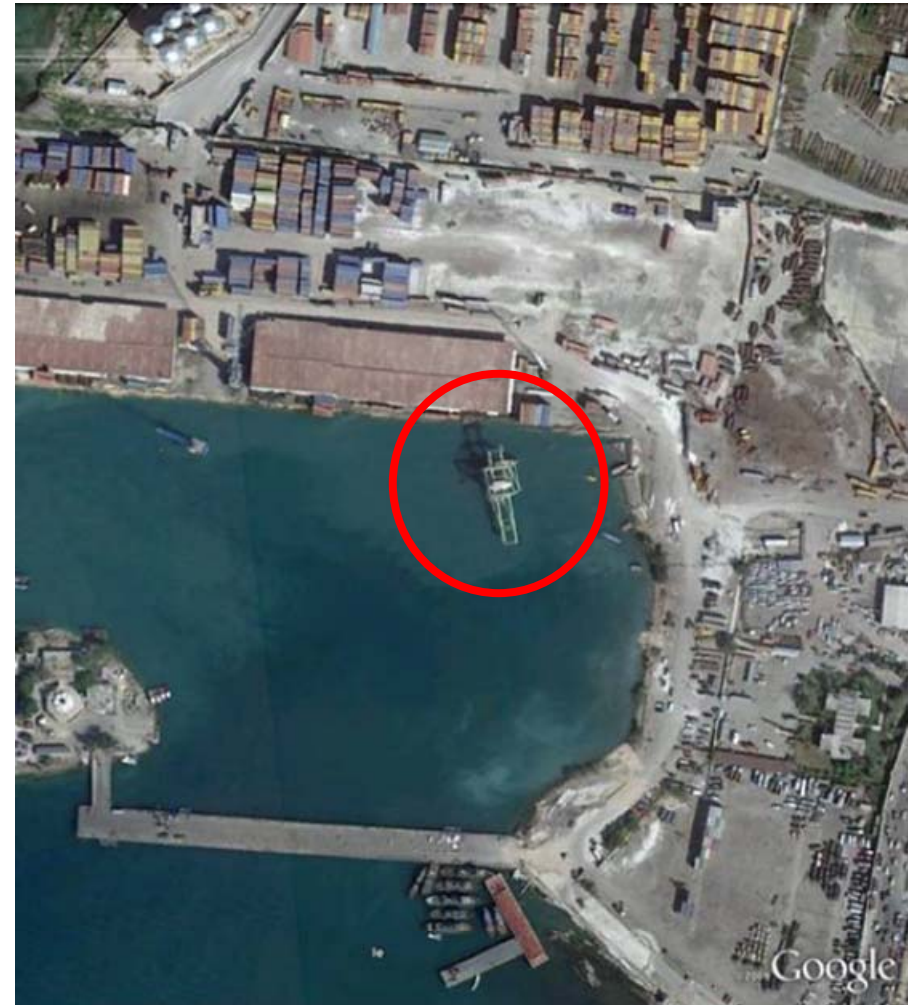
before

after

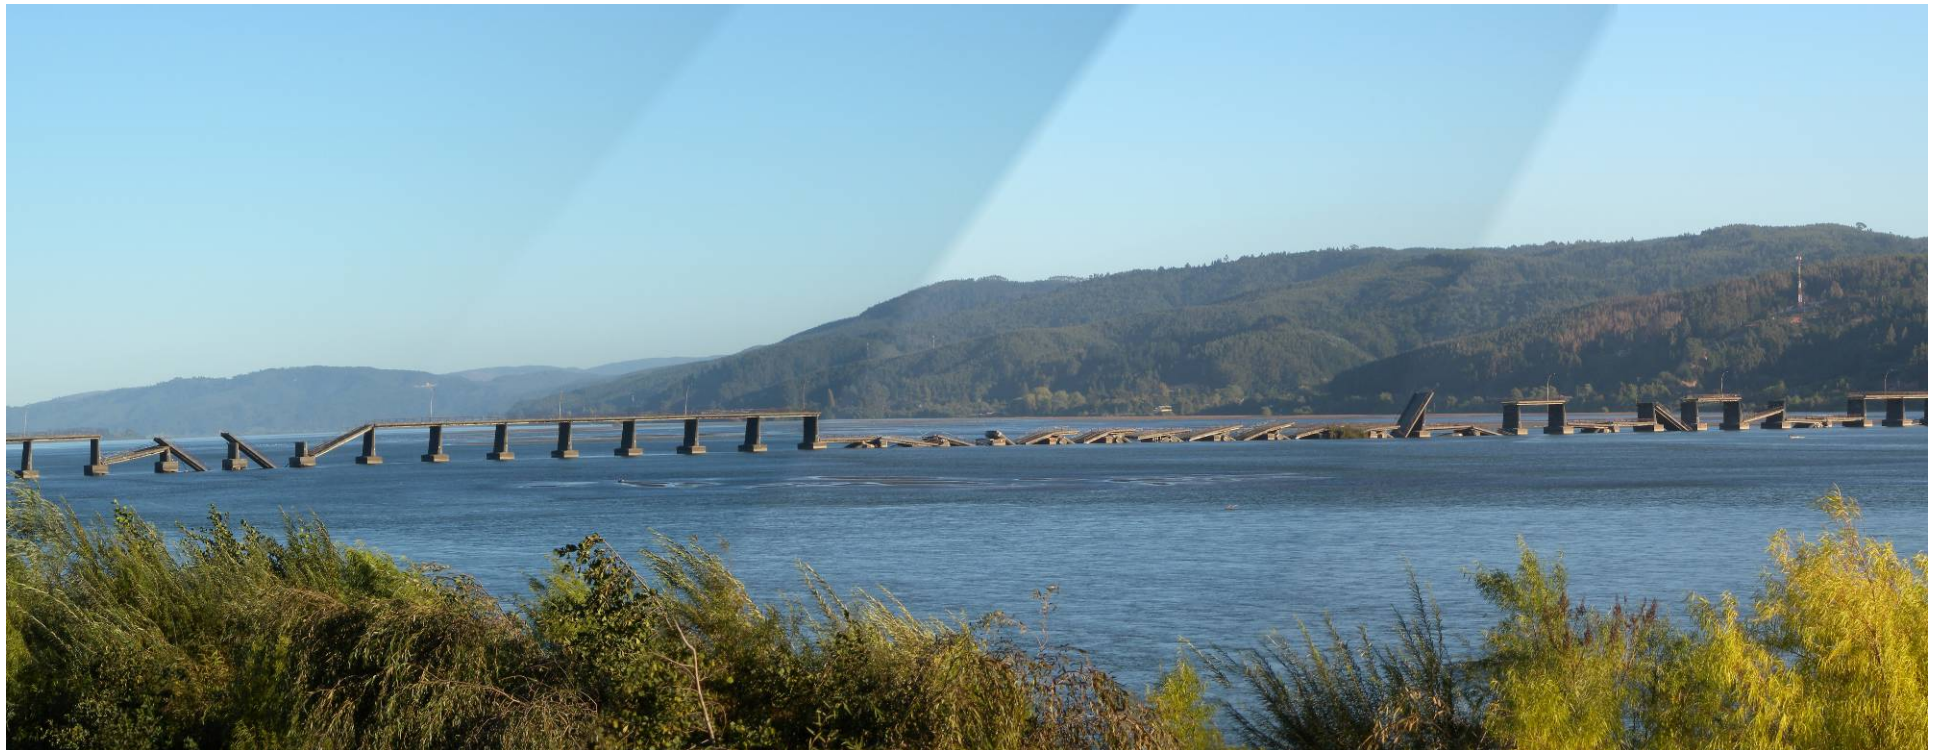
Concepcion, Puente Viejo

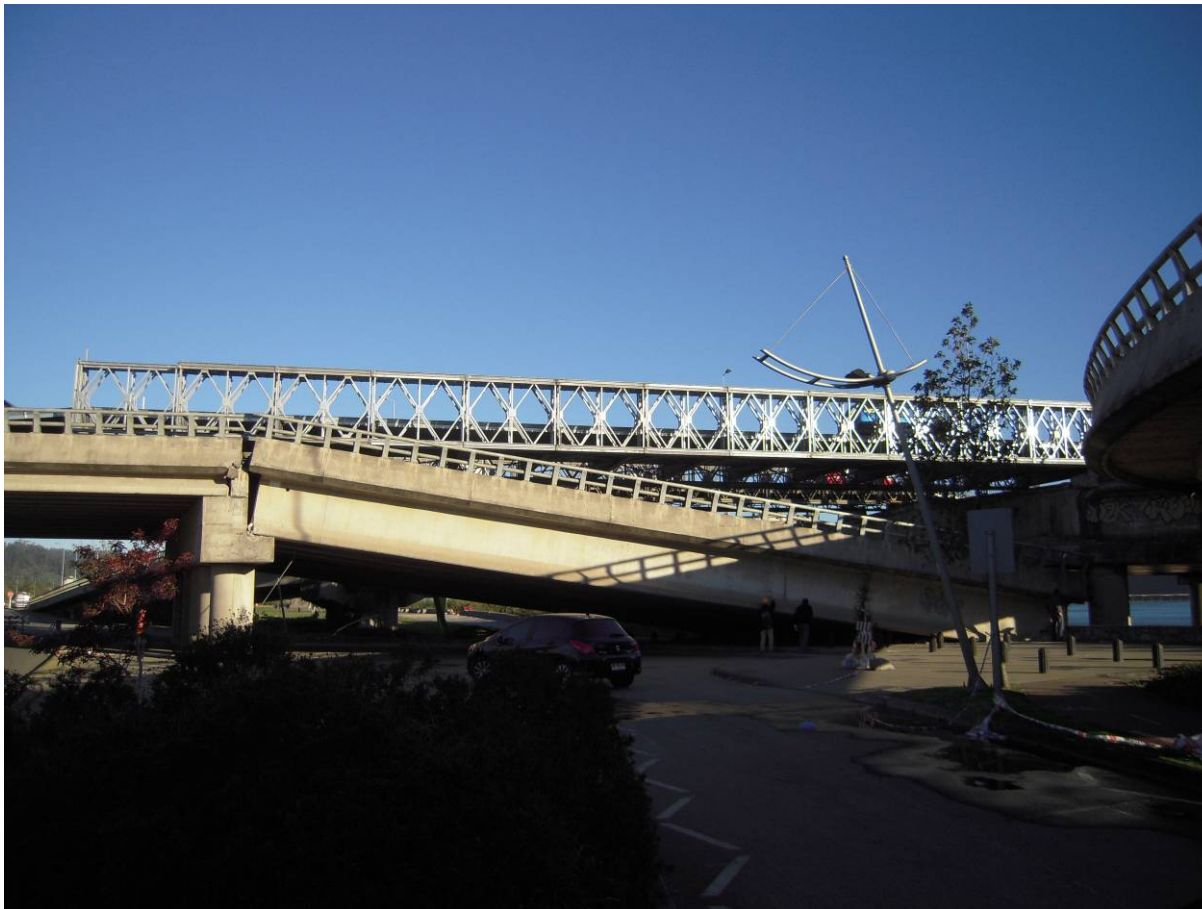
Concepcion, Puente Llacolen

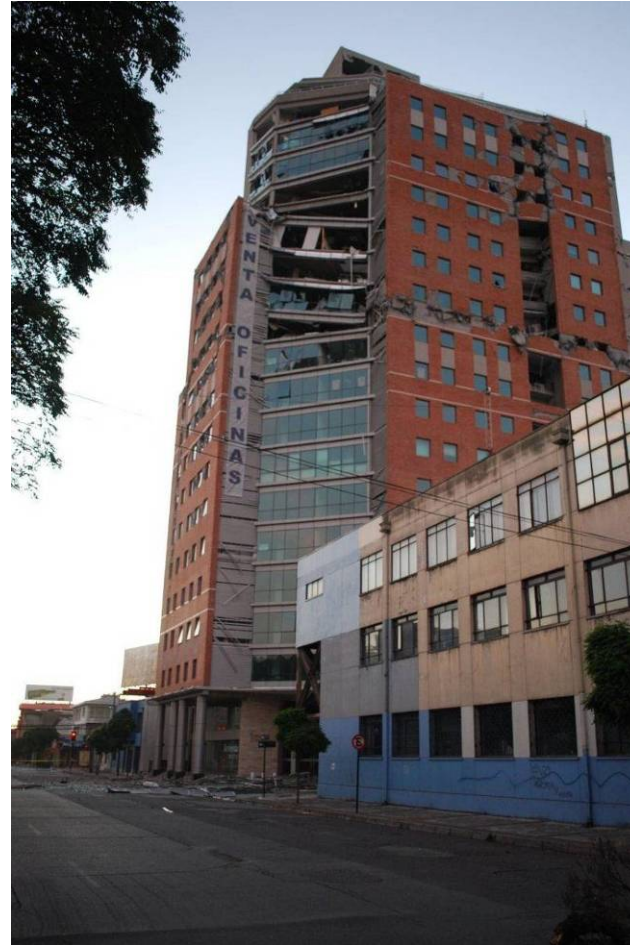
Concepcion, Torre O'Higgins. Completed in 2008.

Concepcion, Torre  
O'Higgins.  
Dramatic failure above the  
10th floor due vertical  
stiffness discontinuity

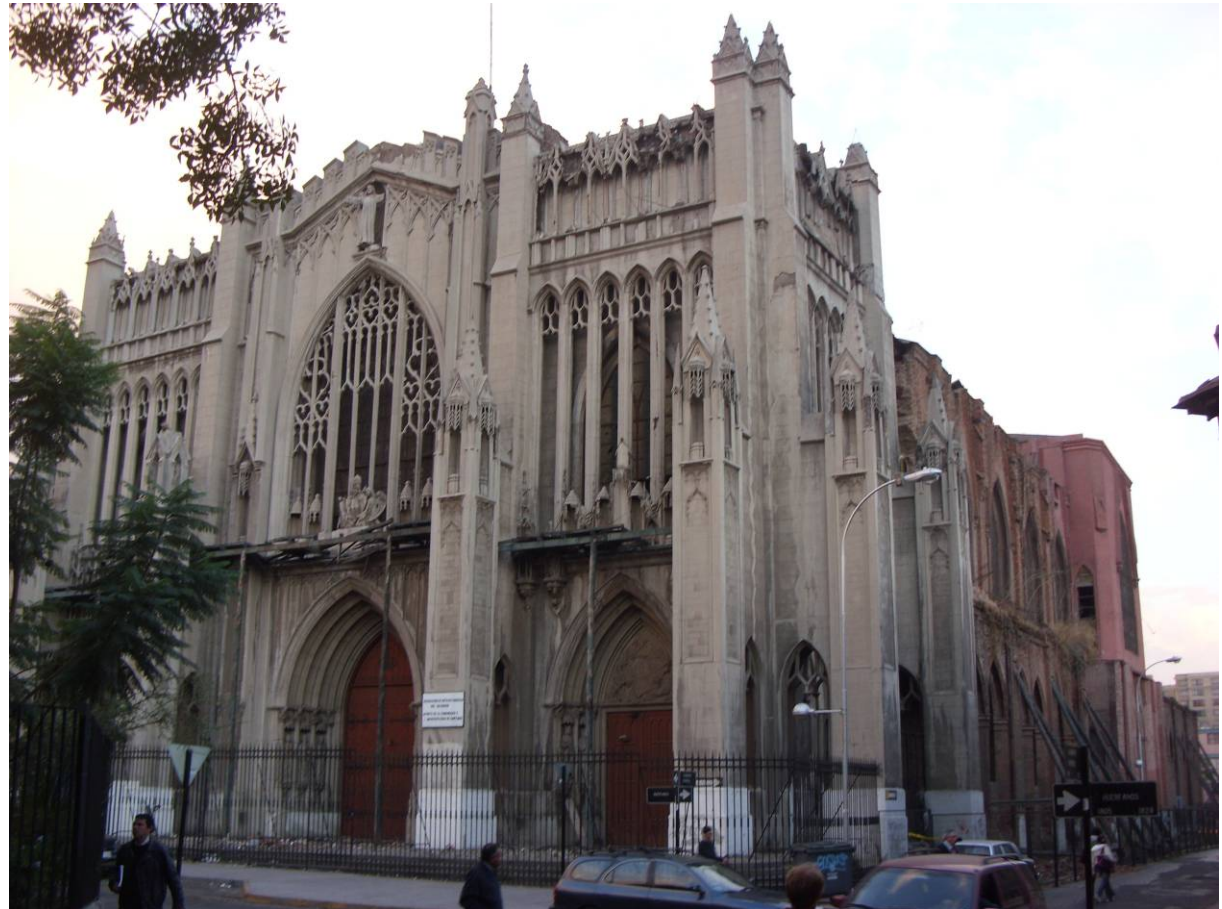
Santiago, Huérfanos esquina S.O de Almirante Barroso

Neogotic church  
(1870 -1872).  
Severely damaged  
(partial collapses  
and shoring) during  
1985 EQ. Only a  
chapel was used  
up to 1990.  
Thereafter closed.  
Dimensions: 98 x  
37 m, internal  
height 30 m  
(capable of 5000  
persons).

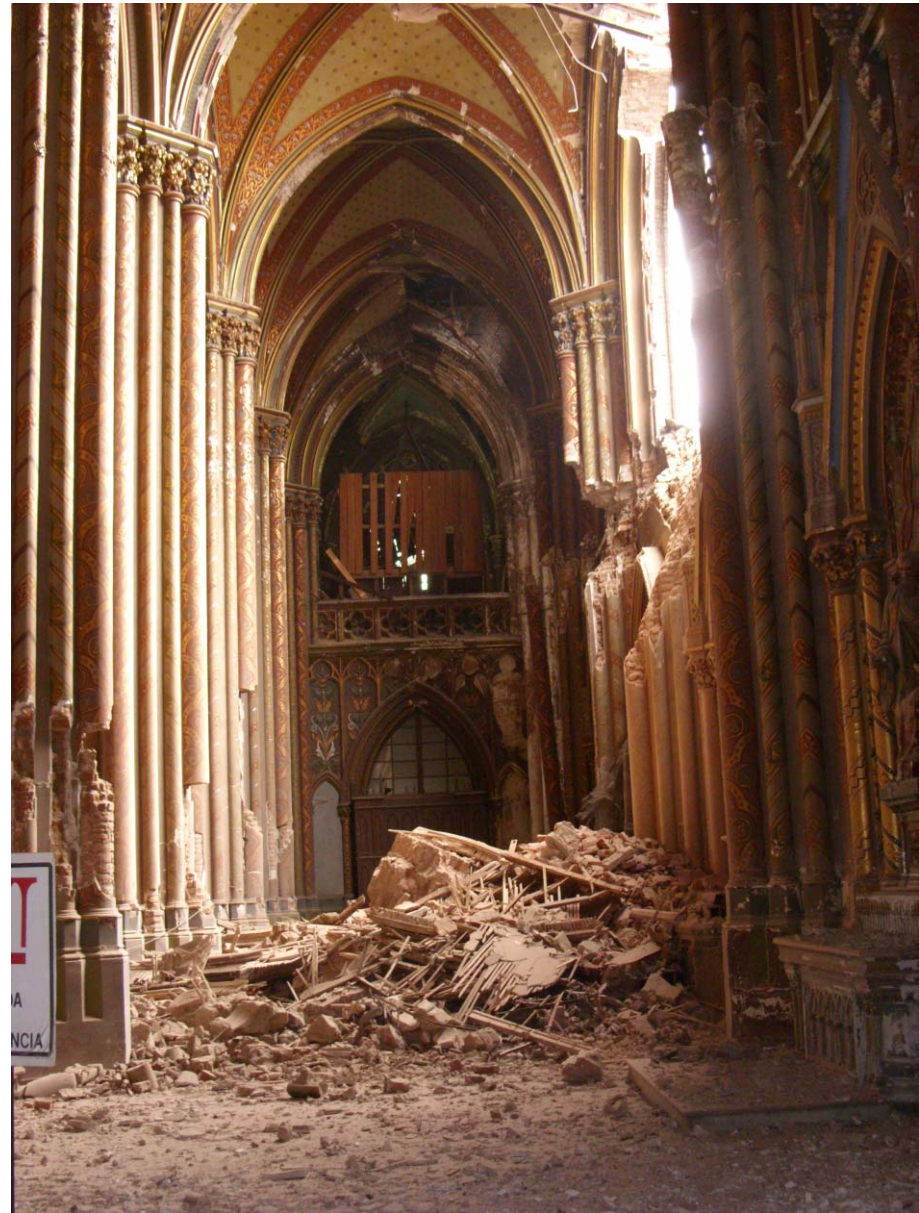
Santiago, Huérfanos esquina  
S.O de Almirante Barroso

Brick masonry.  
Partial collapse of  
the left and right  
walls in the first  
bay; collapse of the  
left wall in the third  
bay; collapse of the  
second right pillar;  
third and fourth  
pillars reinforced  
concrete after the  
1985 EQ; collapse  
of a large part of  
the timber false  
vault.

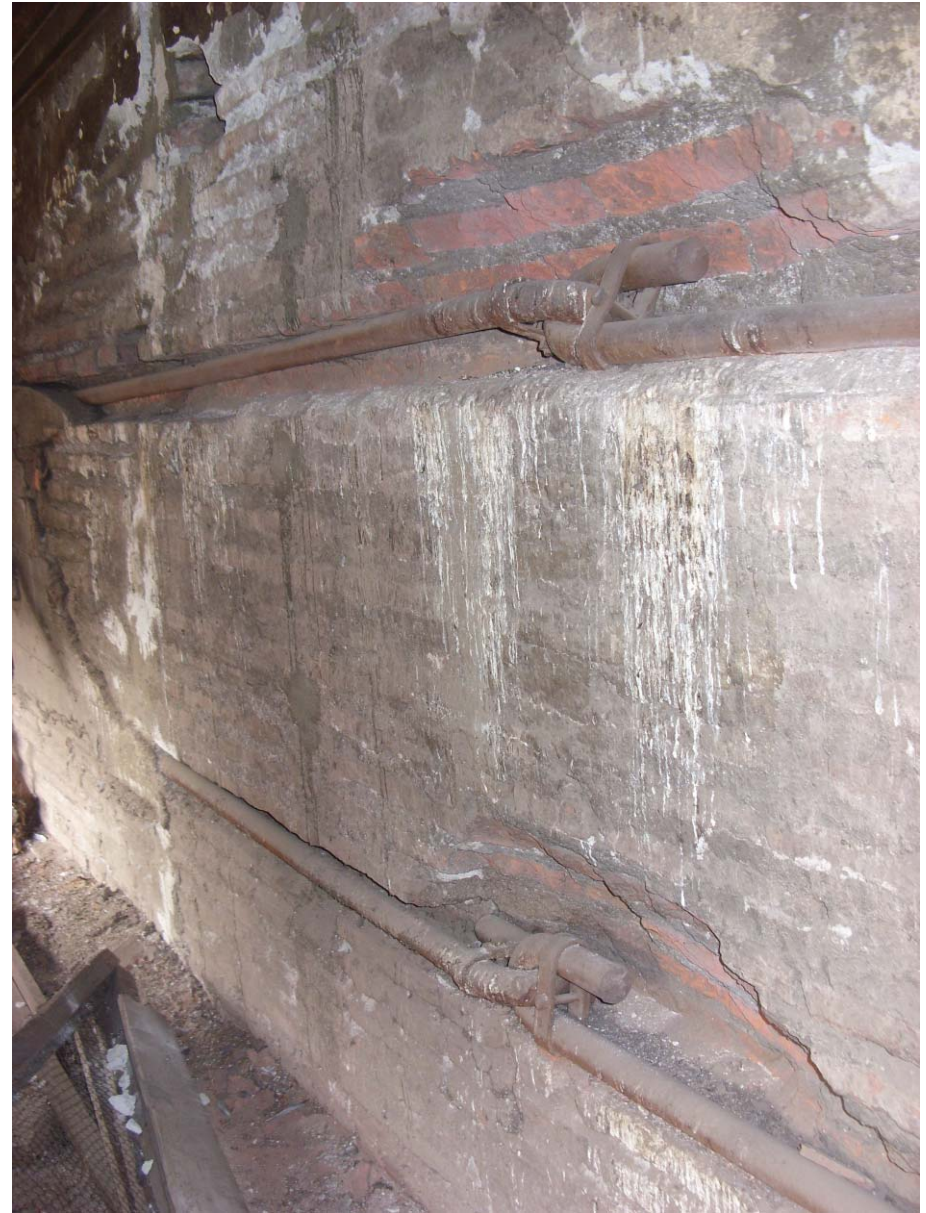
Santiago, Catedral con  
San Martin

Historical tie rods.

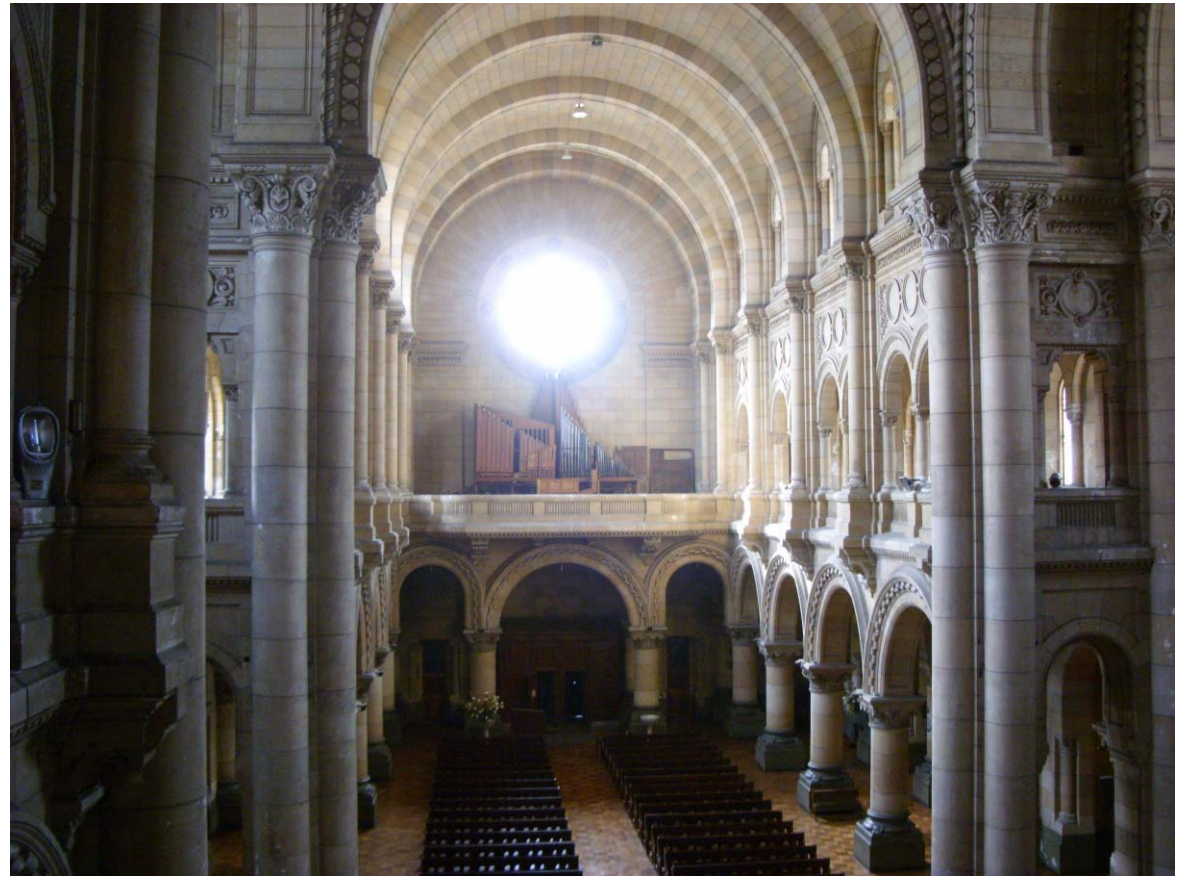
Santiago, Santa Isabel con Arturo Prat

The church is completely built of reinforced concrete. It was one among the first in Chile. In the same era in Santiago other churches have been built using different techniques. Cold joints and gravel pockets are clearly visible.

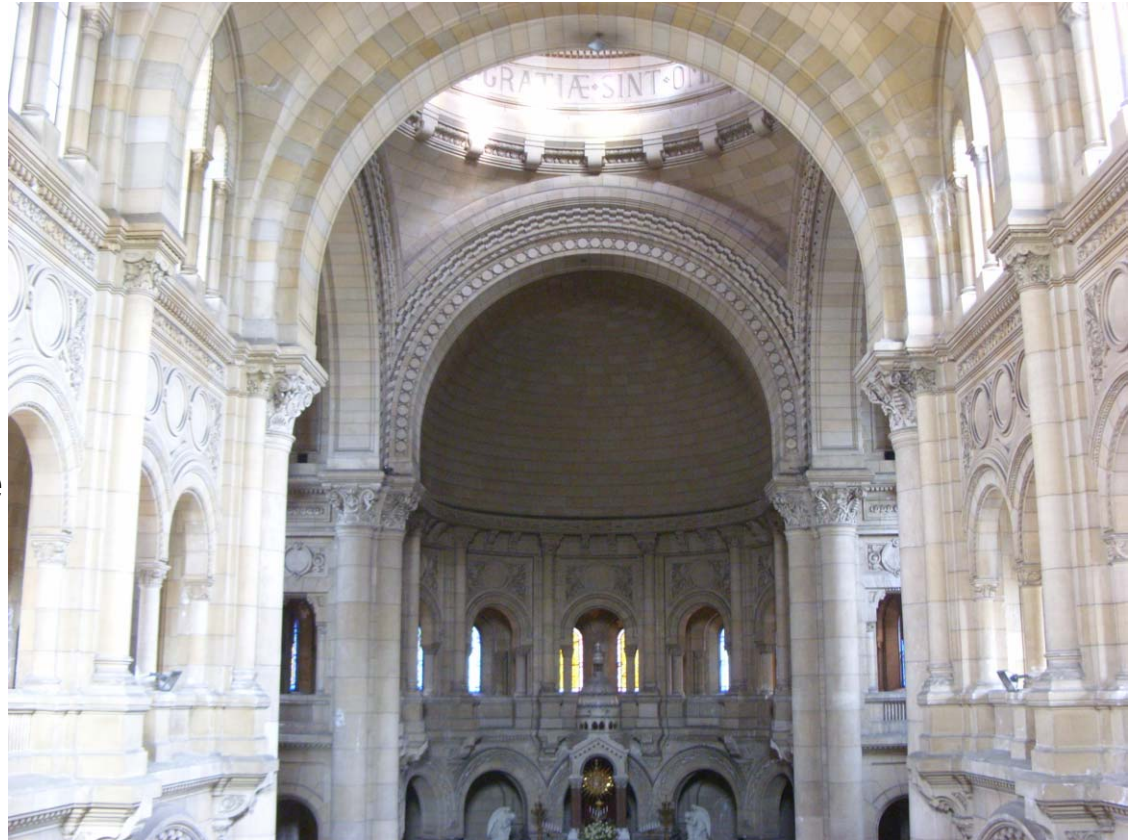
Santiago, Santa Isabel con Arturo Prat

Damages to drum windows and overturning of the crosses on top of the façade lateral pinnacles (the south one due to the March 11th, aftershock).

Very limited cracks inside in the first bay of the central nave.

In 1985 damages to façade crosses and dome.

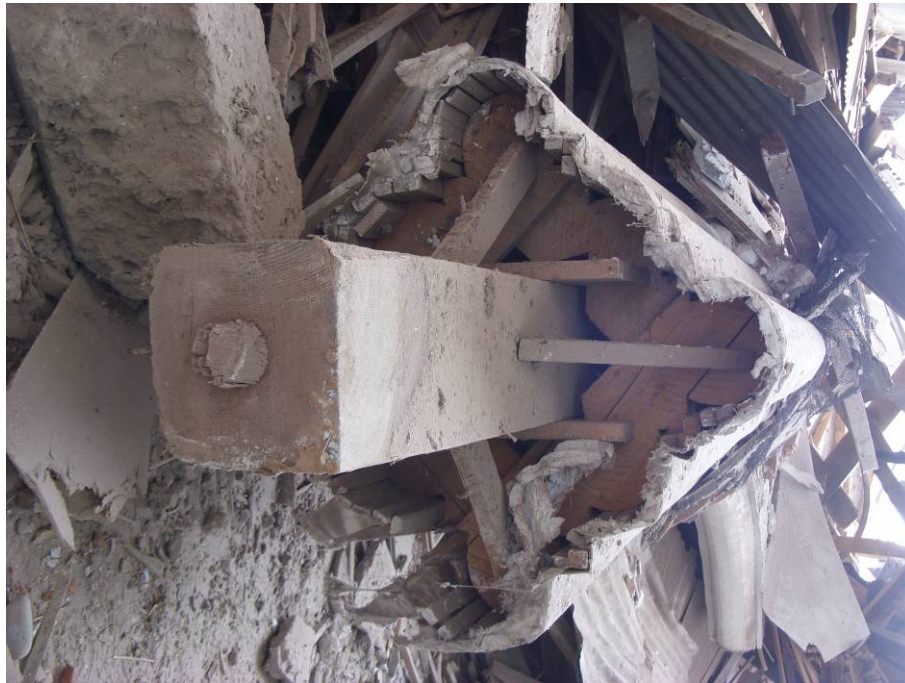
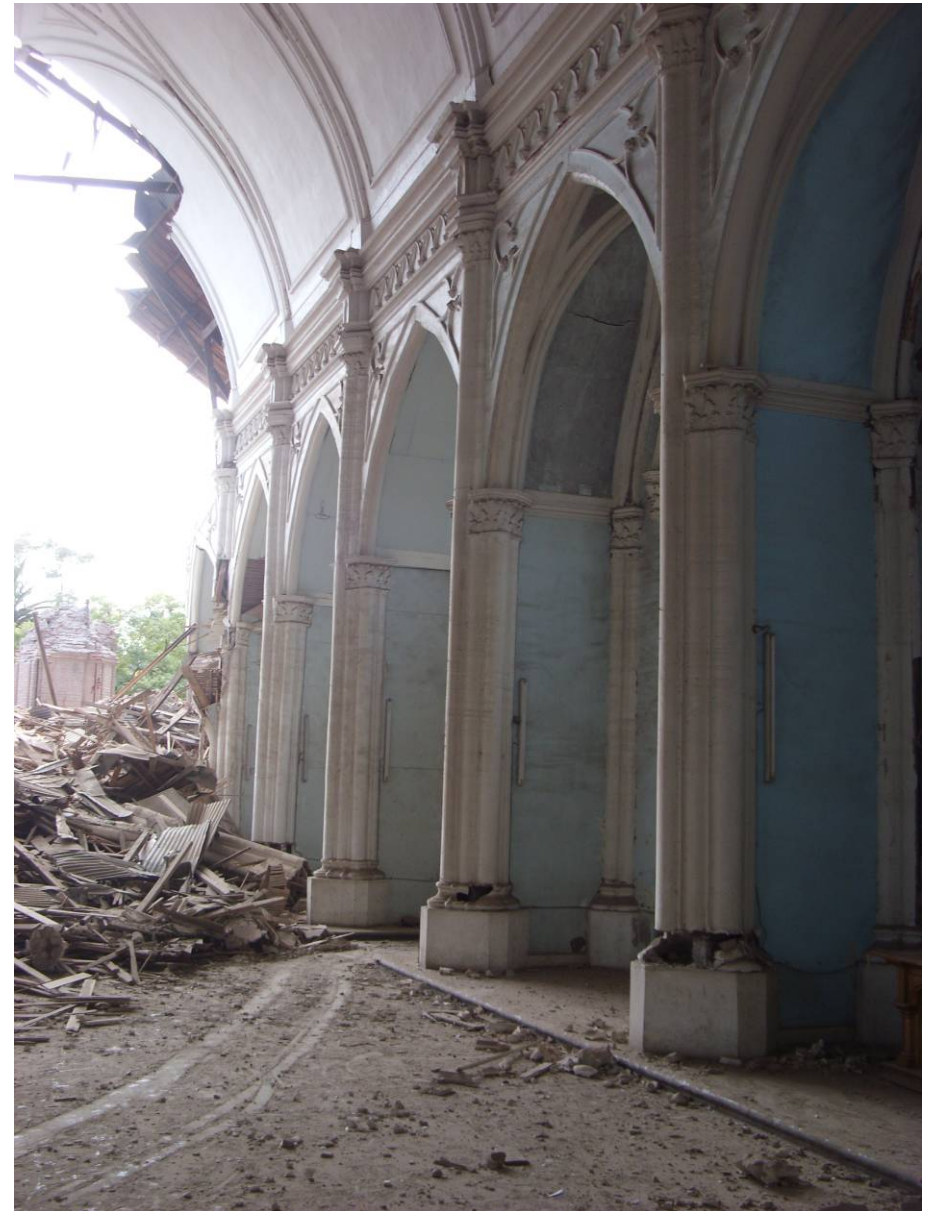
Curicò, España con Las Heras

Timber columns

Brick masonry walls,  
timber false vault.  
Severe damages

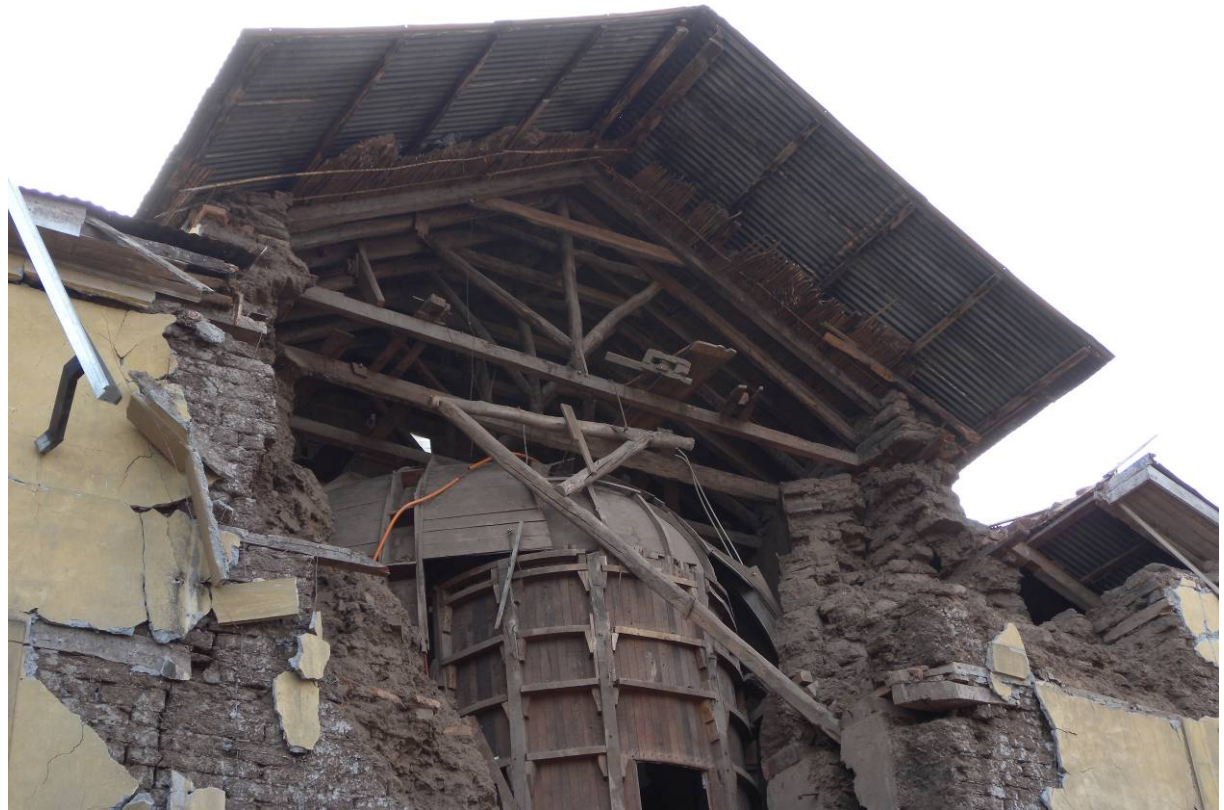
Curicò, San Martín con Carmen

Partial collapse of  
adobe apse.
